Design failures and faults contributing to incidents

Plant Safety in the Mining Industry Seminar

Gerry Gibb

Panthers Club
May 1st 2007

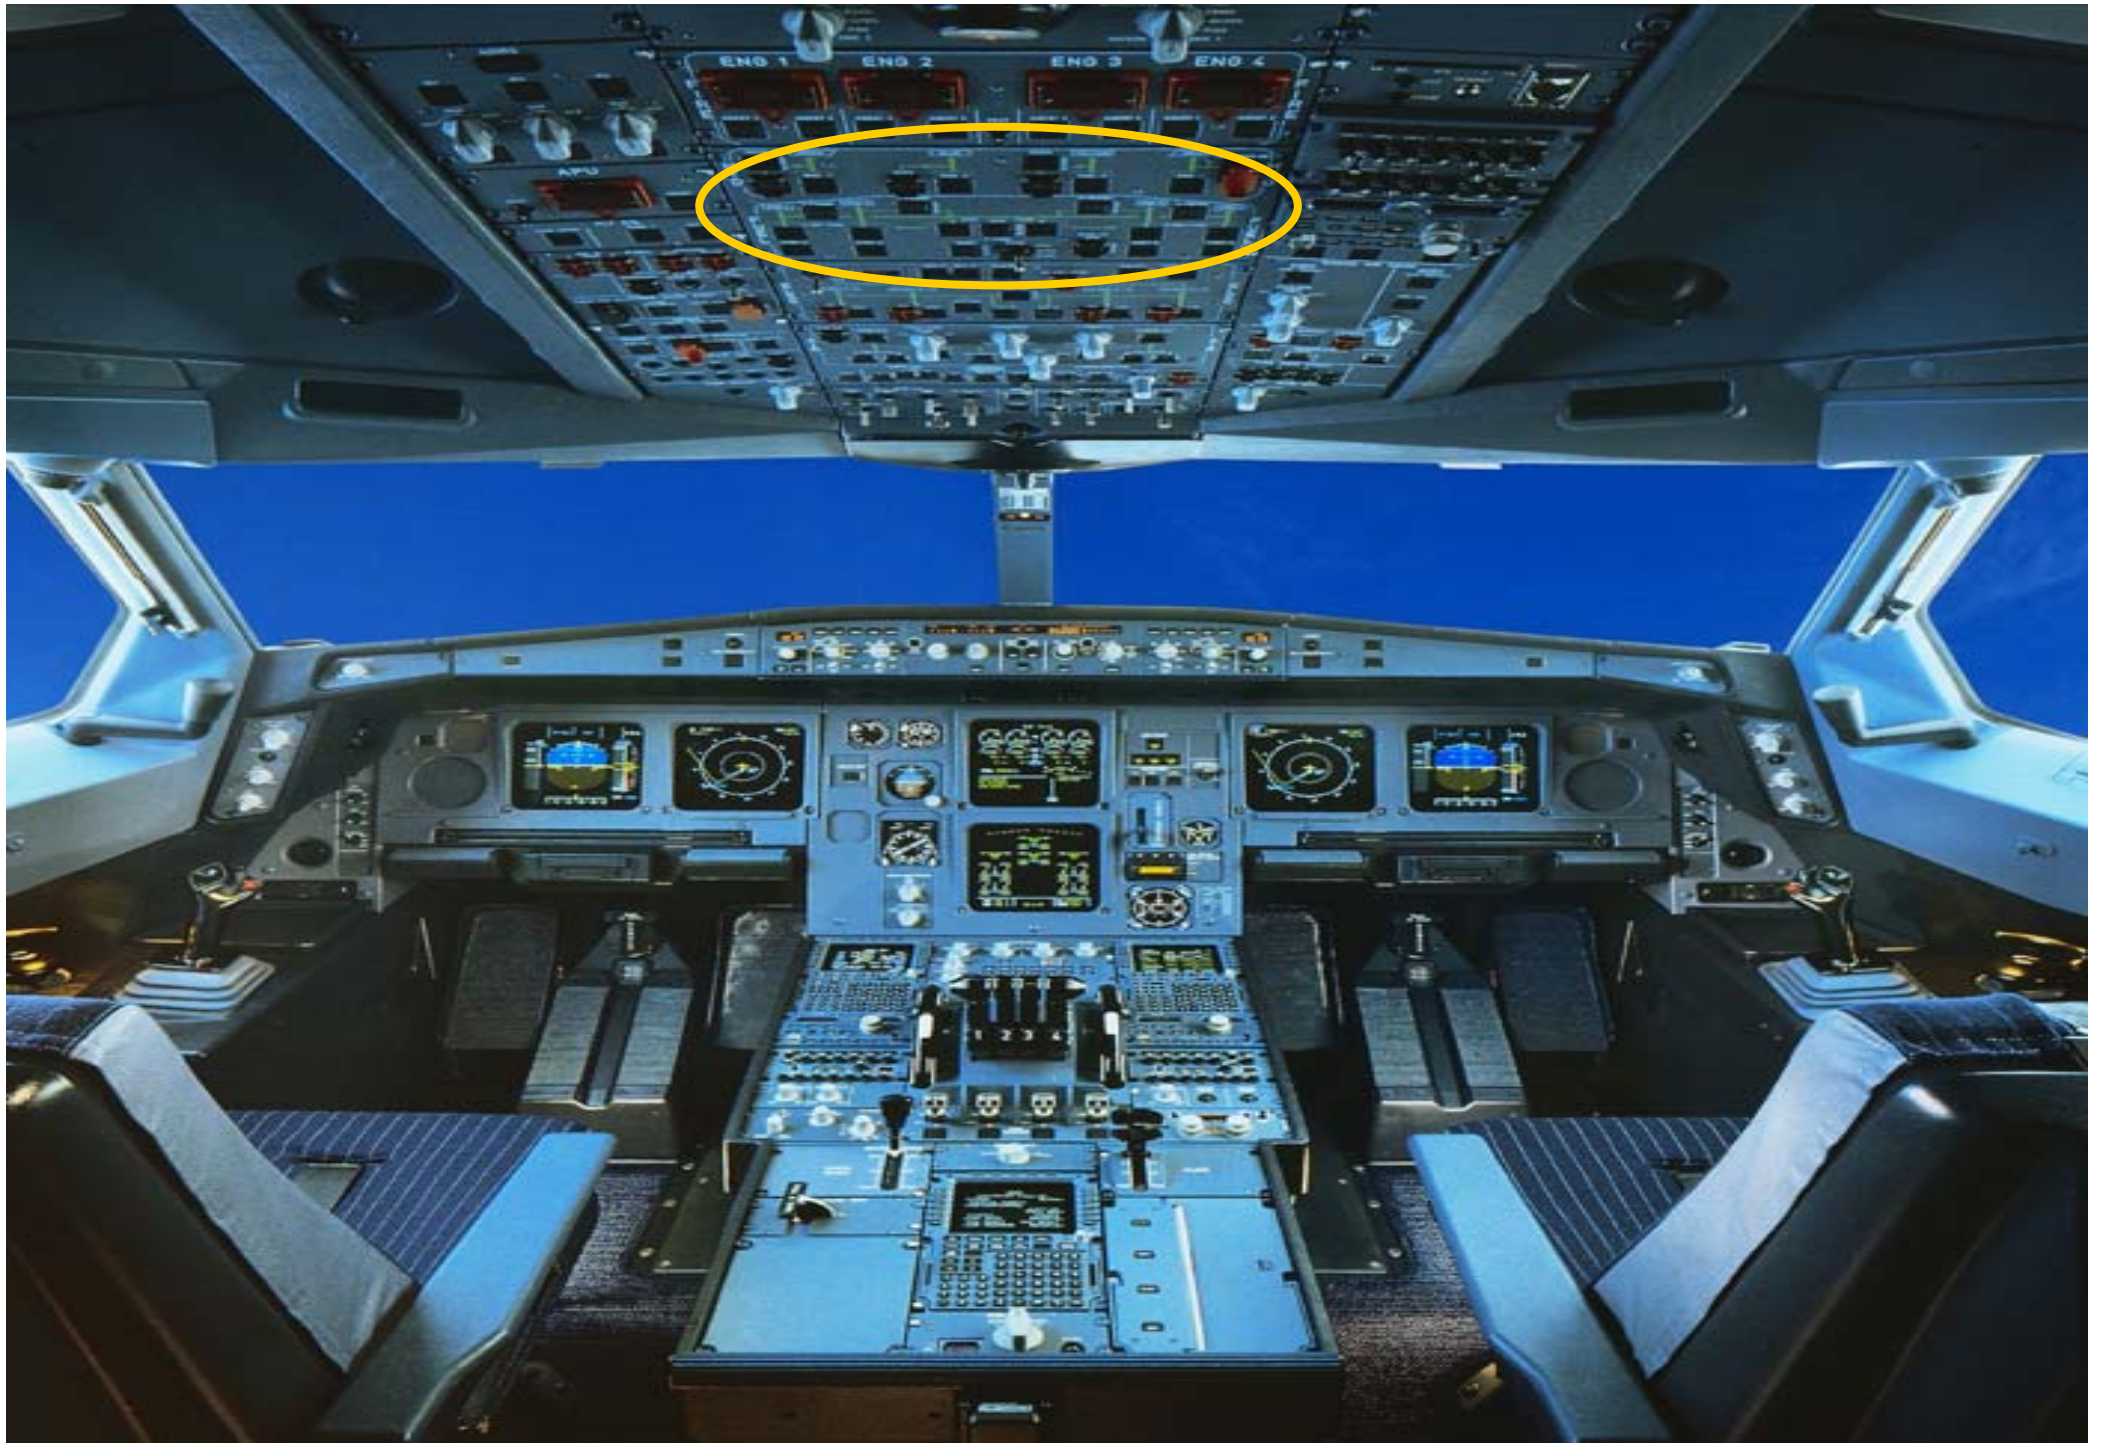
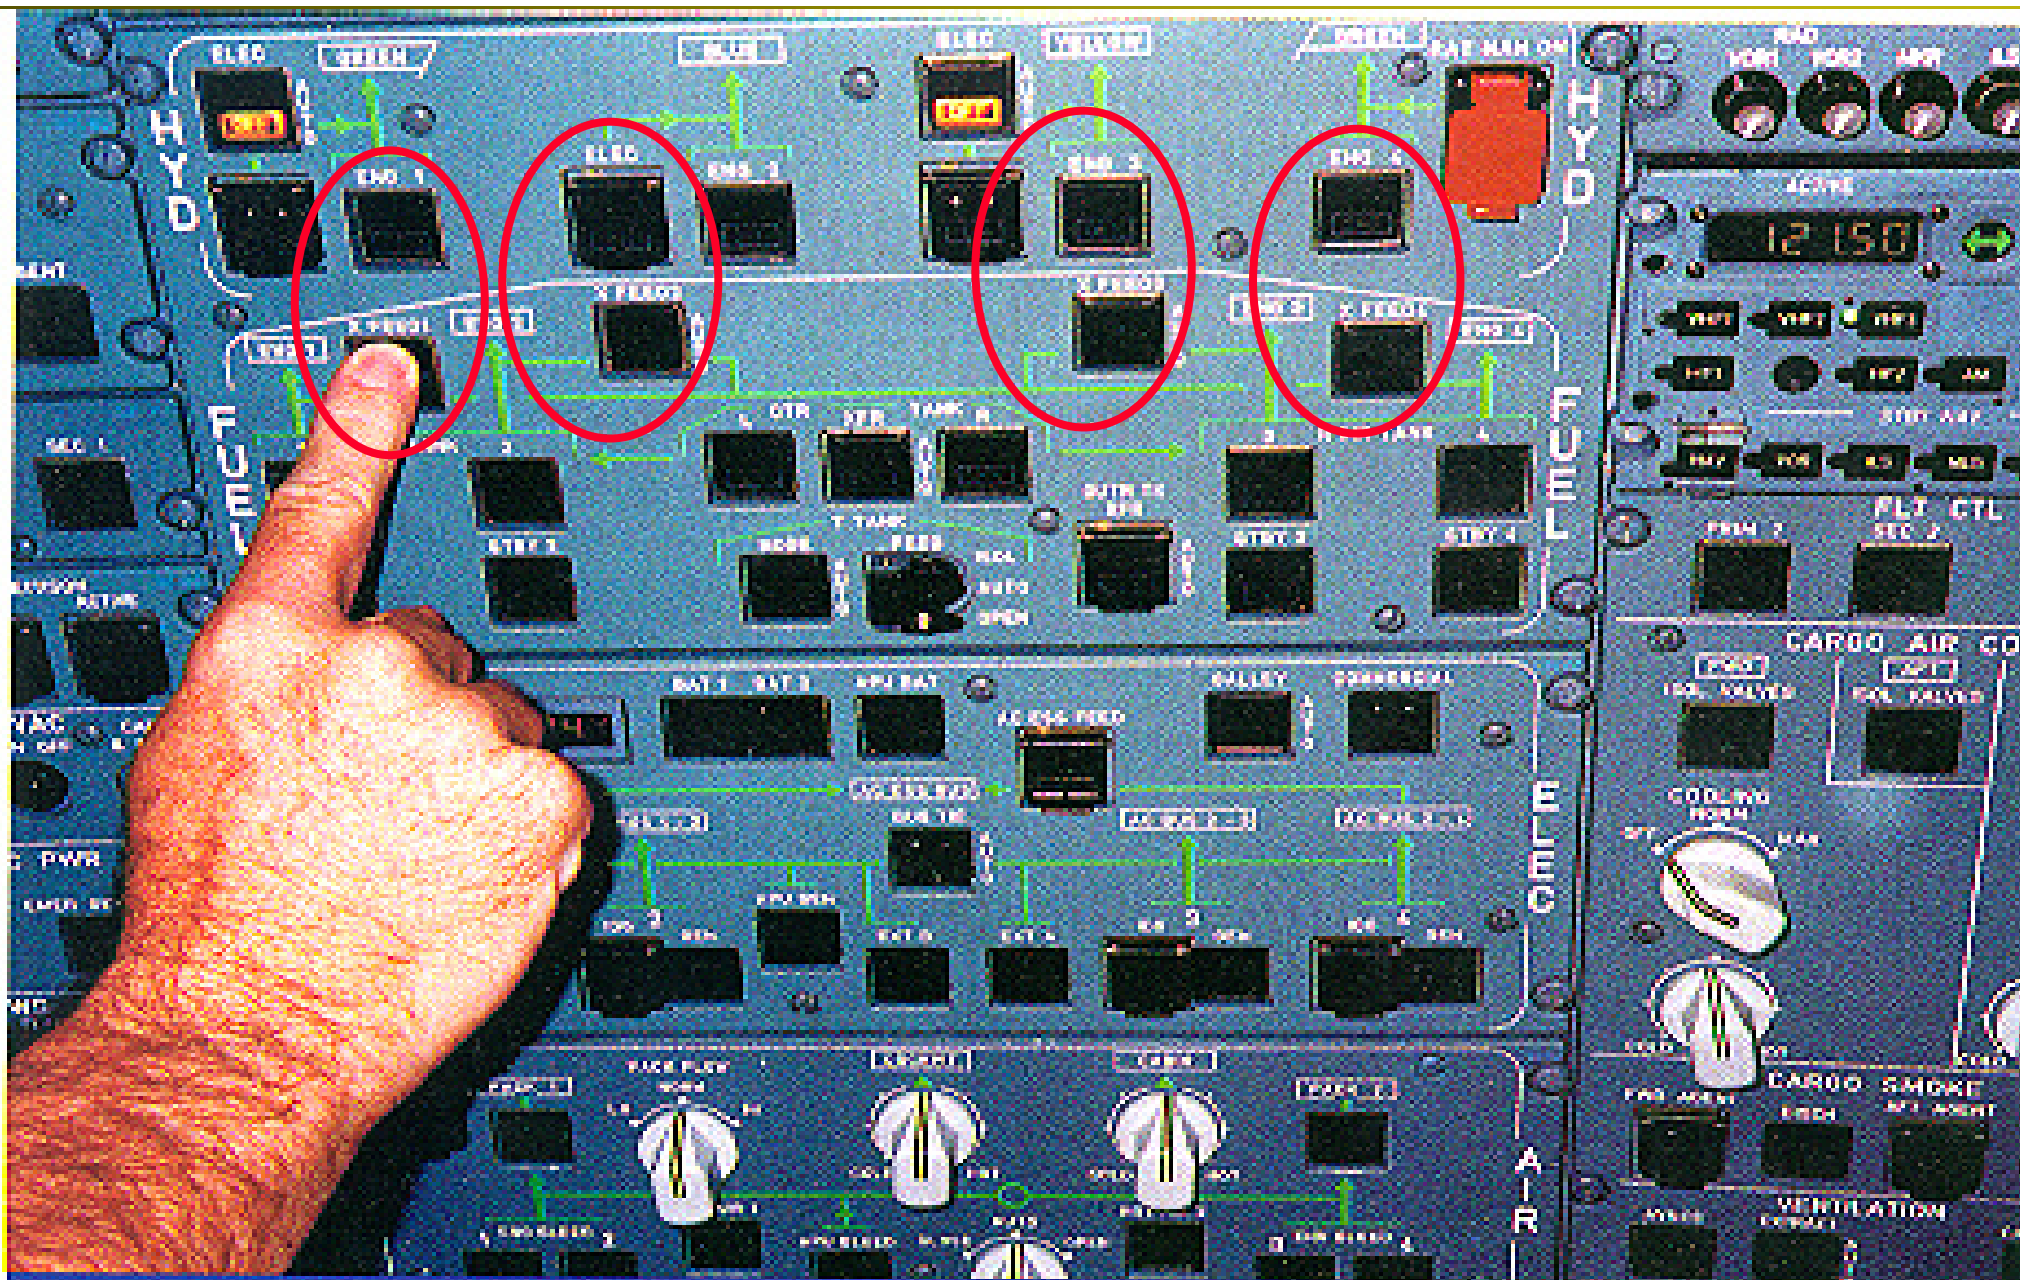
- Pilot (PNF) initially placed his finger on the fuel crossfeed switch,
- Pilot was **distracted**, with attention drawn to the ECAM (engine condition and monitoring) instrument panel
- Whilst pilot was observing the panel, his **finger moved slightly**, repositioning itself over the hydraulics switch
- Pilot continued with the crossfeed - looked up to his finger, and then **pressed the (incorrect) switch**. He then depressed the remaining 3 switches, believing them to be the fuel switches.
- The pilots noticed the problem before complete control was lost. But positive and negative accelerations did result in large pitch changes .
- The aircraft pitched up and then during recovery severe pitch up in the rear of the aircraft resulted in 1 serious injury (neck injuries) to cabin crew member

A340 centre overhead panel. Finger is on number 1 crossfeed valve switch. Number 1 engine driven-hydraulic pump switch is about 3 cm immediately above.

- The switches were not guarded
- They were of very similar appearance as fuel crossfeed switches
- Activated by the same push button switching action (Design/HF Issue - same action/feedback)
- Use same white illumination to indicate activation (Design/HF Issue - same feedback)
- Located immediately above the fuel crossfeed switches (Design/HF Issue - almost aligned)

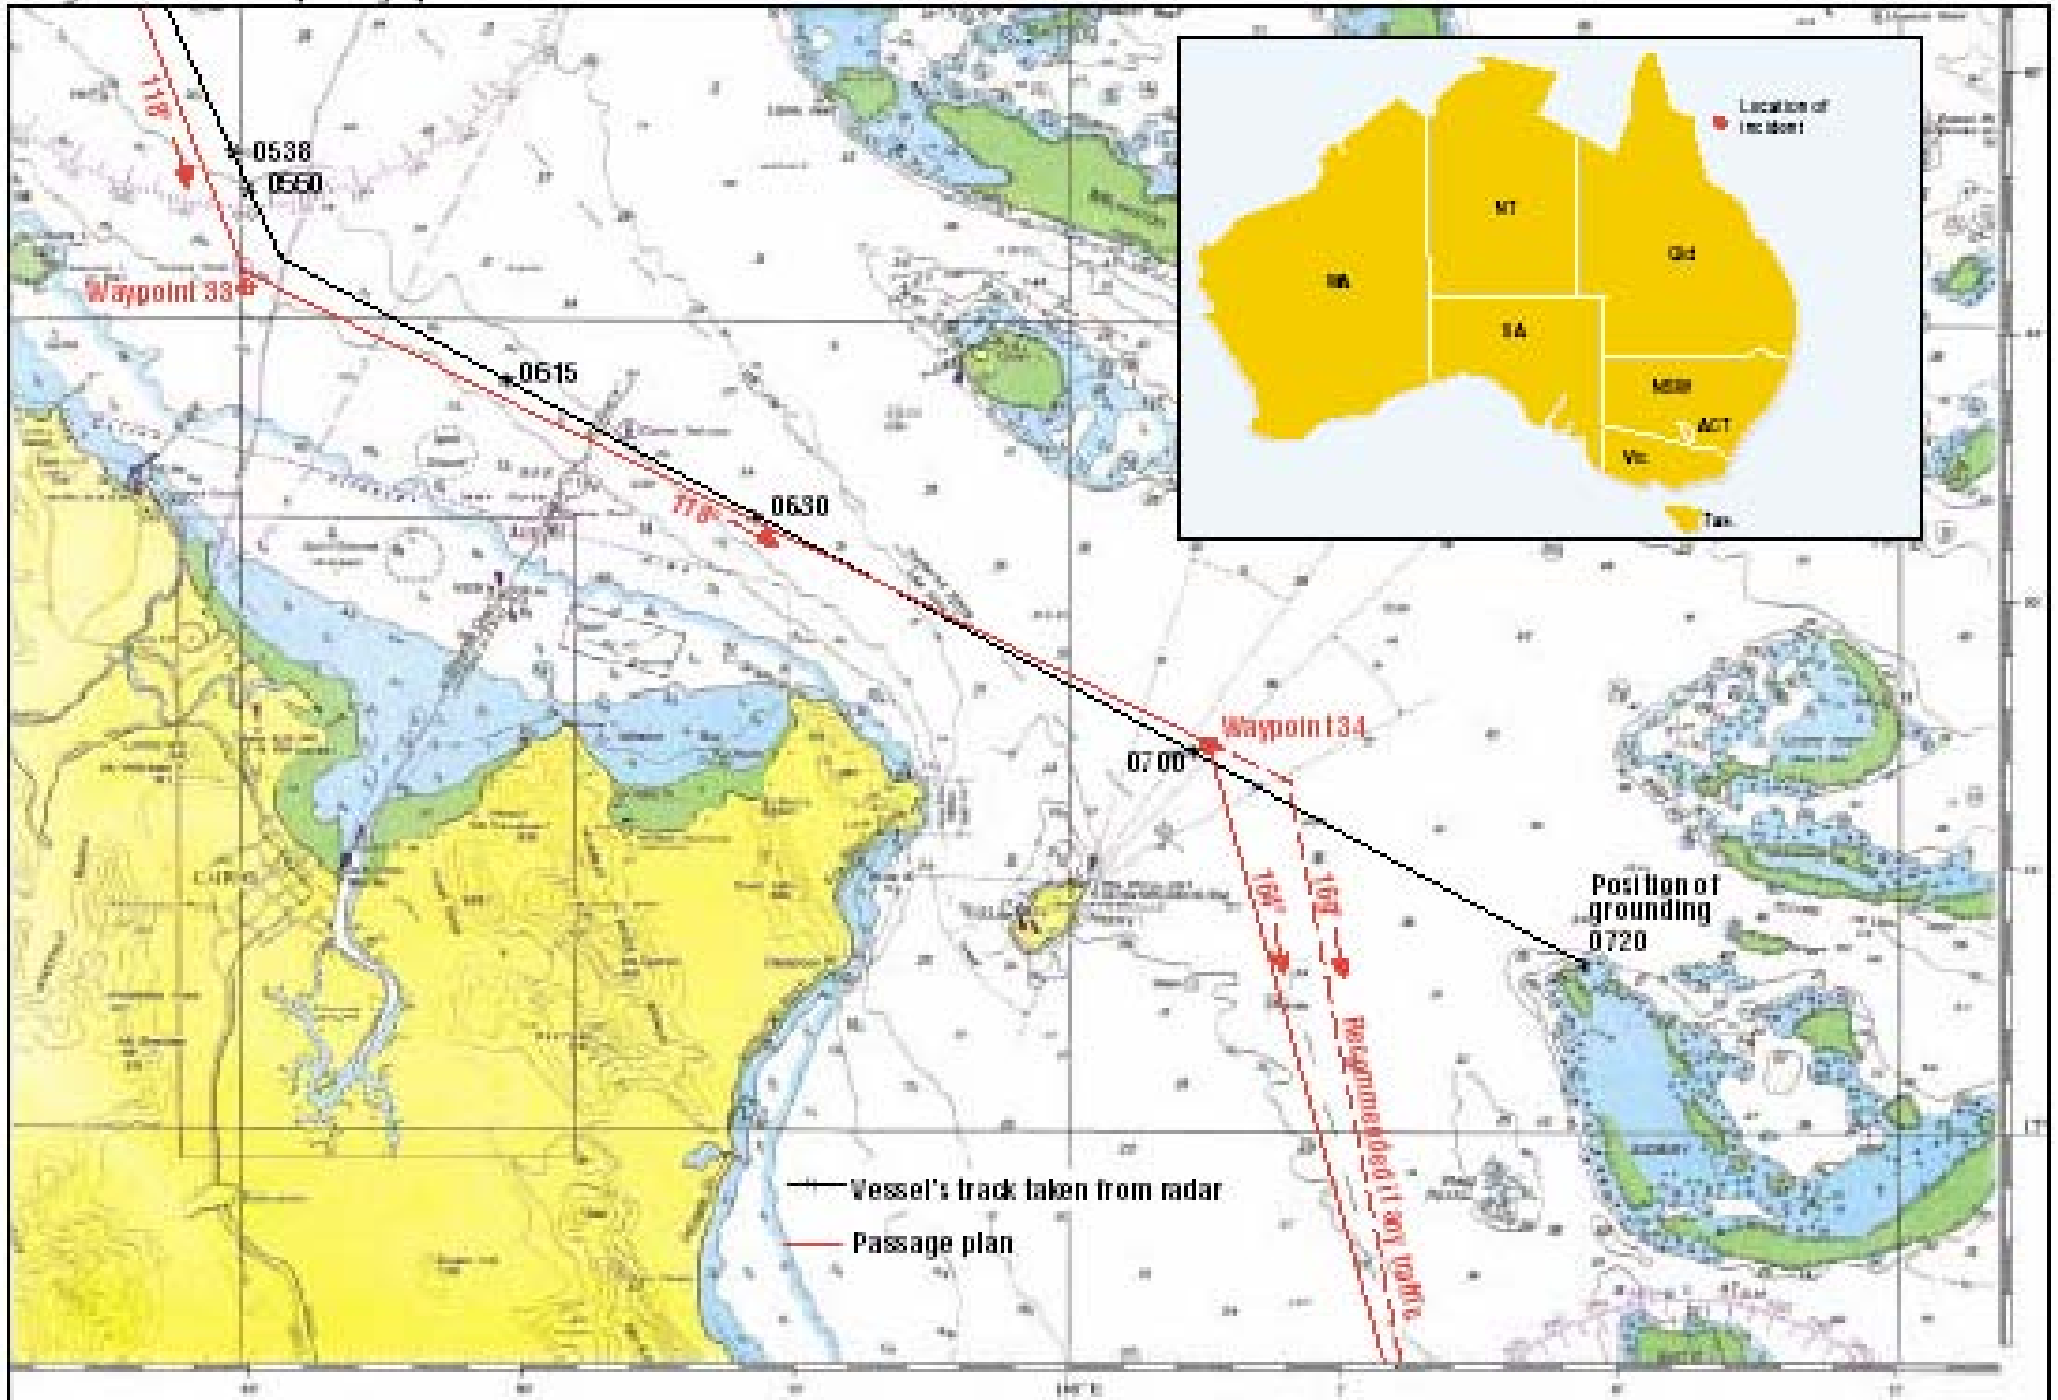
Bunga Teratar Satu's passage plan and track

At about 0723, the ship struck the north end of Sudbury Reef at a speed of over 20 knots on a heading of 120°. It was about 1 3/4 hours after low water and the vessel's bow rode some 100 metres onto the reef leaving the stern in approximately 12 metres of water.

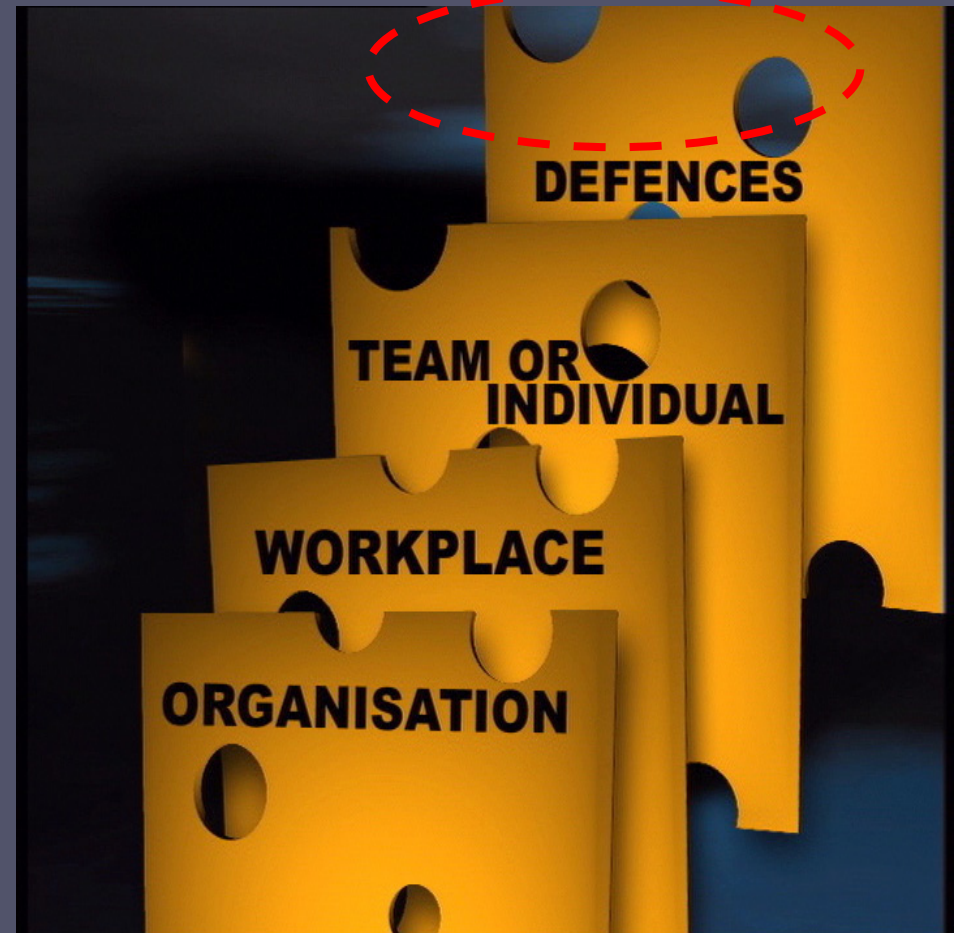
- Ineffective bridge watch procedures
- Poor Bridge Resource Management on the vessel allowed a basic error by one person to result in a serious accident
- The ship's GPS cross-track error alarm was neither loud enough nor strident enough to attract urgent attention. *Design issue*

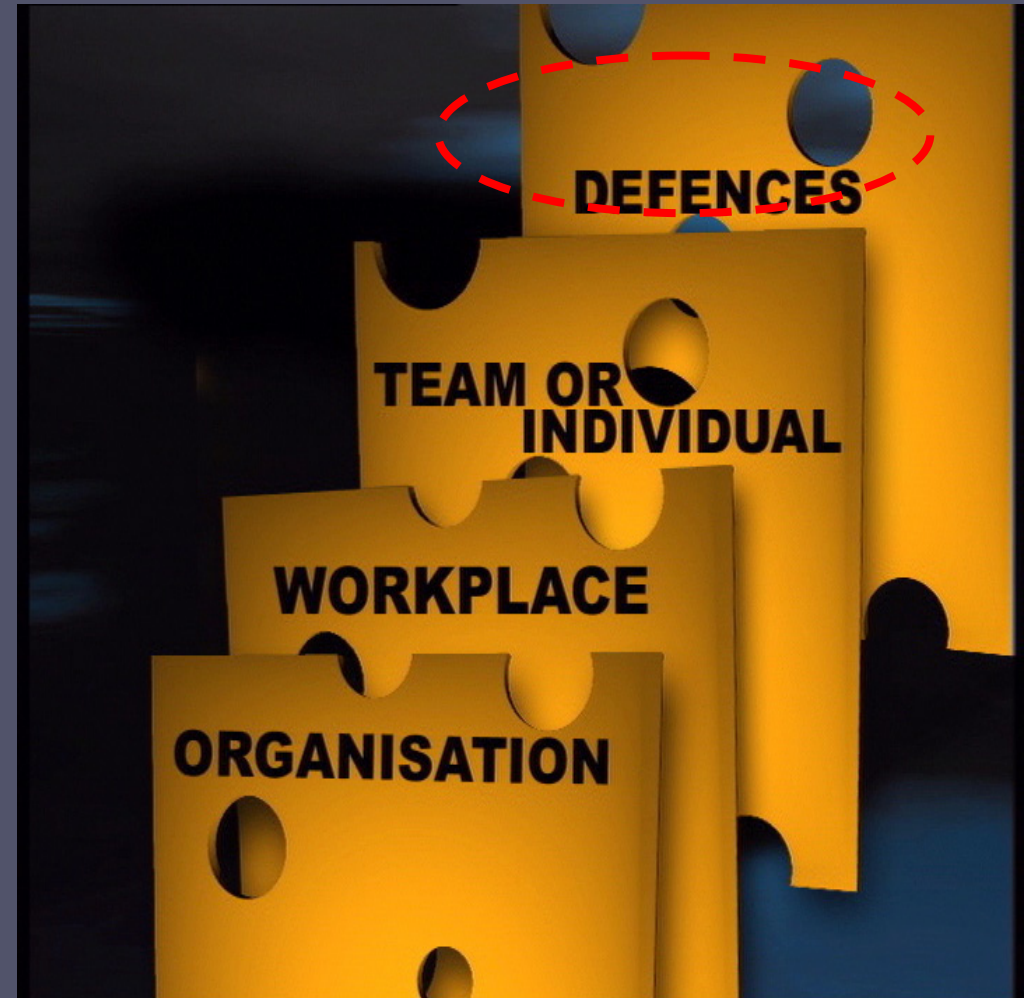
- Reefcentre monitoring of 4 radar displays
Poor user interface
- The frequency of annunciation of Traffic Information Module alarms and associated radar system alarms had led to the desensitising of Reefcentre operators to the whole TIM alerting system
Design issue
