REVIEW OF FAILURES OF BOLTHOLE REPAIRS TO FLAMEPROOF MOTORS

ON BEHALF OF: Mine Safety Division, Department of Primary Industries Review of failures of bolthole repairs to flameproof motors		DOCUMENT NO: 9.4.6_MIN_DPI_28/01/05
		REVISION NO: 3
		PAGES: 22
		DATE: 28 th January 2005
COMPILED BY: G. ALLAN	RECOMMENDED BY: C. SMALLBONE	AUTHORISED BY: C. SMALLBONE

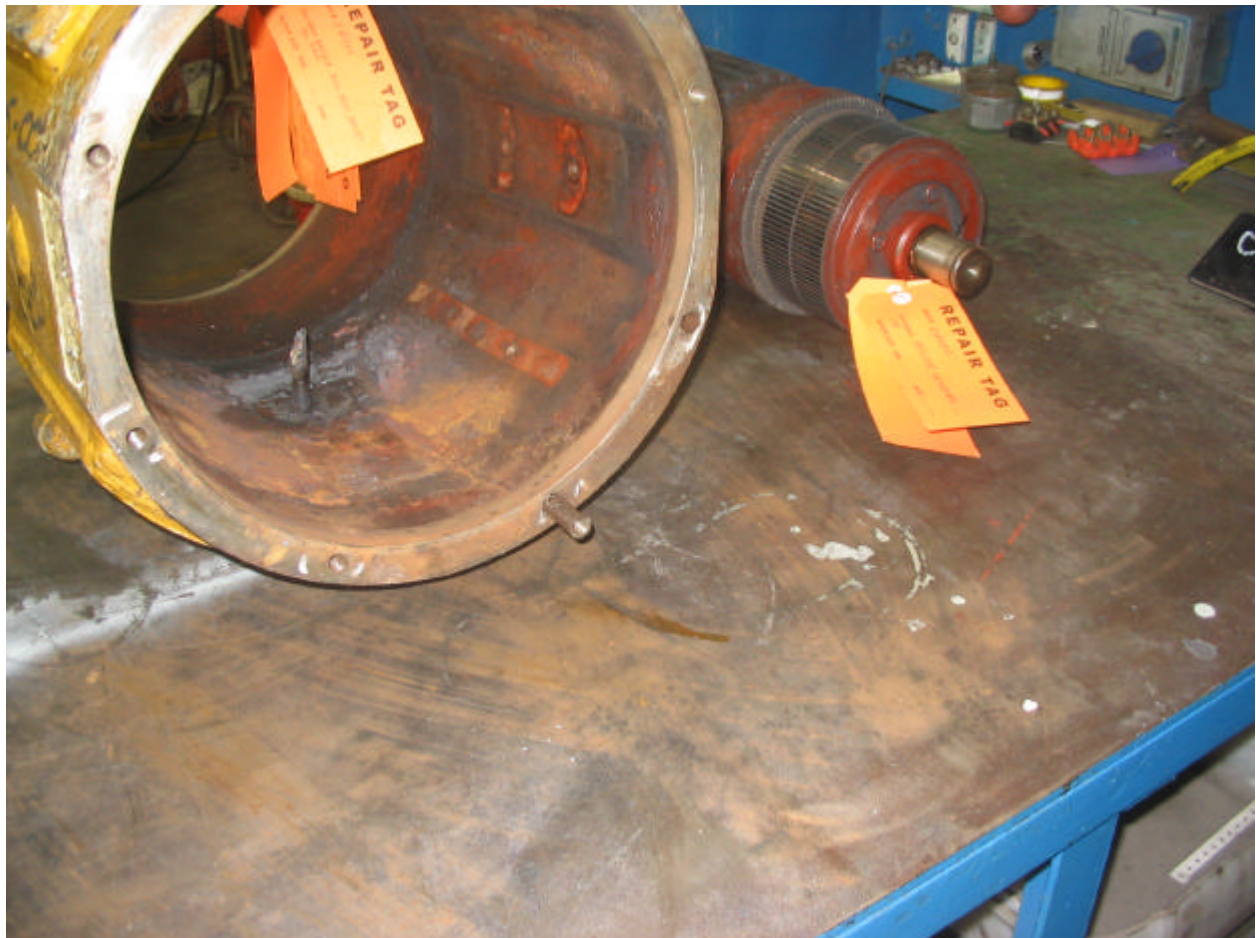
On the motor examined at the MinePro workshop, boltholes had been repaired on the frame ends and on the hand access hole on the stator frame. See Figures 1 & 2.

Figure 1. General view of the stator frame end face of Motor A. An insert has been partially removed.

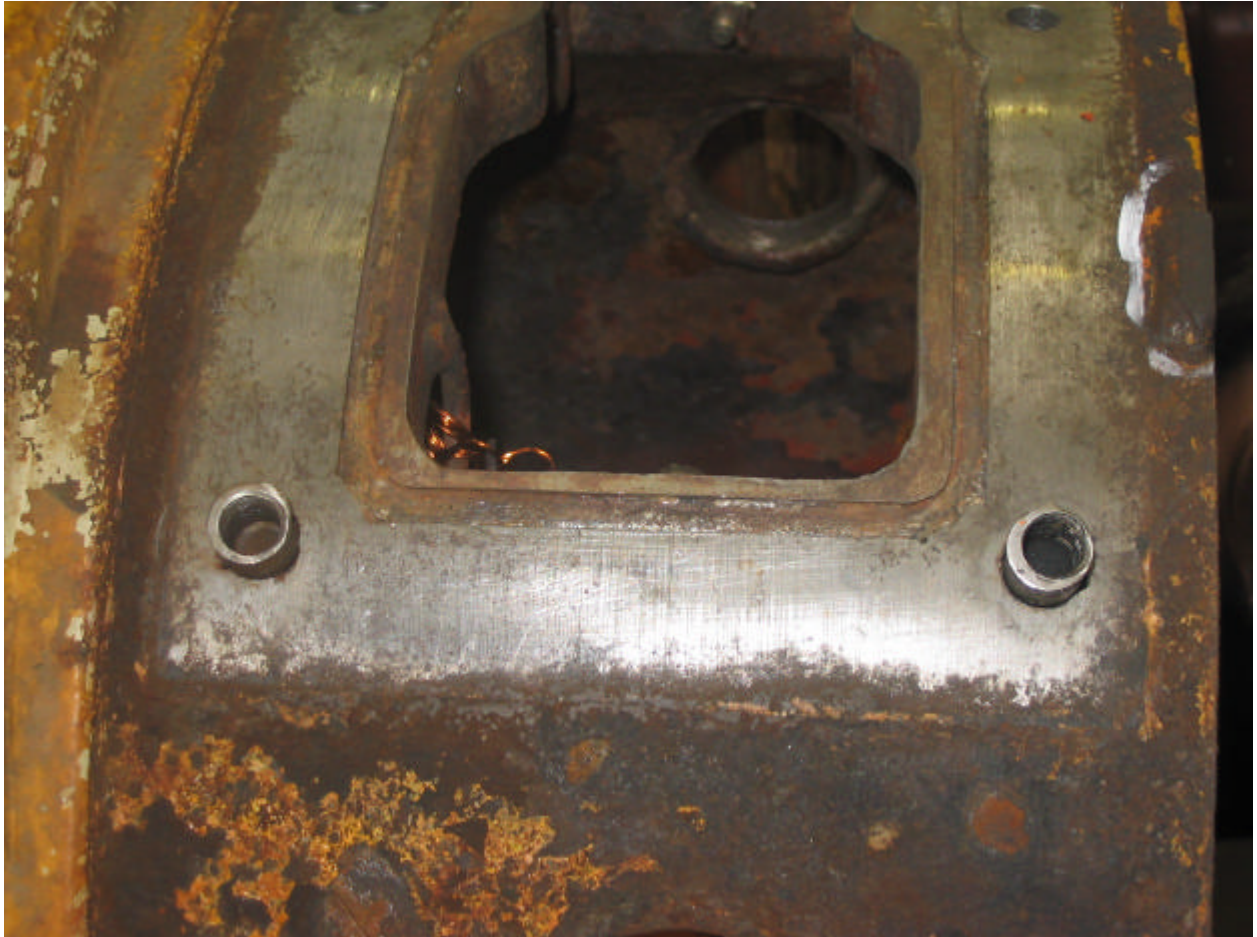
All six bolthole inserts had failed at the hand access hole. At least 13 of the 16 boltholes on the stator frame end faces had been repaired with inserts. There was evidence of insert failure on a number of those repaired holes. See Figure 3.

Figure 2. General view of side cover of Motor A showing partially removed inserts.

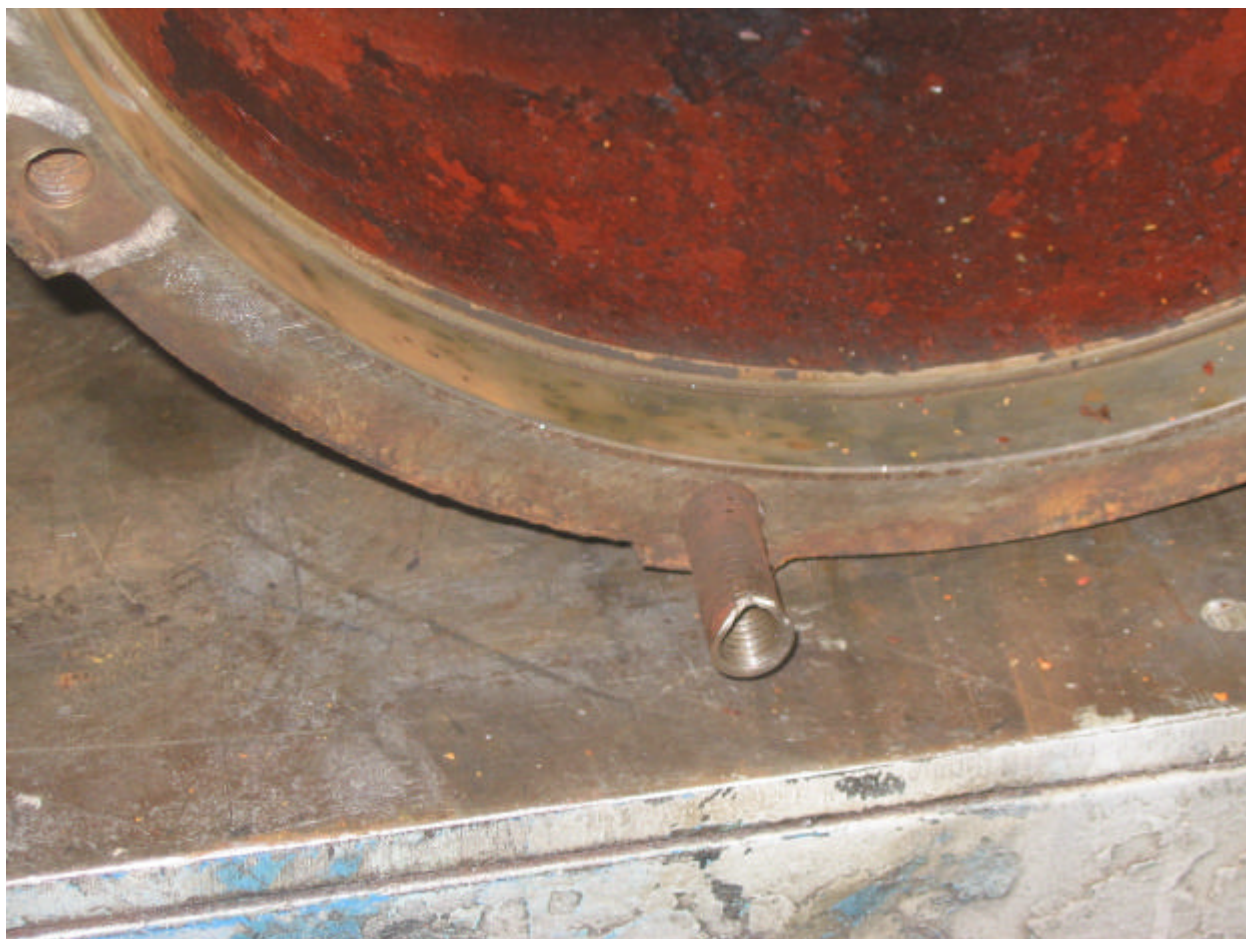
Figure 3. Detail of the partially extracted insert from Motor A.

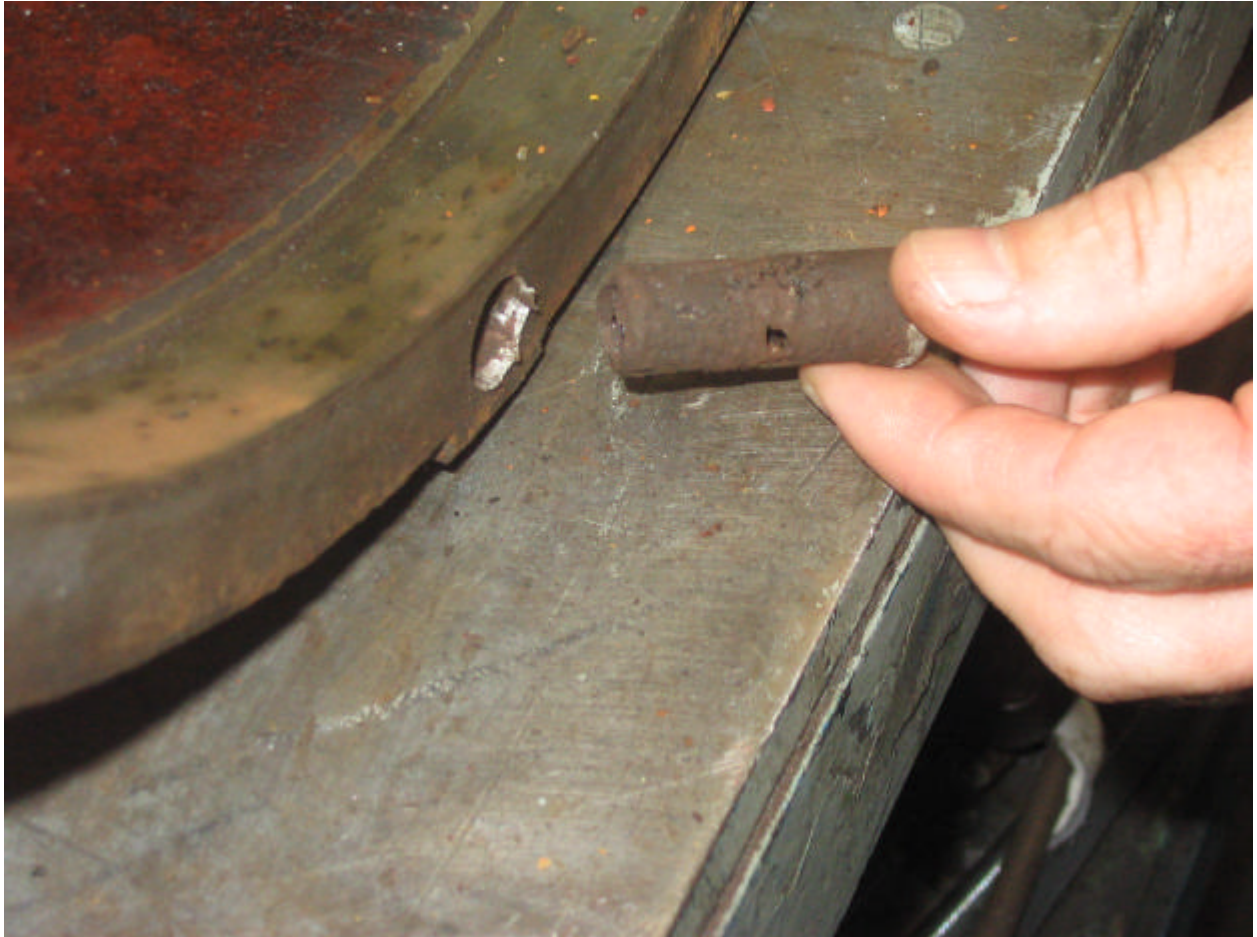
Very little force was required to remove the inserts in some cases. Some inserts could be dislodged with hand force only. See Figure 4.

Figure 4. Insert easily removed by hand.

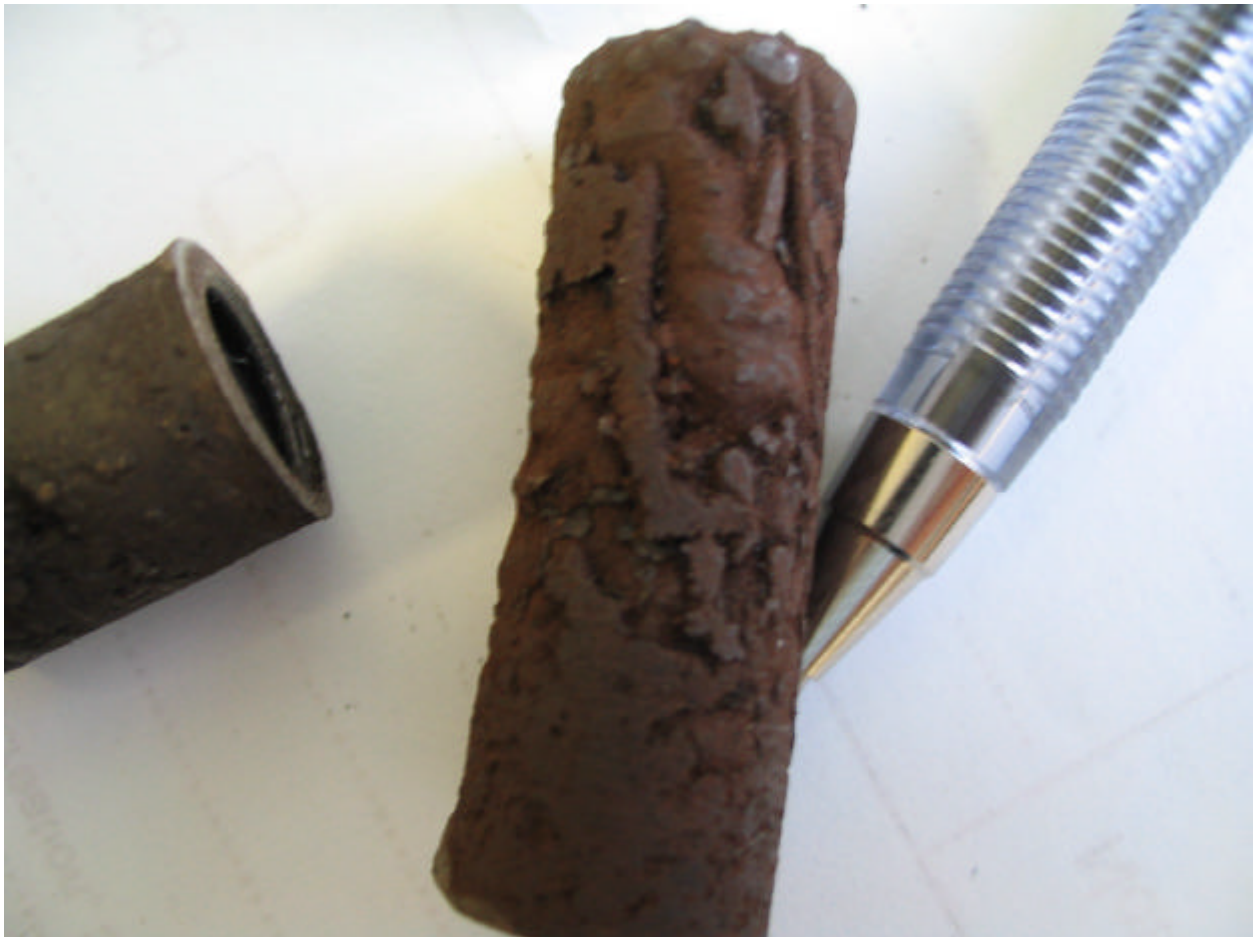
Insert material that had been removed from failed repairs was examined. The specimens were approximately 14mm diameter and up to 45mm in length. See Figure 5. The boltholes for the hand access hole were blanked on the inside with a cover that was welded in place.

Figure 5. Inserts after extraction from Motor A.

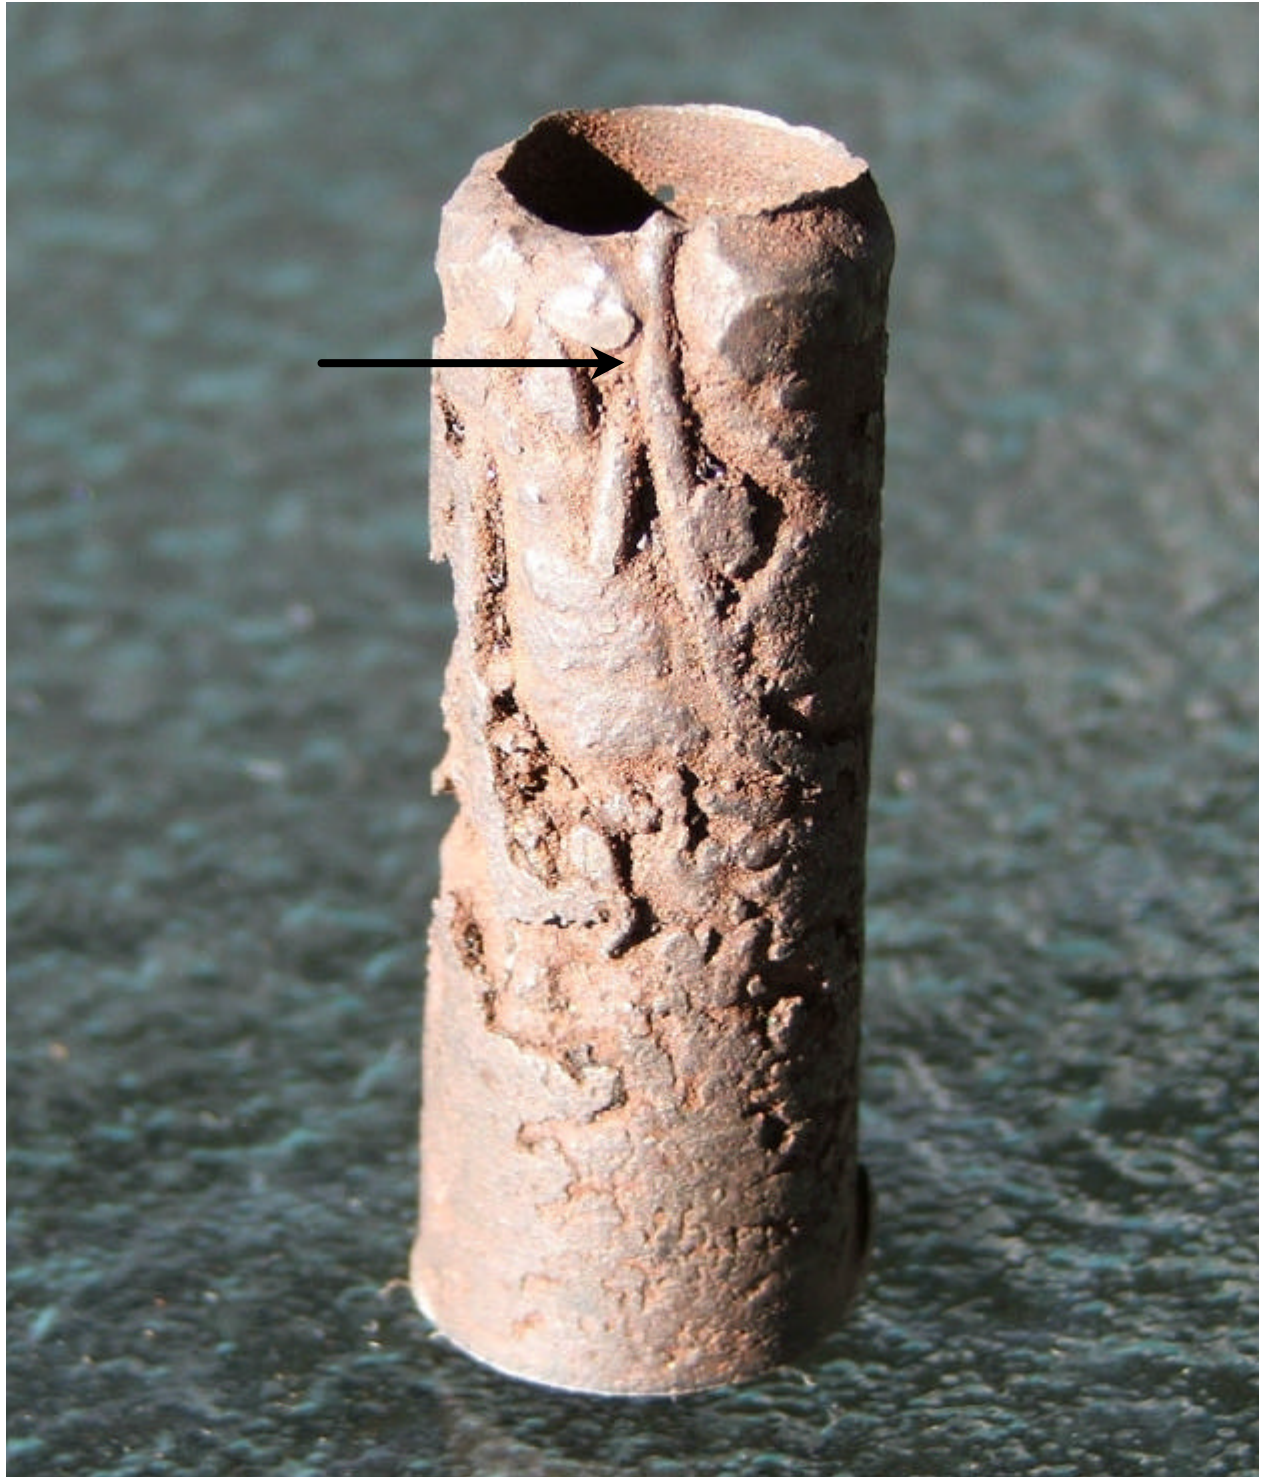
All failed insert specimens were oxidised and had a rough outside surface appearance. There were features on the outside surface of the inserts that were consistent with GMAW wire and weld spatter. See Figure 6.

There was no evidence of fusion to the stator frame parent metal on the specimens examined.

Figure 6. Closer view of insert material after removal from the bolthole (Motor A). Partially melted welding wire is evident.

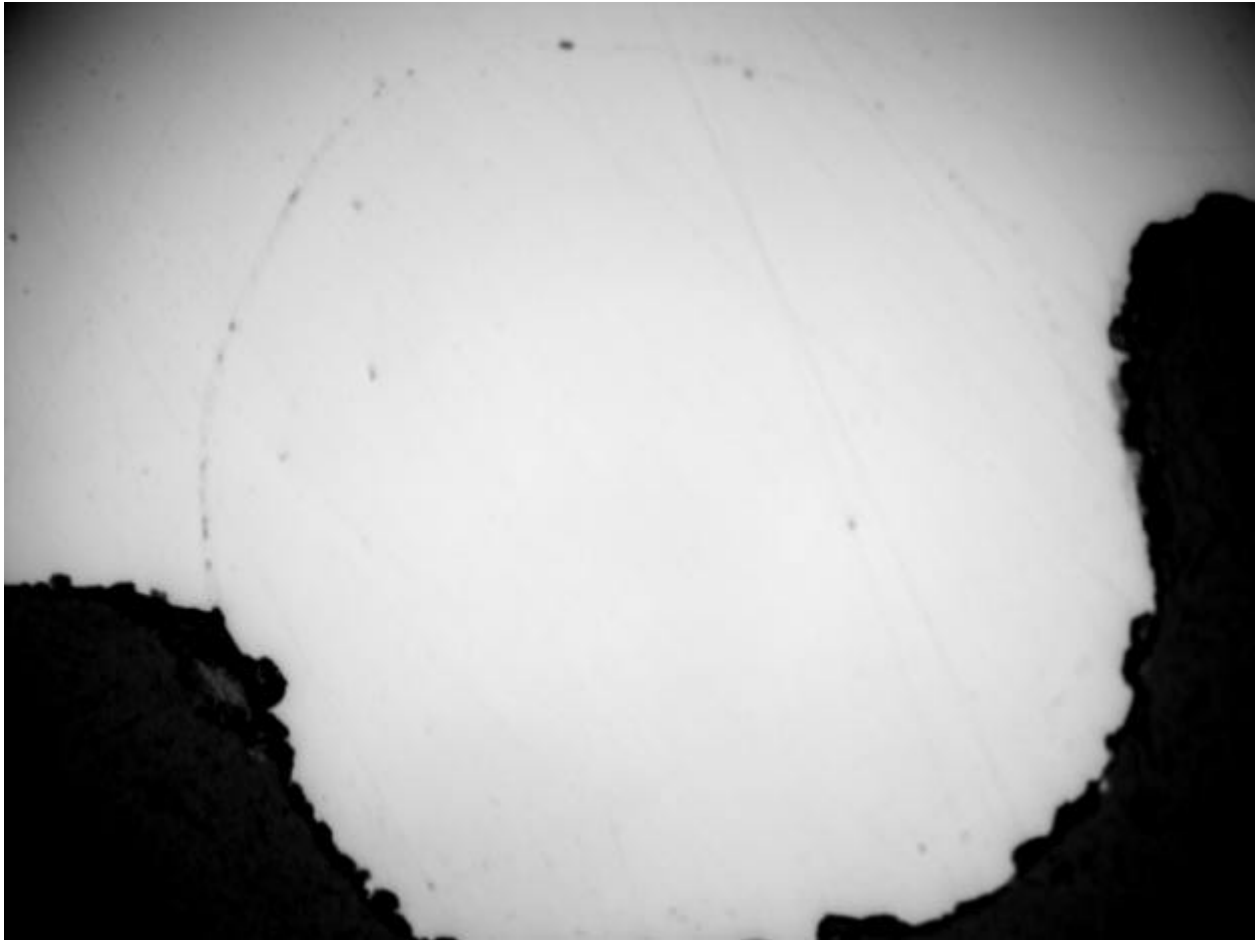
Figure 7. X 100 - Unetched

The specimen was examined in the polished condition. There was a circular form with half of the circle protruding from the body of metal. See Figure 7. The diameter of the circle was measured at approximately 1mm. The form was consistent with a GMAW solid wire consumable.

The photomicrograph was sectioned at the position indicated by the arrow in Figure 6. There is a semi-circular form in the upper part of the field.

The circle was measured at 1.0mm diameter.

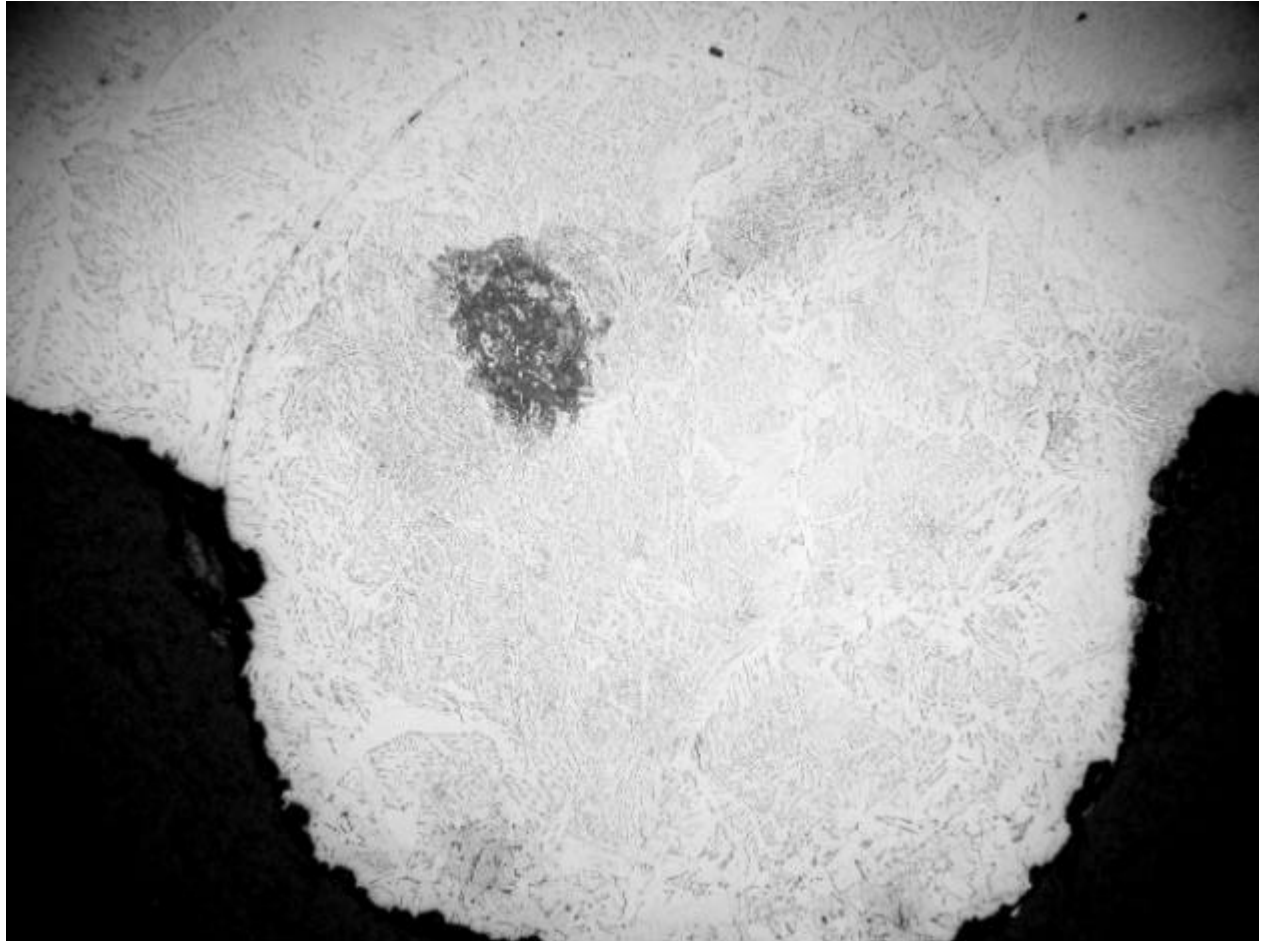
Figure 8. X 100 – 2% Nital etch

The specimen was etched and the microstructures were examined. There was partial fusion of the wire to the body of weld metal. There was a network of fine oxide inclusions and porosity around the circumference of the wire. See Figure 8. This is consistent with molten metal coming in contact with the wire but with insufficient temperature at the boundary for complete fusion.

The same photomicrograph as shown in Figure 7, sectioned at the position indicated by the arrow in Figure 6. A partially unfused boundary can be seen.

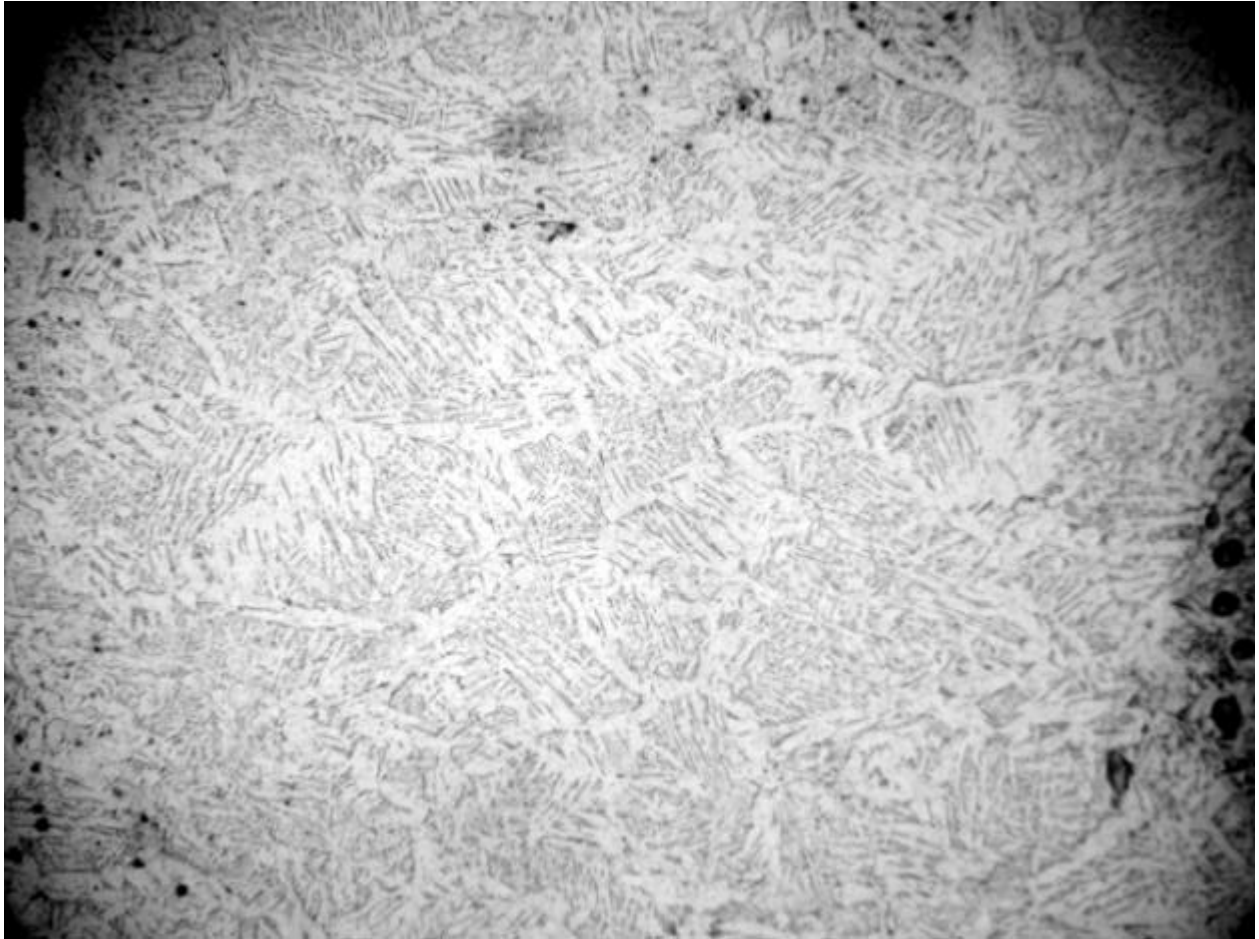
Figure 9. X 200 – 2% Nital etch

A longitudinal section was taken through a failed insert from Motor A. The microstructure was consistent with low carbon steel weld metal. See Figure 9.

Insert material from Motor A. the microstructure is consistent with a low carbon steel weld deposit.

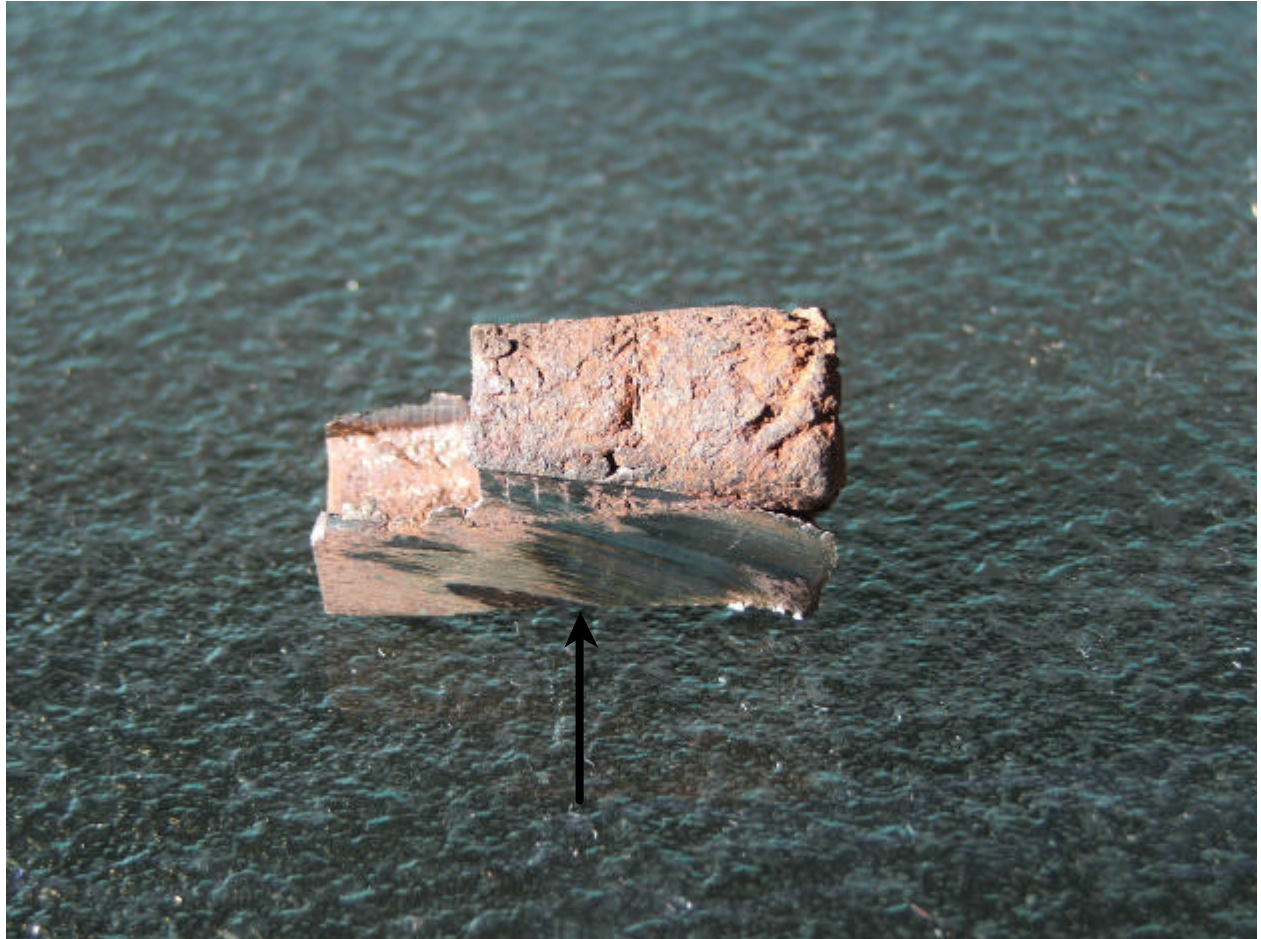
A section was taken through the point indicated by the arrow in Figure 10. The section contained parent metal and insert material.

The polished specimen was examined in the polished condition. There was a gap between the parent metal and insert material. There was no evidence of fusion of the insert material with the parent metal.

Figure 10. General view of a sample from Motor B.

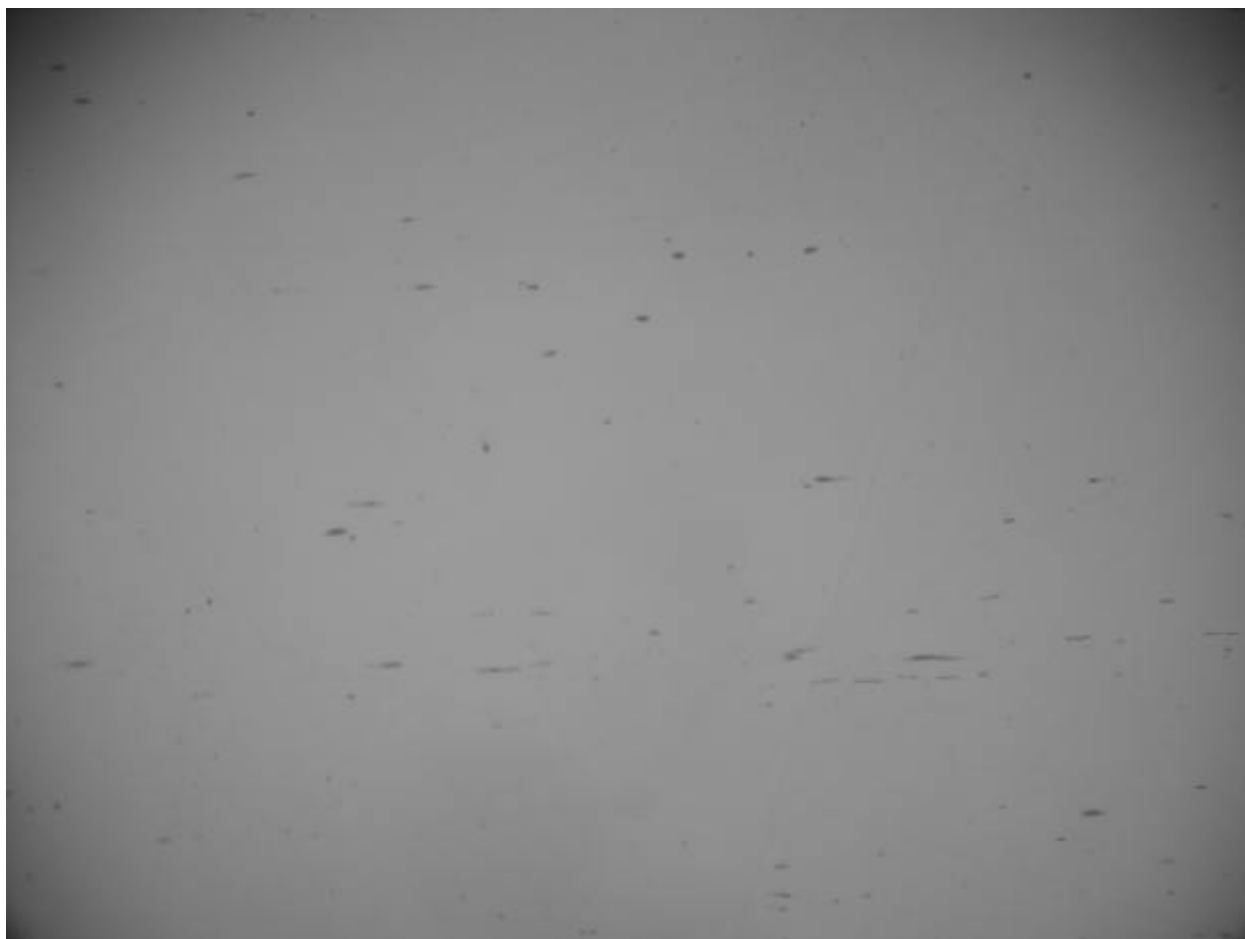
Figure 11. X 200 Unetched.

The parent metal had a significant number of elongated manganese sulphide inclusions. See Figure 11. This feature is consistent with hot rolled steel produced by the ingot route.

Stator frame parent metal sectioned adjacent to a repaired hole from Motor B. Elongated manganese sulphide (MnS) inclusions are evident. The inclusion morphology is typical of wrought steel made by ingot route.

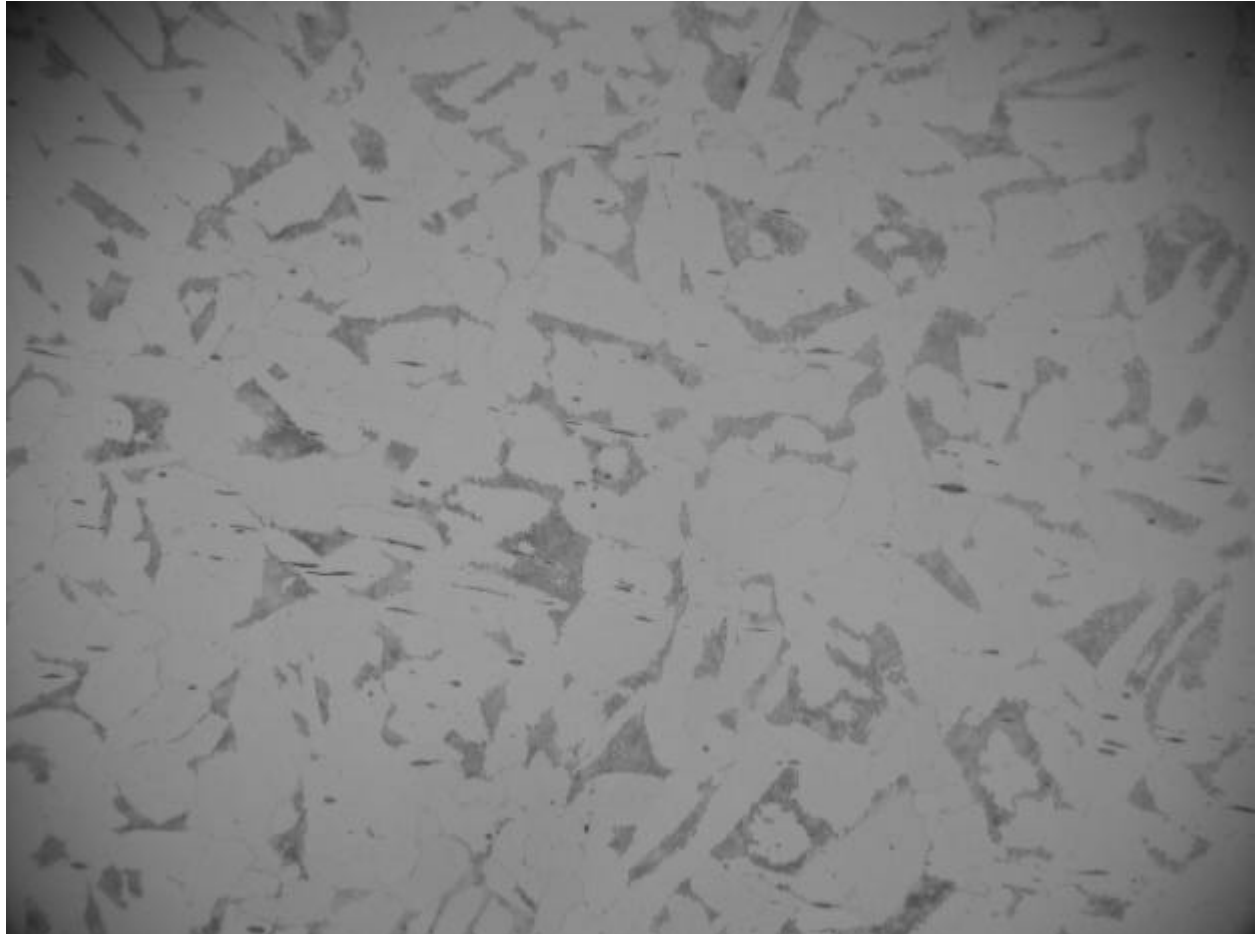
Figure 12. Magnification X 200, Etched in 2% Nital.

The specimen was etched and the microstructures examined. The parent metal was a relatively coarse-grained low carbon steel in the normalised condition. See Figure 12.

Stator frame parent metal sectioned adjacent to a repaired hole from Motor B. The microstructure is consistent with wrought steel produced by conventional hot rolling.

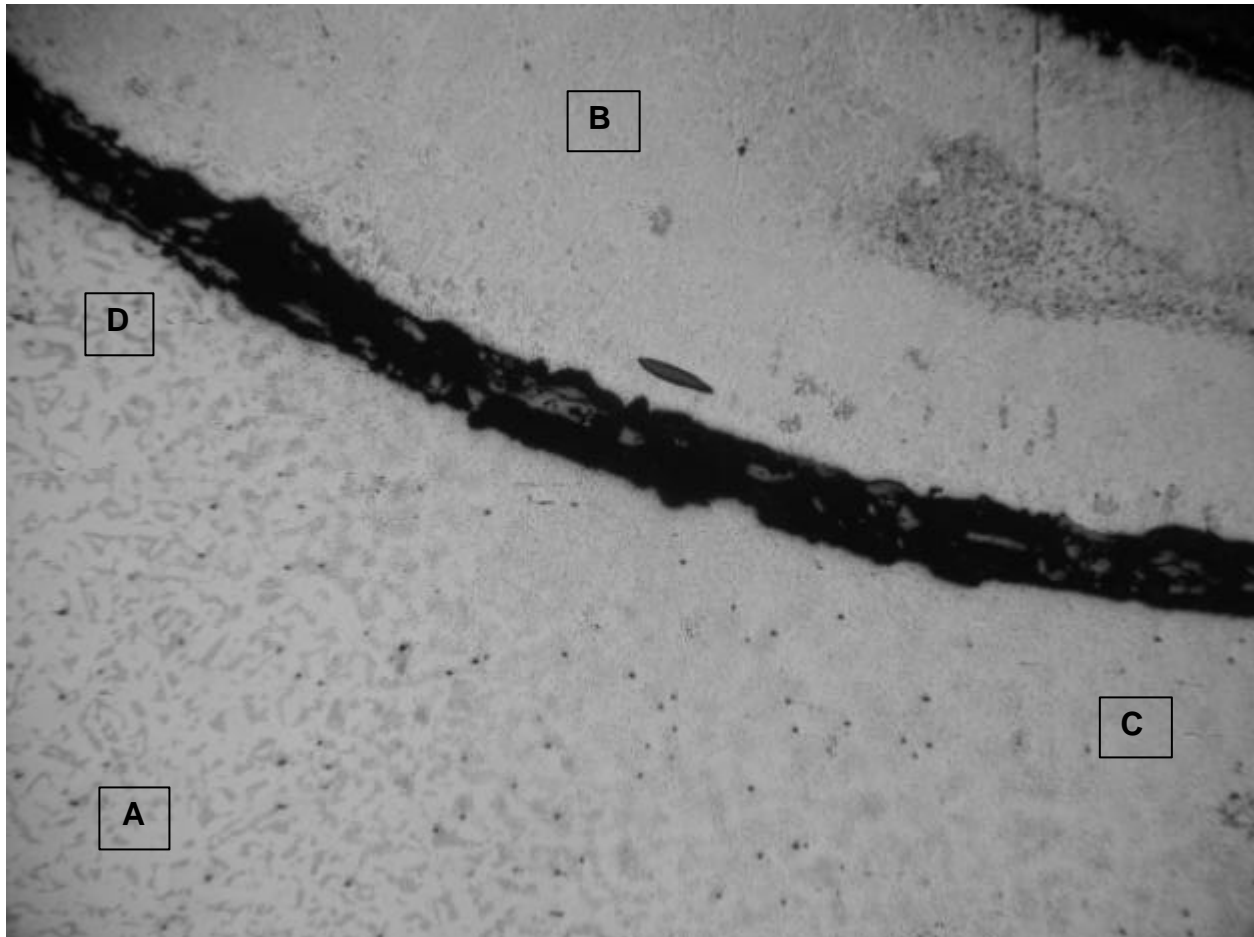
The microstructures in the parent metal were examined in the region adjacent to the insert material. See Figure 13. The micrograph shows parent metal on the lower left of the frame, location A, and insert material in the upper right region at location B.

The parent metal microstructure at location C had been partially modified. The microstructure was consistent with a peak temperature not exceeding 850°C.

The parent metal microstructure at location D was not modified by the welding operation. This indicates that the parent metal temperature did not reach 720°C as the weld metal was deposited.

The melting temperature of steel is in the vicinity of 1500°C. It is clear from the evidence in the parent metal microstructures that temperatures generated in the parent metal were more than 700°C below the threshold minimum temperature required for fusion to the weld metal.

The variation in microstructure between locations C and D is an indicator that there was a higher heat sink in the parent metal in the circumferential direction and a lower heat sink in the radial direction.

Figure 13. Motor A stator frame parent metal (A) and weld deposit (B). The parent metal is partially heat affected (C). There is a region that is not heat-affected zone (D). There is no evidence that the parent metal has approached melting temperatures during the welding operation.
