# The Assessment & Modification of Barriers to Fish Passage in the Namoi Catchment

NSW Department of Primary Industries (2006). *The Assessment and Modification of Barriers to Fish Passage in the Namoi Catchment*. Report to the Namoi Catchment Management Authority. Department of Primary Industries (Aquatic Habitat Rehabilitation Unit), Tamworth.

As a result of funding from the Namoi Catchment Management Authority, NSW Department of Primary Industries undertook a project entitled *“The Assessment and Modification of Barriers to Fish Passage in the Namoi Catchment”*.

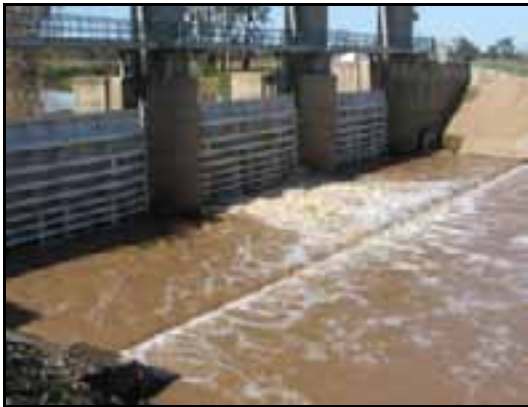
**Plate 9:** Mollee Weir (419/970000/B0103)

Mollee Weir (Plate 9) is situated on the Namoi River in the lower end of the catchment and is located approximately 20km west of Narrabri. The weir is approximately 5m in height and 60m across the length of the crest. Mollee Weir is a regulating structure that acts as a barrier to fish passage throughout the year except during high flow conditions. When flows are less than this, the weir restricts fish passage due to excessive headloss and increased turbulence across the face of the structure. There is currently an ineffective submerged orifice fishway associated with this structure.

Recommended management options at this site include the installation of a Deelder fishlock, replacing the existing submerged orifice fishway. Management of the vertical lift gates is also essential at this site to limit the potential effects on fish larvae and the natural flow regime. Through implementing these management strategies approximately 220km of waterway will be reinstated.

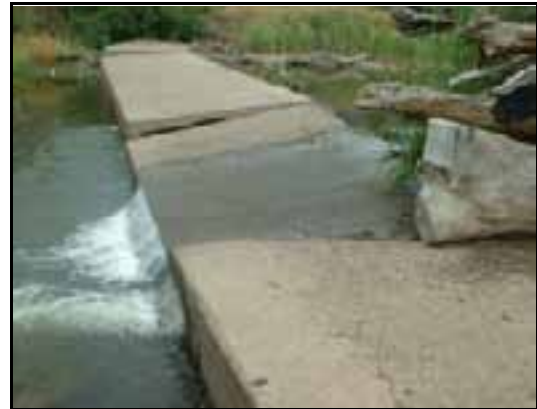
**Plate 14:** Jewry Street Causeway (LPRA)

The Jewry Street Causeway (Plate 14) crossing is located on the Peel River within the town limits of Tamworth. The disused crossing is located approximately 50km upstream of the junction of the Namoi and Peel Rivers and is approximately 1.2m in height and 10m across the length of the crest. The causeway acts as a barrier to fish passage during flows less than approximately 1200 ML/day due to excessive headloss and increased turbulence across the face of the structure.

The complete removal of the structure would provide the greatest benefit to the aquatic environment of the Peel River and provide significant improvements in the availability of aquatic and riparian habitat. When investigating this recommendation it is essential to take into account the potential erosion impacts that may jeopardise the structural integrity of the upstream bridge. This may result in the additional construction of a bed control structure at the site with appropriate fish passage infrastructure. Addressing the fish passage issue at this site would complement recommended fish passage works at the upstream concrete capped pipeline, significantly benefiting the aquatic environment by reconnecting over 230km of waterway.

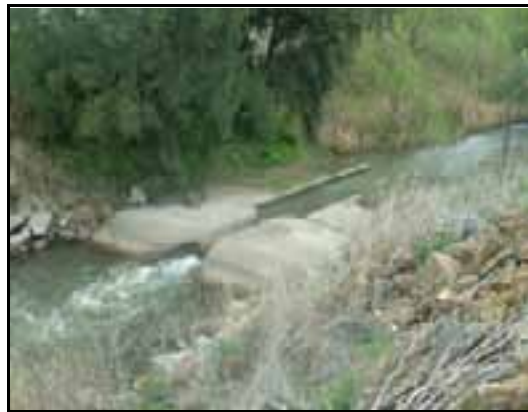
**Plate 20:** Peel River water gauge (WGS13)

The Peel River water gauge structure (Plate 20) is located on the Peel River in the middle section of the Namoi Catchment. The structure is situated in the eastern suburb of Calala, approximately 200m upstream of the Tamworth Water Treatment Station. The water gauge is a fixed weir structure that is composed of a vertical flume "San Dimas Weir", and is approximately 1.2m in height and 10m across the length of the crest. The structure acts as a barrier to fish passage during flows less than approximately 350 ML/day, restricting fish passage due to excessive headloss, as well as increased velocity and turbulence through the vertical flume. There is also a temporary sandbag weir that occurs downstream to secure town water supplies during periods of low flow.

The complete removal of the structure is the recommended remediation option for this site, as well as the appropriate management of the downstream temporary weir to ensure its removal during key migration periods. When investigating this option it is important to consider alternative gauging technology that may replace the current structure. If alternative stream gauging innovations cannot be pursued, the structure will have to remain in place and fishway options further investigated. By implementing the suggested strategies at this site approximately 40km of waterway would be reinstated.

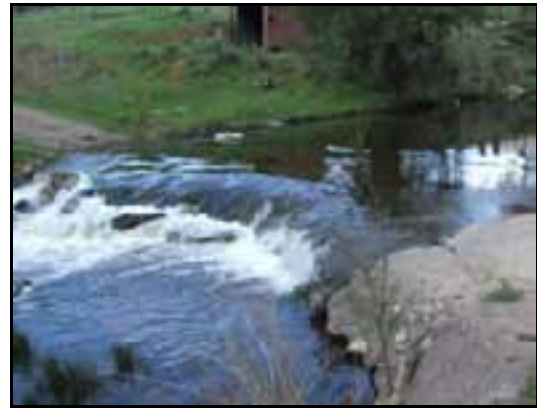
**Plate 24:** Mulla Creek Causeway (CR24)

This private road crossing (Plate 24) is located on Mulla Creek, a major tributary of the Cockburn River, and is situated in the middle of the catchment near the small town of Limbri. The crossing is approximately 1m in height and 18m long and is constructed of concrete, with the downstream side of the causeway experiencing erosion effects from high flows resulting in a plunge pool and bank erosion. The presence of the instream crossing significantly impacts on fish passage due to excessive headloss, as well as an associated increase in turbulence.

It is recommended that the causeway be replaced by a train carriage bridge design. This option recycles old train carriages, using them as road crossings by removing the sides to allow for effective water flow. Complementing this remediation action, it is also suggested that bank stabilisation efforts and riparian management also be considered at this site. The modification of the causeway has the potential to reinstate approximately 12km of aquatic and riparian habitat.

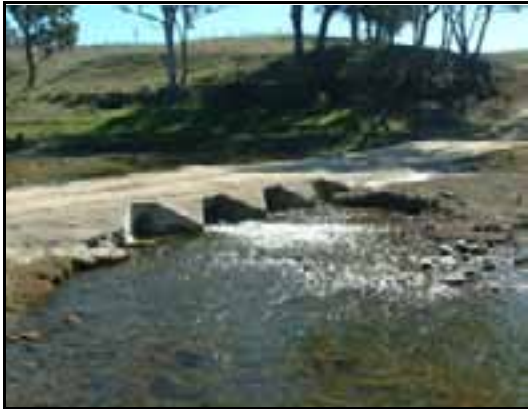
**Plate 29:** "Plumthorpe" Culvert (UMA73)

The multicell pipe culvert (Plate 29) on the “Plumthorpe” property is located on the Manilla River in the middle of the catchment, just outside the town limits of Barraba. The crossing is approximately 0.5m high and 35m long, and contains four individual cells through the base. The inappropriate design and construction of the culvert has resulted in a combination of minimal flow depth and high velocity associated with the pipes, resulting in the crossing acting as a barrier to fish passage.

Remediation options for this site include the removal of the pipe culvert and replacement with a suitable box culvert design. When considering this option it is important to ensure that the effective flow area of the crossing is at least equal to the natural channel flow of the waterway. The modification of this crossing would complement recommended fish passage works to the immediate upstream High Priority barrier of the Mayvale Road Culvert (UMA76) and the immediate downstream High Priority barrier of the Barraba Weir (UMA78), significantly benefiting the aquatic habitat of the Manilla River. By reinstating fish passage at this single site, an area of approximately 30km will be opened up.

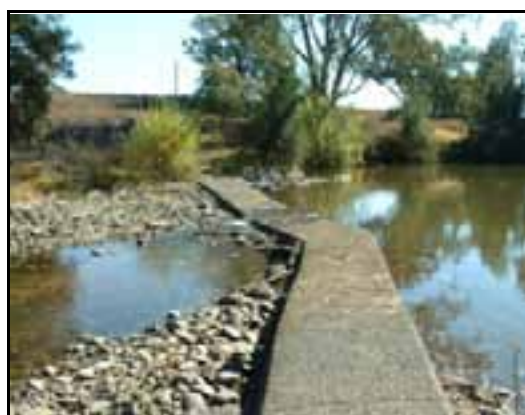
**Plate 34:** Namoi River water gauge (WGS1)

The Namoi River water gauging station (Plate 34) is located on the Namoi River on the "North Cuerindi" property near the town of Manilla. The gauge is a fixed weir structure that is constructed of concrete, and is approximately 0.3m in height and 10m across the length of the crest. The structure acts as a barrier to fish passage during low flows, restricting fish passage due to excessive headloss, as well as increased velocity and turbulence across the face of the gauge.

The complete removal of the structure is the recommended remediation option for this site. When investigating this option it is important to consider alternative gauging technology that may replace the current gauge. If alternative stream gauging innovations cannot be pursued, the structure will have to remain in place and fishway options further investigated, with a partial width rock ramp being a feasible option for this site. By implementing the suggested strategies at this site over 70km of waterway would be reinstated on the main stem of the Namoi River.

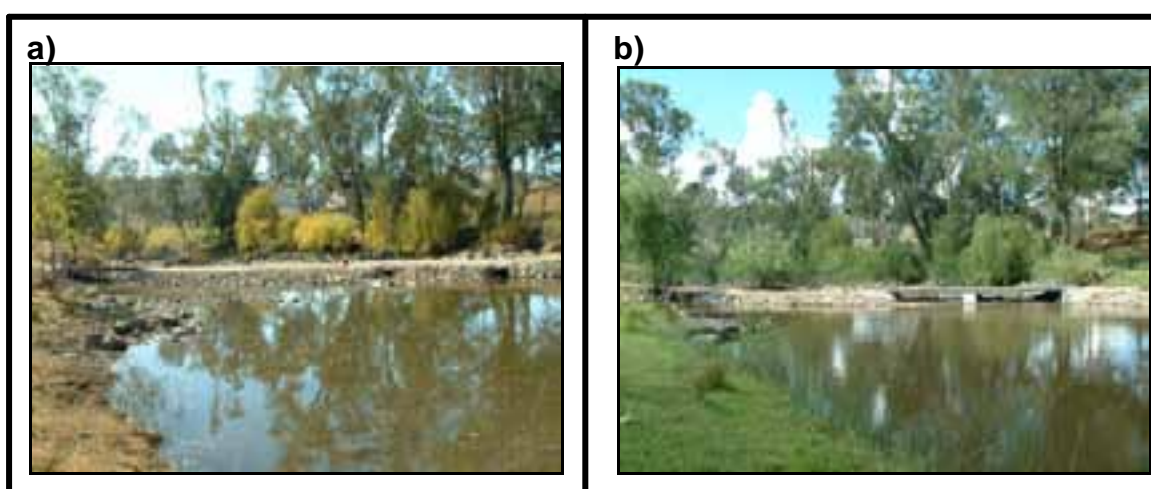
The causeway is a privately owned crossing that provides access to agricultural land on the “Wittagoona” property. NSW DPI Conservation Management staff approached the landholder regarding compliance concerns associated with recent works that had been conducted on the crossing, which had not incorporated fish passage requirements. Remediation by the landholder reinstated fish passage adjacent to the western bank of the river, however complete remediation for fish passage will involve the removal of a section of concrete on the eastern side of the river down to the natural bed-level to reinstate the low-flow channel. The landholder agreed to the proposed actions, and provided in-kind contributions of equipment, including a 20 tonne excavator, and labour.

**Figure 1:** “Wittagoona” Causeway a) before remediation works, and b) after remediation works.

Arrangements were made to implement the remediation action, with NSW DPI Conservation Management staff on-site to oversee works in early February 2006, when the flow of the Namoi River reached favourable levels of less than 20ML/d. The works involved the removal of a 12m section of the concrete causeway down to natural bedrock level (Figure 1). The removed area will be replaced with a bridge section to allow fish passage in the low-flow channel, reinstating 56km of aquatic habitat.

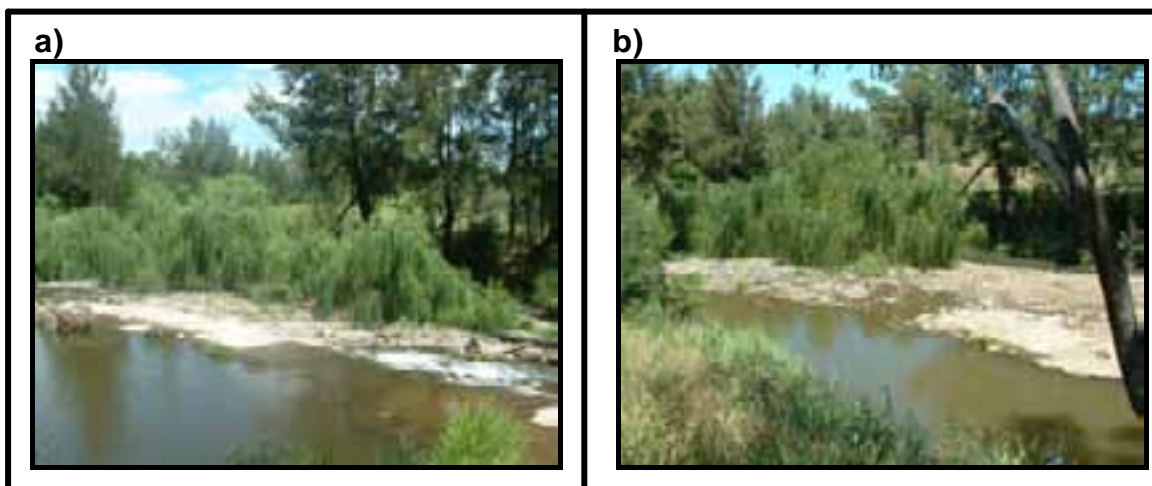
This redundant causeway located on the Cockburn and Peel River junction has recently been used to increase water levels of a pumping pool utilised by a local construction company. NSW DPI Conservation Management staff approached the company regarding an associated compliance issue, with work to the causeway included in the proposed remediation of the site. Discussions were held between representatives from NSW DPI, Namoi CMA and Hanson Construction Materials, with suitable designs to reinstate fish passage developed by NSW DPI. Hanson Construction Material agreed to the proposed actions, as well as providing in-kind contributions of excavation equipment, and labour.

**Figure 2:** Hansons Causeway a) before remediation works, and b) after remediation works.

Remediation works were conducted in late January 2006, with NSW DPI Conservation Management staff on-site to oversee works. The works involved the removal of willow trees, the realignment of large woody debris, and the removal of a 10m section of the concrete causeway down to natural bedrock level (Figure 2). Monitoring of the site will continue, with it anticipated that subsequent high flows in the Cockburn River would produce natural scouring in the remediated area to form a riffle section at the junction with the Peel River, reinstating 7km of suitable fish passage.
