# SAFETY ALERT

## Overheated tyres require miners to use self-rescuers

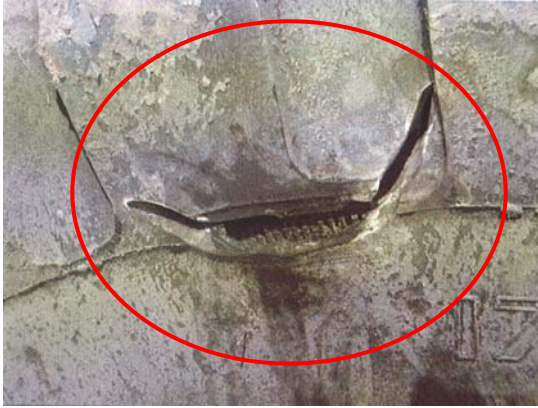
2. Both rear tyres overheated internally with the RL inserts failing from thermal degradation (internal heating).
3. The internal heating created internal pressures which subsequently burst the side wall of the tyre and allowed products of combustion gases to escape.

*The initial pressure split in the tyre*

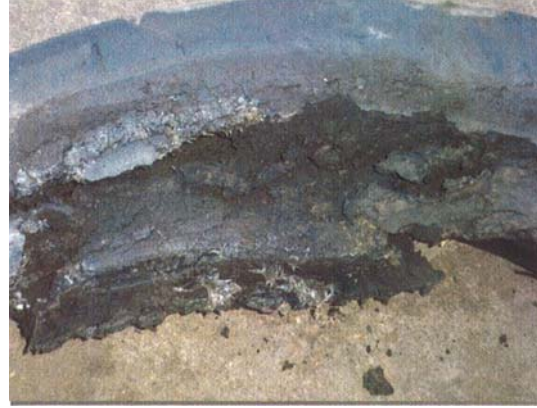
4. The white and brown smoke-like substances included toxic gases from products of combustion of the rubber compound.
5. Twenty-four hours after the incident, when the tyres and inserts were inspected in a workshop, there was sufficient heat inside the RL insert such that a person's hand could not remain on the RL insert for any period of time.

*Heat degradation of RL insert*
