Technical Bulletin

Bulletin Number: TB0814

Subject: 913 Exhaust Conditioner (Scrubber)

All Eimco 913's fitted with MDA DES 15010 Scrubber (dual float)

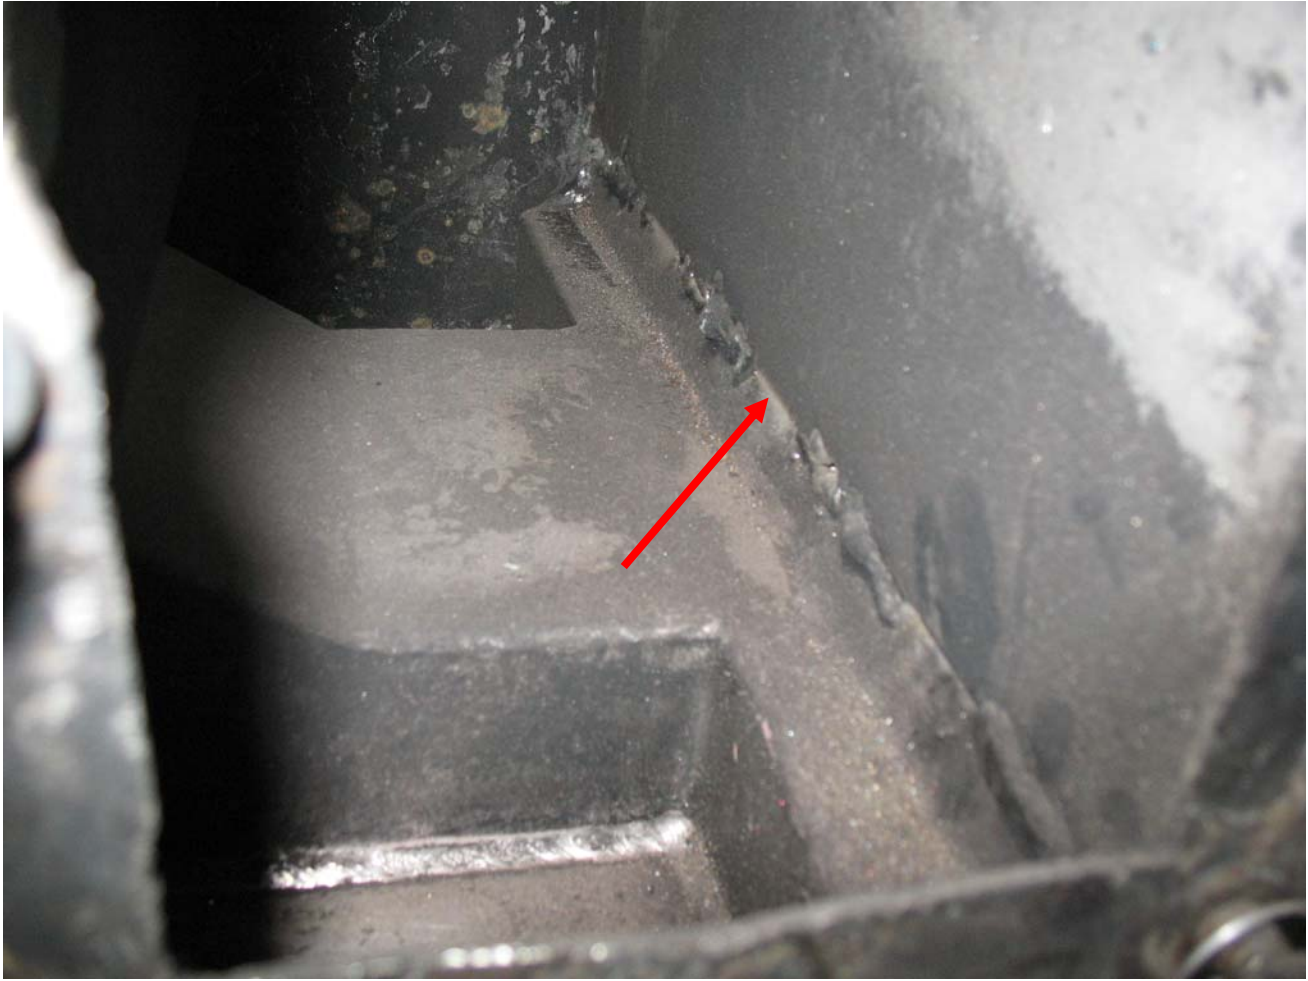
The cause of the failure may be attributed to the transfer of exhaust gas into the float chamber volume via gap between plates separating the main exhaust flow and float sections.

Photo – Showing weld discontinuities.

The remedy to the problem is for this gap to be sealed by continuous welding. For the incident in question, the shutdown failure was demonstrated on 2 Scrubber units and while another unit with a continuous weld operated without fault.

With the machine isolated, the float chamber access port should be removed and inspection of the welded area should be made to confirm any gas passage into the float chamber (ref photo).

Regardless of wether failure was observed or not, at the next major overhaul, significant repair work or Code D, the access port should be removed and the subject part of the Scrubber system should be inspected for the beginnings of corrosion or discontinuities in welding that could lead to exhaust entering the float chamber.
