CASE STUDY – BRINGING BACK THE FISH: NORTHERN RIVERS

KUNGALA ROAD, DUNDOO CREEK TRIBUTARY, GRAFTON

[An extract from: NSW DPI (2006) *Reducing the impact of road crossing on aquatic habitat in coastal waterways – Northern Rivers, NSW*, Report to the New South Wales Environmental Trust, NSW DPI, Wollongbar, NSW]

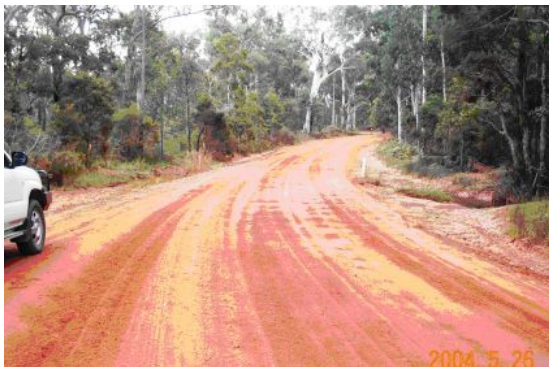
Unsealed Kungala Road at waterway crossing site.

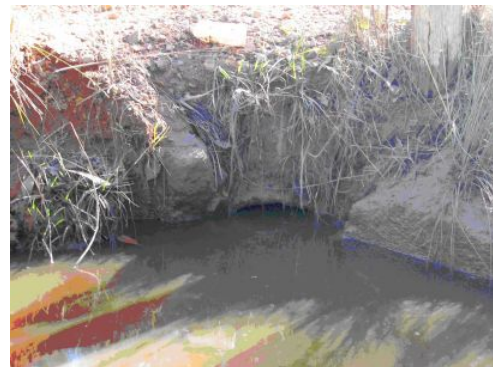
Heavily silted pipe culvert, downstream view.

The pipe culverts at Kungala Road cross an unnamed tributary of Dundoo Creek, a tributary of the Orara River in the Clarence Valley Shire local government area. The crossing consisted of an 8.3 m by 0.35 m pipe that was blocked with sediment, thus effectively forming a weir preventing the movement of water and instream fauna beneath the road.

The crossing is owned by Clarence Valley Shire Council and is used by upwards of 250 vehicles per day. Due to the inability of water to pass beneath the crossing, Clarence Valley Shire Council approached DPI (Fisheries, Conservation and Aquaculture) with a proposal to remove the existing pipe culvert and replace with a large box culvert that contained a low-flow channel. Bed level surveys were consulted to determine the invert of the middle cell to ensure that water maintained a depth of 300 mm through the structure.

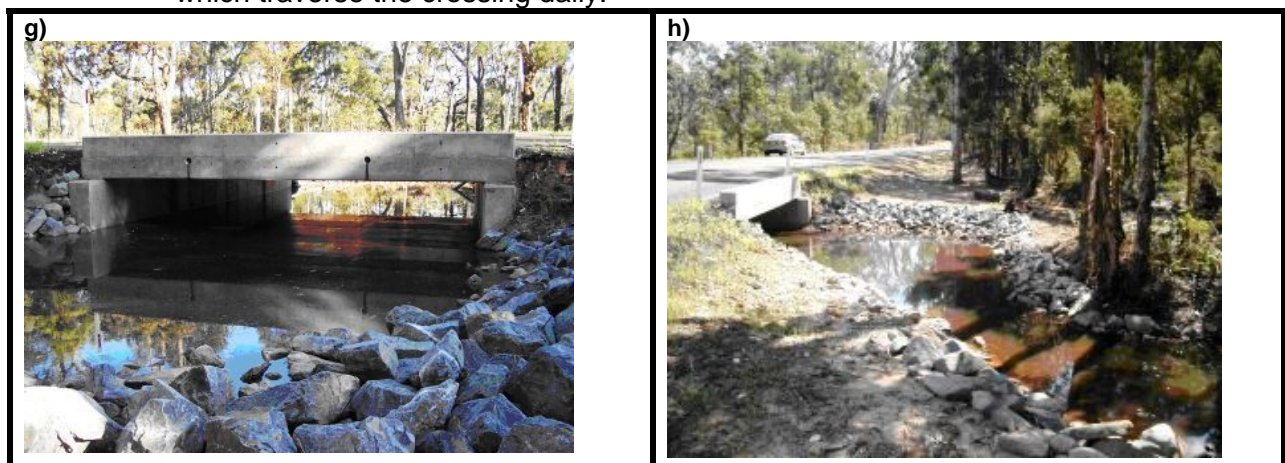
- Improved stream connectivity for native fish species (Plate g-h);
- Reinstatement of a natural flow regime to the unnamed tributary along with reduced sediment inputs associated with the sealing of road approaches; and
- Improved safety and reliability of the crossing for approximately 250 vehicles which traverse the crossing daily.
