## rock lining of a gully

**Landholder** Vic and Lynette Walters

**Map reference** 1

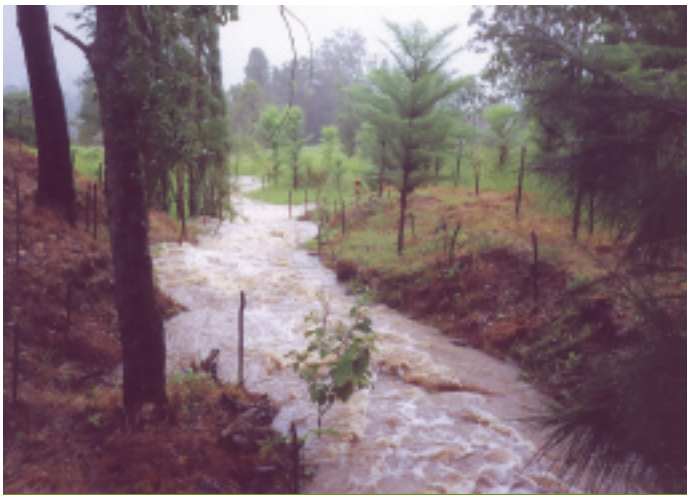
The stream in flood

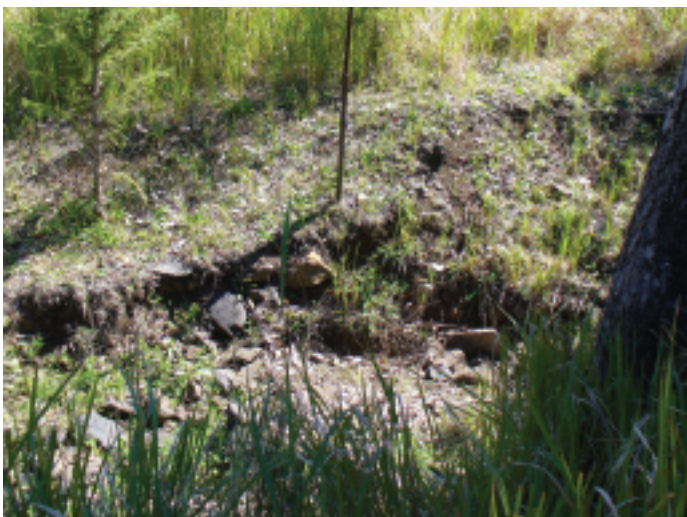
Gully erosion of the toe of a large landslip threatened to destabilise the slip area. The landslip encroached on a natural watercourse, and the floor of the watercourse was also eroding.

The toe of the old slip starting to erode

- The site was fenced to exclude cattle.
- The gully floor and toe of the bank were armoured with rock.
- Native trees were planted along the banks.

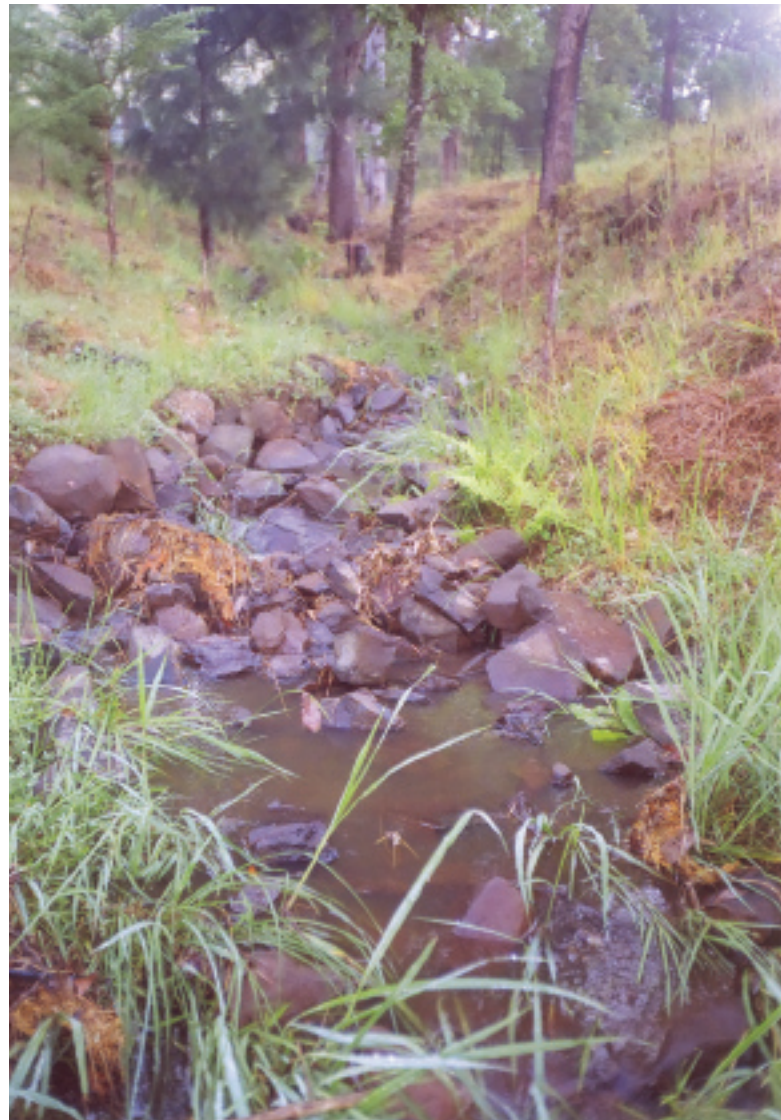
After the flood, rock work has protected the gully

- The watercourse is now stable, and handled the January 2008 flood well.
- Less sediment is entering Fawcetts Creek below.
- Tree plantings will link up with existing significant remnant vegetation.
