Investigation Report

Serious injury involving a fall from height at
the Perilya Broken Hill Southern Operation on
6 November 2007

Mine Safety Investigation Unit

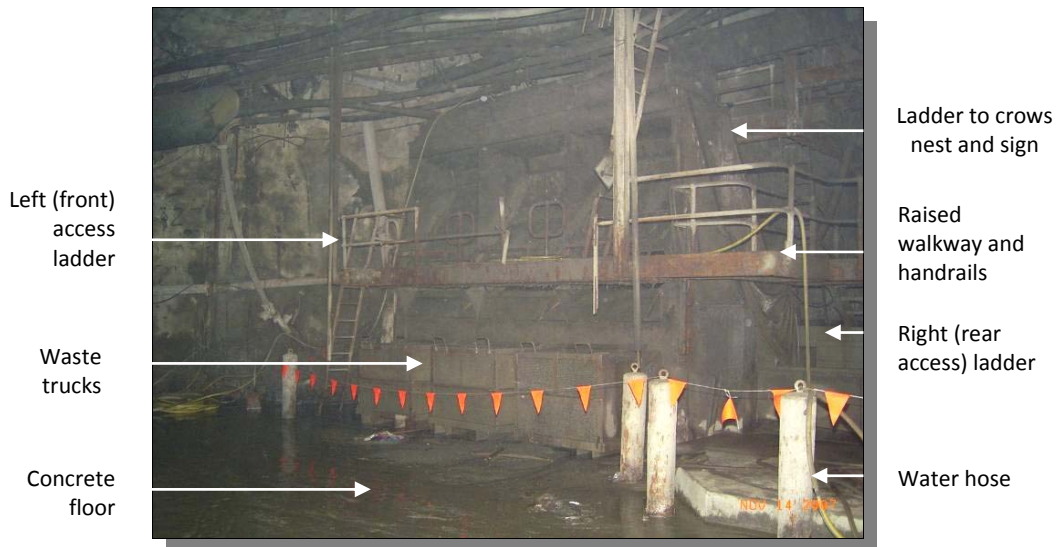
Cleans screens from walkway

Mr Battams used the ladder near the steam high pressure cleaner to access the walkway (seen on right of photo above). On the walkway he picked up the hose and cleaned the steps that were raised above the walkway. That done he hosed down the screens standing on the raised step, with the waste material falling into the trucks below. Each section of screen has a strainer at each end. Mr Battams hosed one strainer and then turned to step back onto the walkway to go to the other strainer.

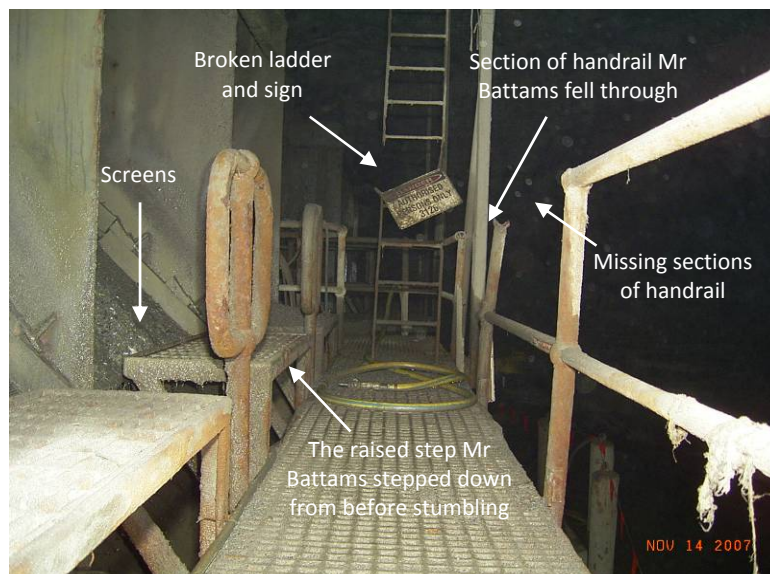
23 Level Pre-screens walkway
(Photo by Investigator Mark Freeman)

According to Mr Battams, while stepping back onto the walkway, he stumbled hitting the handrails of the elevated platform. He could not explain why he lost his footing. As he fell it appears he grabbed at the ladder near to him to stop himself, but a piece of ladder came away in his hand (see following photo).

Falls to ground	<p>The handrail gave way under the impact of Mr Battam's falling body and he fell about 2.5 metres to the concrete floor below.</p>
Injured and waits for help	<p>Lying on the floor, Mr Battams saw he had dislocated a finger on his left hand. Although he couldn't see his right leg he could wriggle his toes. But when he tried to get up he found the leg would not support him and he was in pain. He lay back down to ease the pain, using his helmet to support his head.</p> <p>Mr Battams got his cap lamp and shone it up the drive in the hope someone would see it and come to his aid. He checked his watch and found it was about 3.00 pm.</p> <p>He made himself as comfortable as possible and continued to call out for help. At one point he appears to have lost consciousness for some time.</p>
Team becomes worried	<p>By about 6.20 pm the other team members became worried. Mr Battams usually returned to the 24 Level with his IT at about 6.15 pm.</p> <p>A maintenance fitter went in search of him. He drove his Toyota ute up the drift from the 24 Level to the 23 Level pre-screens to check on Mr Battams.</p>

Unsafe plant The handrails provided at the pre-screens raised walkway to prevent persons from falling off were found to be corroded:

- steel of the pipe of the handrail was found to be very thin, offering little strength when a force or load was applied, and
- inspections of the pre-screens plant after the incident by the Inspector and Investigator readily identified surface rust and possibly deep corrosion on other steel components of the plant.

Further examples of unsafe plant and equipment were identified, in particular the ladder that went from the platform up to a crows nest near the roof of the cavern. This ladder appears to have been redundant for some time and had a sign attached prohibiting unauthorised access.

As Mr Battams fell he grabbed at the ladder hoping to stop his fall, only to find that a section of the extremely corroded ladder stile came away in his hand.

Corroded steelwork removed The redundant ladderway to the crows nest above the pre-screens was removed, along with the walkway structure and its access ladderways.

New walkway completed Following the incident the mine reassessed the pre-screens and began an evaluation and upgrade project. Pipe work and other structures were replaced, with a permanent raised walkway and access being completed in June 2010.
