Investigation Report

Serious injury involving roof bolter at
AUSTAR COAL MINE on 3 March 2008

Report prepared for the Director General of NSW DPI.

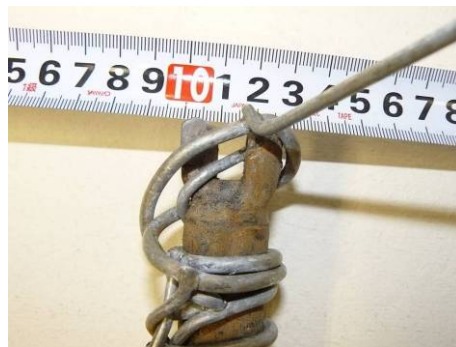
Photo 1

The incident occurred because the twin wing drill bit was able to engage the roof mesh, and the measures to prevent unplanned rotation of the drill steel were inadequate. There were also insufficient safeguards to ensure separation at all times between the workman and moving powered equipment.

Result of the drill rotation incident on 3 March 2008

A 27mm twin wing drill bit and drill steel that has engaged a strand of rib mesh.

Mesh is wrapped around drill steel after rotation occurred

Twin wing drill bits were withdrawn from service. A trial with a full spade bit proved unsuccessful. A modified spade bit with a smaller indent was introduced that is expected to reduce the likelihood of mesh becoming caught.

A designated guide steel was introduced with the drill bit thread removed so that a drill bit could not be fitted to it.

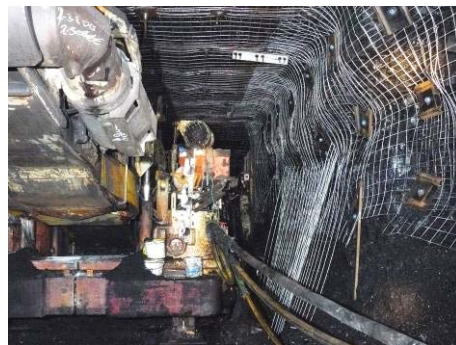
Photo 2

Incident scene showing roadway conditions and installed strata support on the right hand side rear of the continuous miner.

Visible is the overlap of roof and rib mesh at the roof horizon.

Development strata support plans have been revised so that rib mesh is now not pinned by outer roof bolt and rib mesh is not required to overlap the roof mesh.

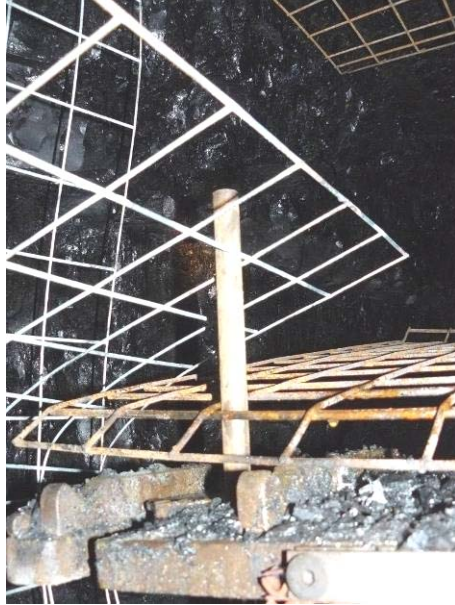
Photo 3

1.3m guide steel without a drill tip attached located in the drill rig on the left hand side of the continuous miner as found following the incident.

The guide steel locates the roof mesh and rib mesh above the continuous miner temporary roof support.

The guide steel is then used to locate the third sheet of mesh as seen at the roof level.

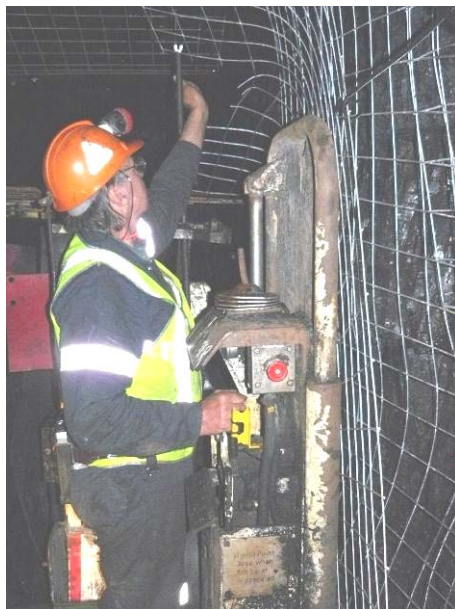
Photo 3

Simulation of the approximate position of McSporran's left arm in relation to the drill steel and rib mesh as demonstrated by Inspector of Mechanical Engineering W. Koppe.

(Note: A replacement 1.3m drill steel and white drill bit was used for the simulation. The folded rib mesh was cut during the rescue of McSporran. The drill rig is isolated for the purposes of the simulation)

The rib mesh sheet wrapped around the twin wing bit and as a consequence pulled McSporran's left hand and arm into the rotating drill steel.

Safe Work Procedures have been developed instructing mineworkers not to operate bolting rigs while handling mesh or steels, and not to operate any function of the drill rig with mesh caught in the guide steel.
