SAFETY ALERT

Electric shock and arcing results from ineffective earthing

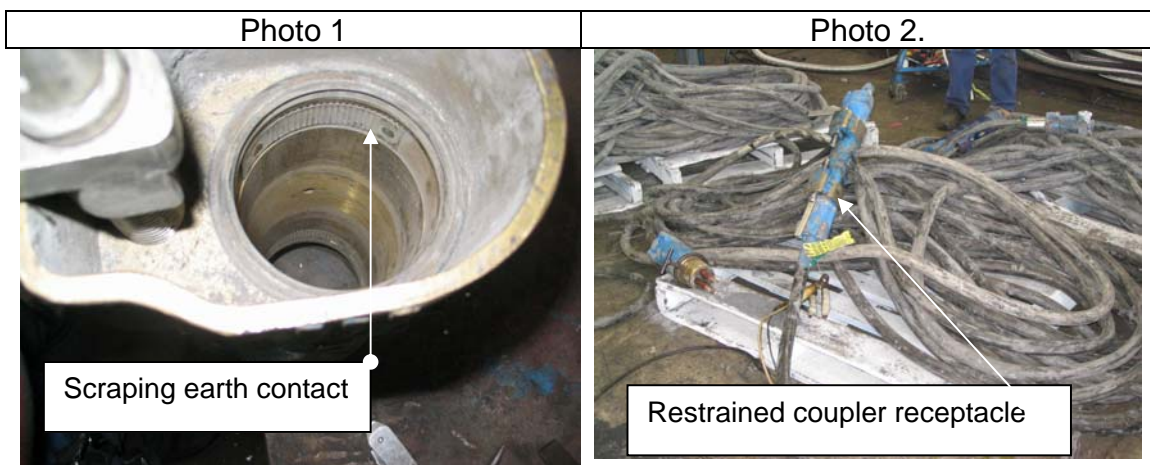
Incident 1: The scraping earth connection between the plug earth sleeve and receptacle body was not continuously effective.

- 1) The back-to-back coupler (photos 1 and 2) was examined and the scraping earth did not comply with Australian Standard AS1299. (Other receptacles utilising this scraping earth design may potentially have similar non-conformance.)

- 1) Mines should immediately inspect equipment in service to confirm integrity of earth connections.
- 2) Mines must ensure that tripping times for earth leakage relays and earth continuity relays are set to minimum values to achieve adequate prospective touch voltage/operating time characteristics.

- 5) Cable Repair Workshops and Approved Workshops receiving receptacles and cables of these types for repair should apply information from the product manufacturers to assess the compliance of product and mechanical integrity of scraping and internal earth connections.

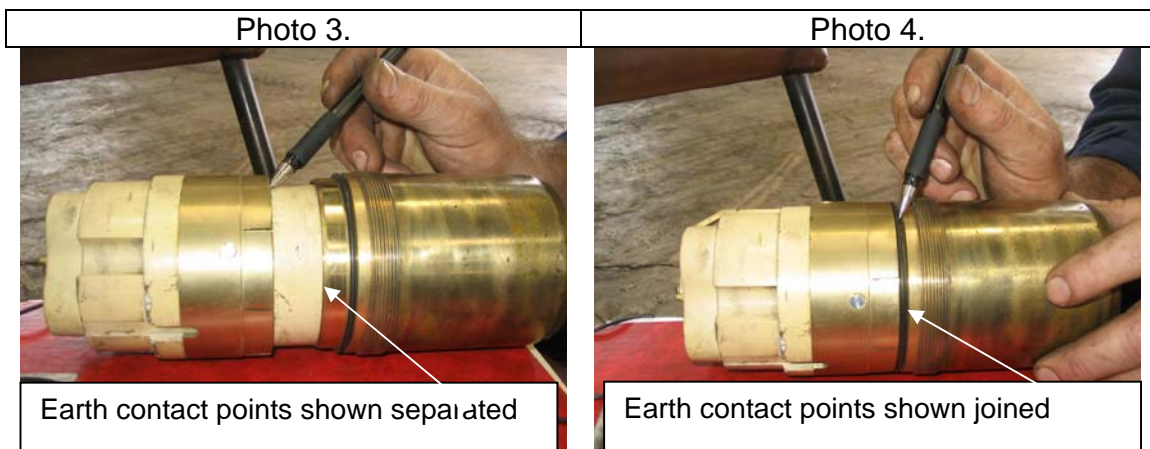
Incident 2: A trailing cable plug was found to have an ineffective earth connection inside the plug body between the earth sleeve and the earth attachment ring mounted on the moulded interior. Earth leakage trip times had an intentional and unauthorised delay. The earth continuity relay was set for pilot control however the external circuit was not wired for pilot control. (Drop-out resistance is increased approximately 300 per cent).

- 2) The cable plug (photos 3 and 4) was disassembled and the earth sleeve was found to have an unreliable contact with the earth ring attached to the moulded interior. (Other plugs utilising sliding or butt internal earthing connections may potentially have poor electrical integrity).
