**INVESTIGATION UNIT**

**Serious Injury – Roof Bolting – 3 March 08**

# Serious Roof Bolting Injury

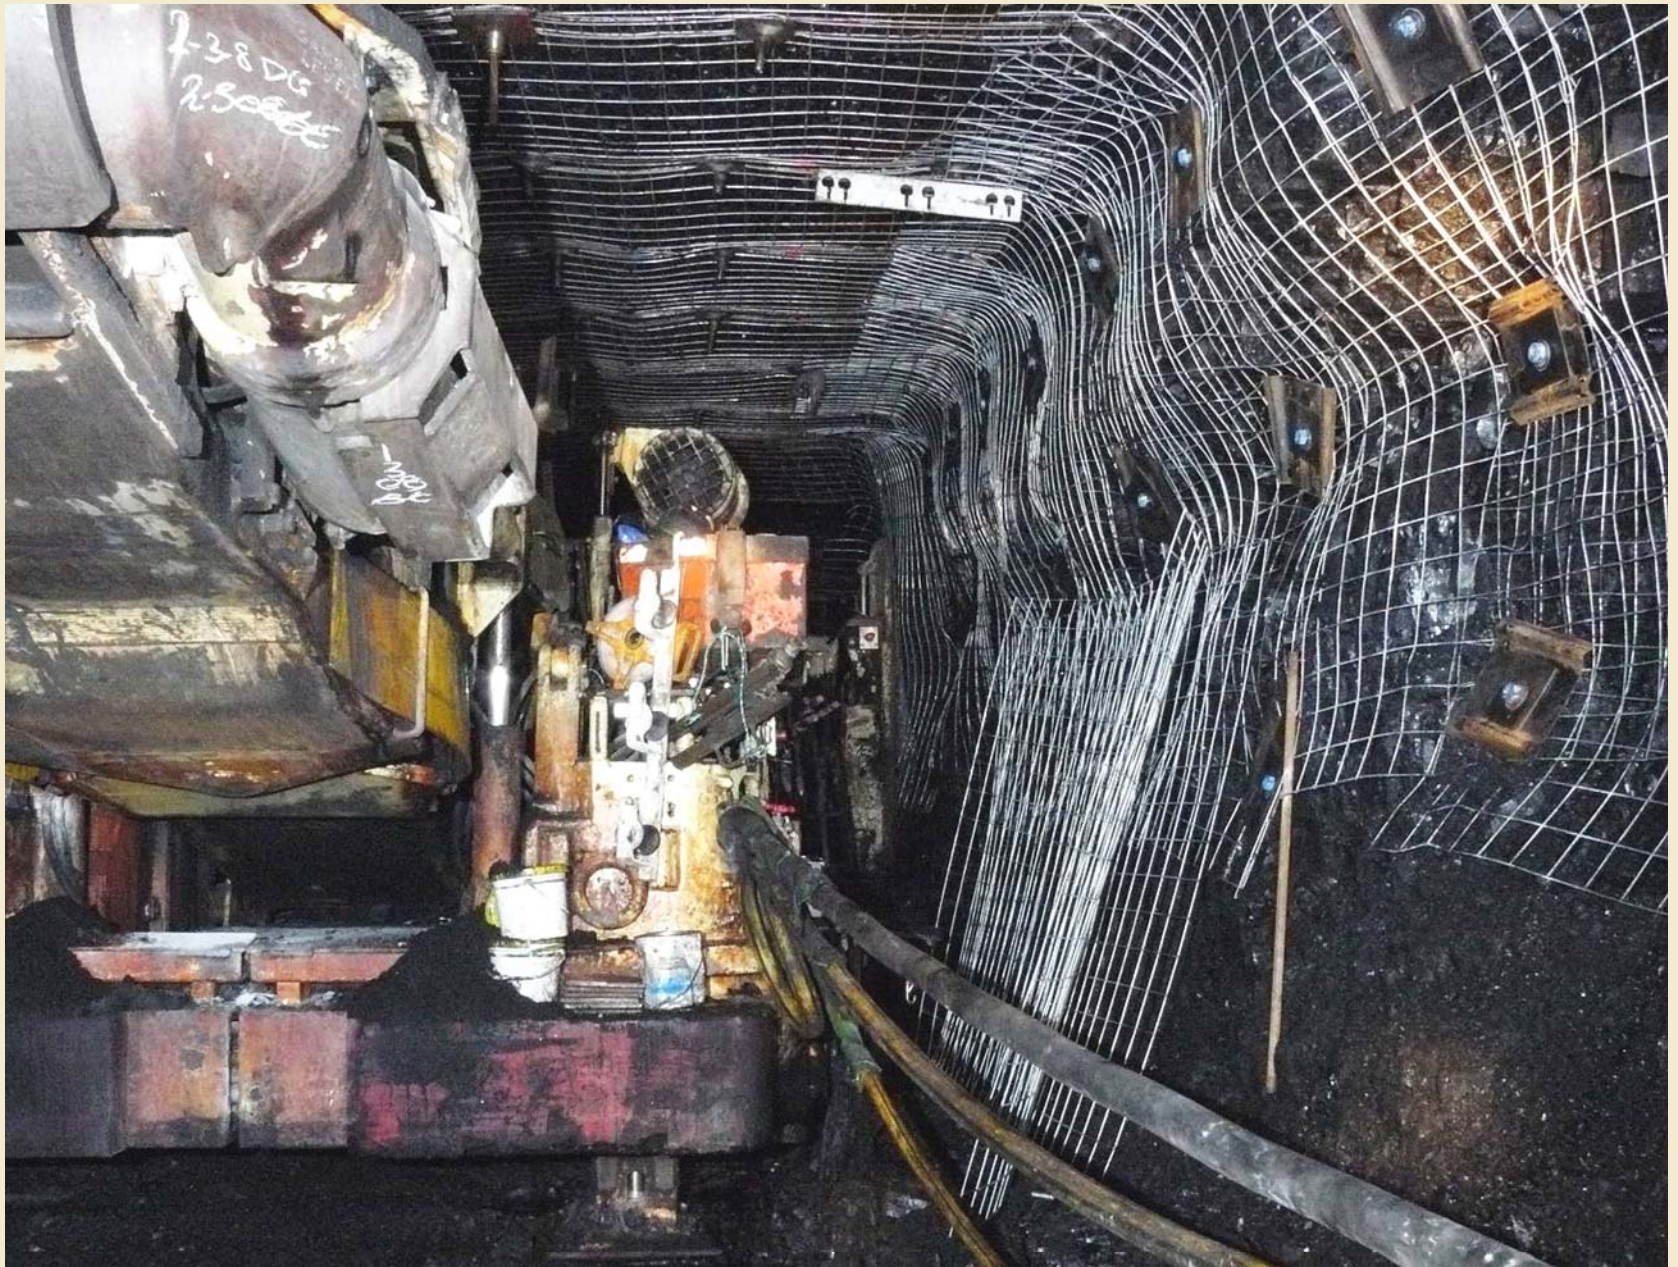
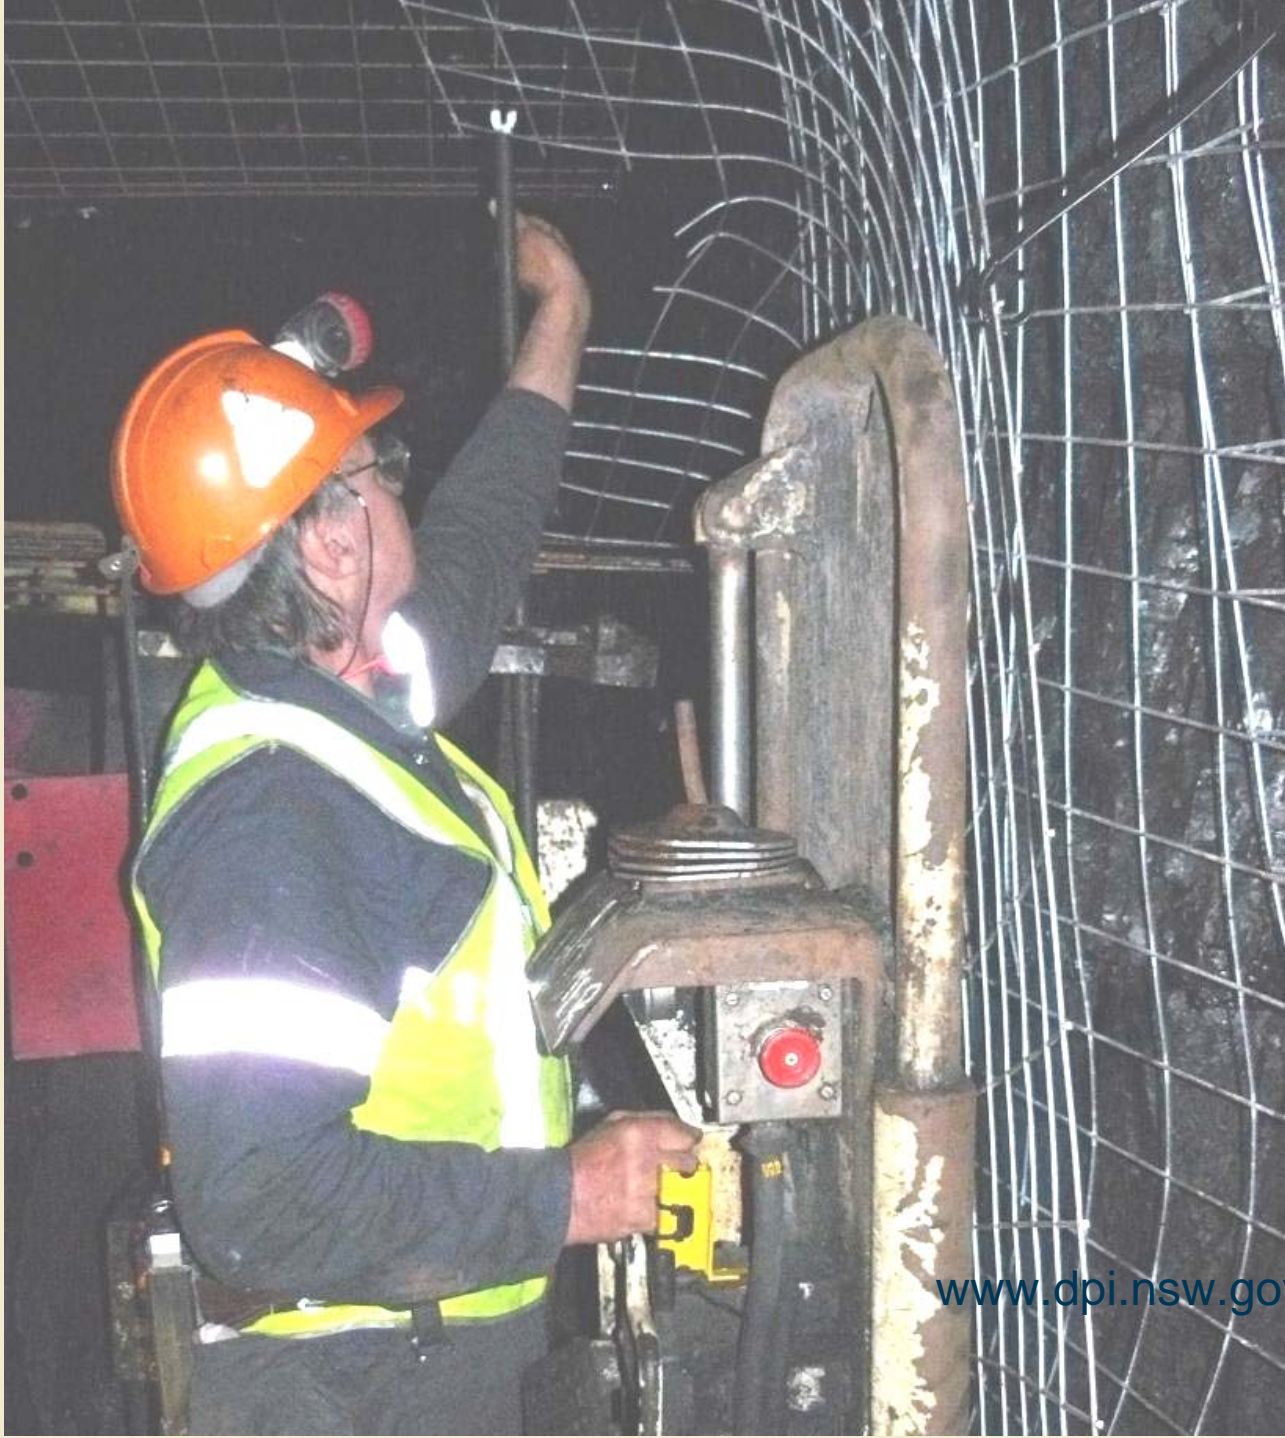
- 3rd March 2008
- Underground Coal Mine near Cessnock NSW
- Production face – operating a bolting rig
- 39 year old production worker
- 2 ½ years at the mine

- Incorrect drill steel used to locate mesh.
- Inadequate measures to prevent unplanned operation of rotation.
- Insufficient safeguards to ensure separation of mineworker from moving parts.

- Risk assessment and implementation of risk controls for moving machinery
- Application of standards such as AS4024 and MDG35
- Bolting rigs that need both hands to be on the controls to operate it.
- Control handles that are segregated and readily identified by shape.
