Rubber Tyred Vehicles

Technical Bulletin

Bulletin Number: TB1008

Subject: Strangler Valve Protection Device

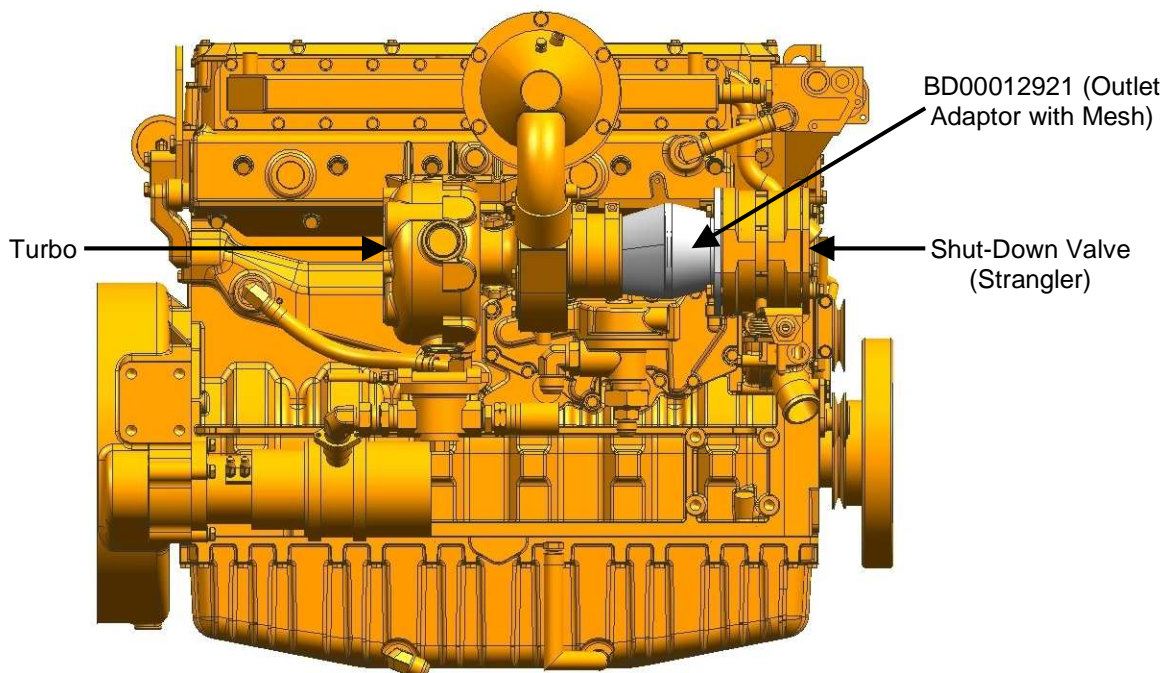
Sandvik has upgraded the connection flange between the turbo and the strangler valve p/n BD00012921. The new design incorporates a stainless steel mesh guard to stop a broken turbo impellor shaft from entering into the strangler valve operating area. (Please refer to images 1 and 2).

Image 1. Image shows position of connection flange as fitted to 3126DITA engine.

Sandvik recommend all owners/operators of 3126DITA Diesel Engine Systems install this new connecting flange at the next major service.

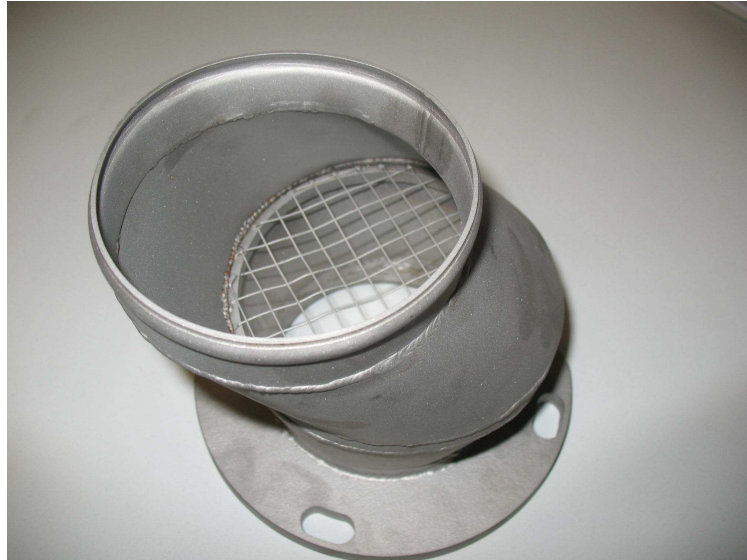
Image 2. Improved connection flange p/n BD00012921
