# Electrical Incident Report

## Spread the Safety Message

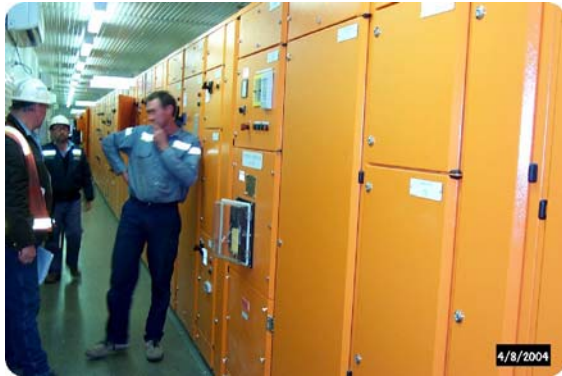
A contract electrician received an electric shock while working in a distribution board.

He thought the cubicle was isolated but had overlooked a back feed to a control wire.

- ✓ **TEST BEFORE TOUCH.**
- ✓ If the scope of work changes, check that the JSA is still relevant.
- ✓ Electrical isolation **MUST** include checking for live conductors.
- ✓ Best practice is to use two forms to prove that a circuit is de-energised.
  1. A Fit for Purpose meter (e.g/ Cat III multimeter or better.)  
Make sure it is working.  
Test the conductors you are going to touch.
  2. A non contact tester.  
Test before and after use.  
Test generally all locations in the work area.
- ✓ **MAKE SURE YOU HAVE YOUR TEST EQUIPMENT WITH YOU**
- ✓ In addition, consideration must be given to the possibility that conductors may become live during the course of the job.

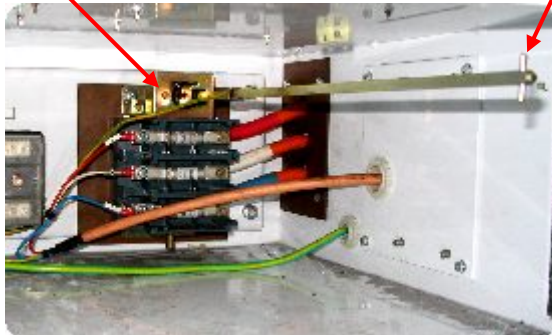
### Crane isolator (Upper compartment)

**Note: live incoming supply at back, right of isolator.**

The equipment was a Stromberg OESA 32 G1, 32amp isolator. The isolator is believed to be more than 15 years old and no longer available for purchase. The incoming supply to the isolator is taken straight from the bus

6 He received an electric shock through both hands.

- ✓ **TEST BEFORE TOUCH.**
- ✓ The isolator had exposed live parts and should not have been worked on without isolating upstream.
- ✓ review and confirm isolation points from circuit diagrams and request circuit diagrams from site operator if not issued at commencement of job

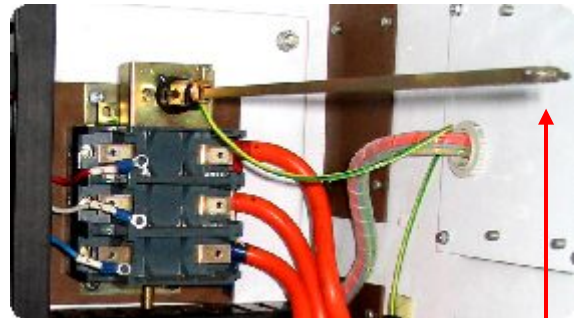
### Magnet Isolator (Lower compartment)

**note: extension bar incorrectly aligned to switch (indicator)**

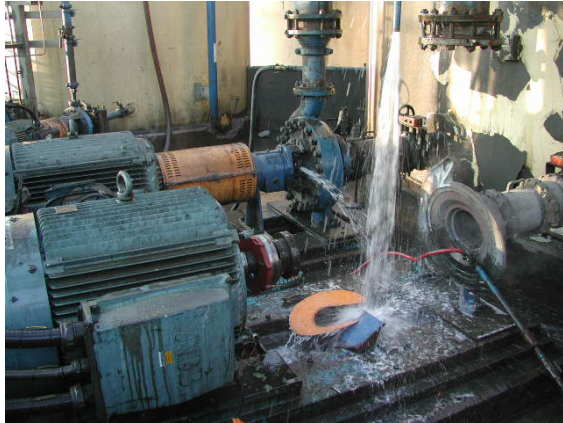
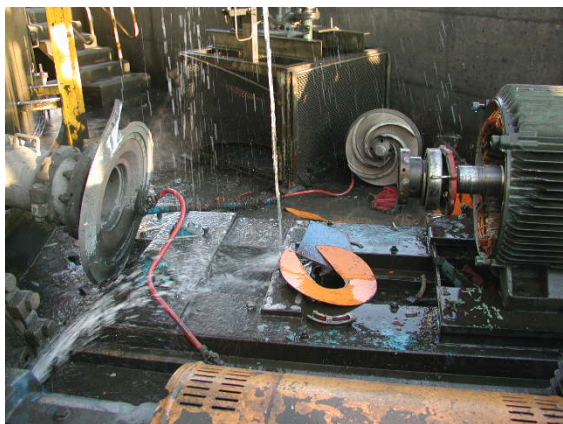
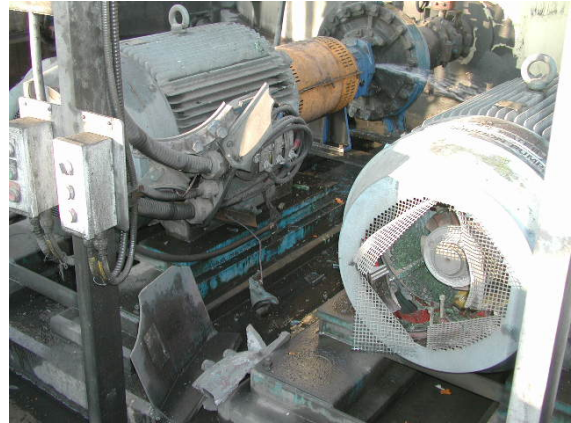
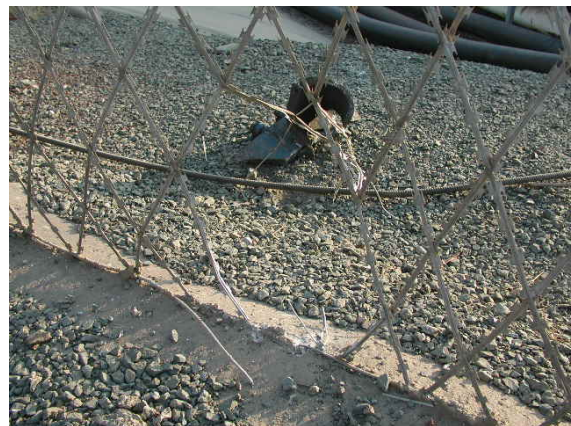
We recently received a report about a pump that exploded causing considerable equipment damage, and risk from flying debris.

The incident could have resulted in severe injury or fatality to persons if they had been in the vicinity at the time of the explosion. The impact and heat of the explosion and flying shrapnel / pump parts exposed the major threats. The actual loss is production loss.

Process Water Pump was operating with both suction and outlet valves closed. The water contained within the pump casing superheated and the high-pressure steam caused the pump to explode.

A procedural failure allowed the pump to be started without the suction and outlet valves first being opened. The other pump was still operating, hence the Process Plant was still receiving the required water flow and it was not noticed that Pump 040 was operating 'dry'.

Shrapnel had been ejected mainly within the concreted containment area, however some pieces of shrapnel had flown outside the containment area, up to 18 meters away. The second pump motor was damaged. Damage was also caused to the water tank, process water piping and nearby support structures.
