Summary Investigation Report

Serious injury involving longwall service
cassettes at the Beltana Mine on

21 August 2008

Mine Safety Investigation Unit

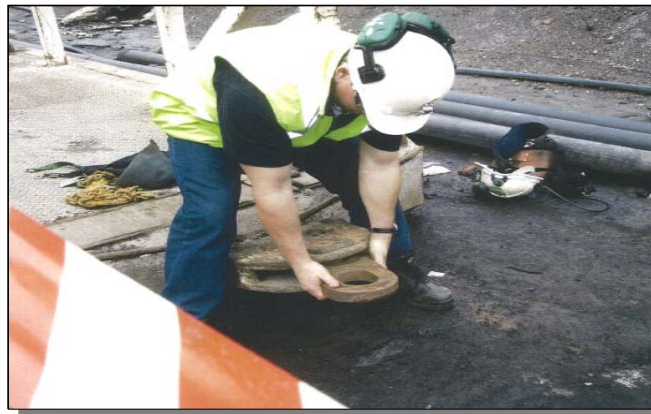
As Mr Thomas lent down to pick up the coupling he put his right leg on the ground next to the front of the coupling of SB2 as shown in the next photo. He lifted the 18 kg coupling and lug (a 9kg lift) to about horizontal position. As SB3 cassette was pushed closer (from the right of Mr Thomas' position) it swung clockwise toward the join area. SB3 continued to move past the coupling joint point and caught Mr Thomas' leg between the two cassette couplings. The crushing force of the impact caused several compound fractures to Mr Thomas' right lower leg.

Photo showing re-enactment of lifting the cassette coupling

- Scene preservation and restricted access to the site
- Upon withdrawal of the section 89 Notice by the Department's Inspector an assessment of joining longwall service cassettes was undertaken by the mine
- Beltana reviewed the longwall service cassette couplings and developed a system to support the coupling so people are no longer required to support it manually
- Beltana completed a job safety analysis (JSA) for the task of coupling the longwall service cassettes and made it available on the company intranet to all personnel and contractors.

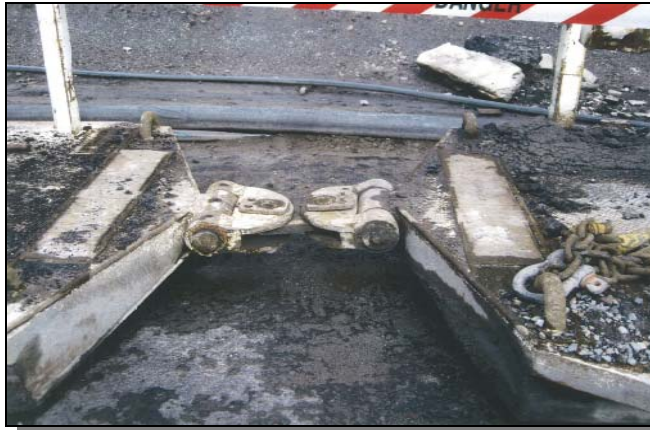
Photo showing cassettes with joined couplings

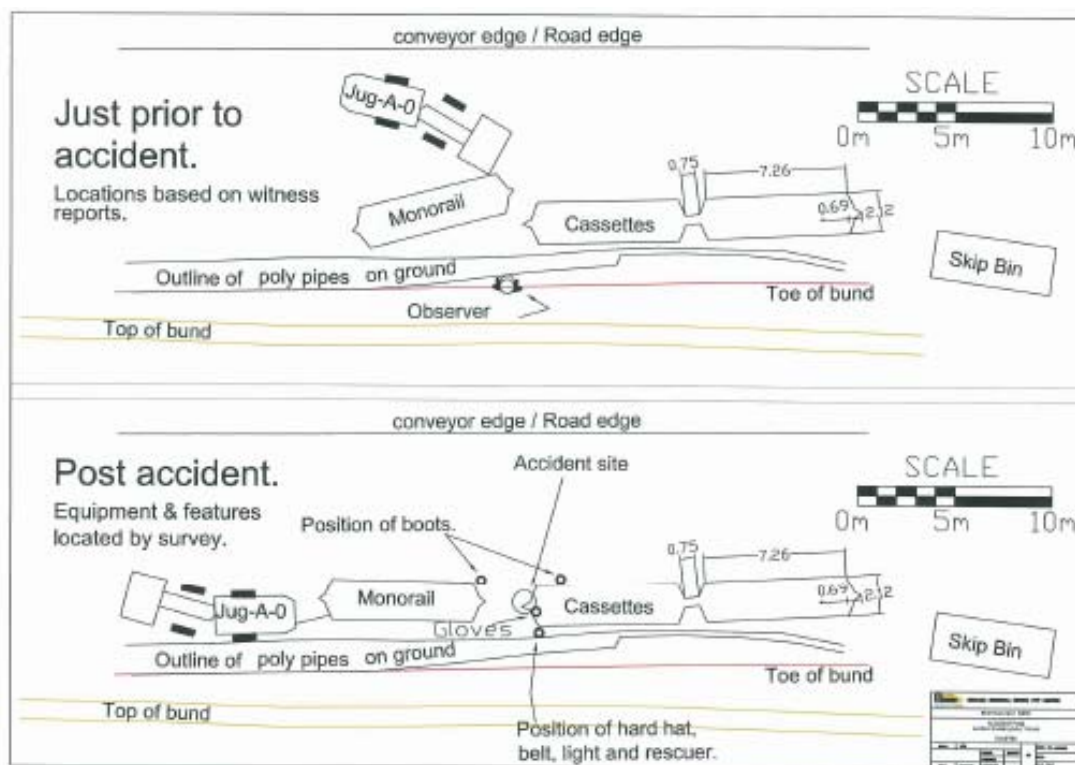
Plan of incident supplied by Beltana Highwall Mining
