# **Investigation Report**

Incident resulting in fatal injuries to a  
subcontractor on Eastern Star Gas  
Petroleum Assessment Lease 2 on  
1 August 2009

Report prepared for the Director-General of the  
Department of Industry and Investment by the  
Investigation Unit, Thornton

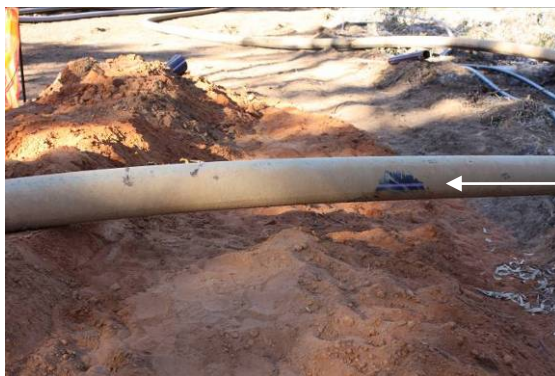
When the pipe recoiled it was covered in drilling mud. As it recoiled it apparently struck Mr Austin creating a 'wipe' mark on the pipe. Testing showed the DNA of Mr Austin was present on the pipe.

The pipe with the wipe mark, showing the point where the pipe is thought to have struck Mr Austin.

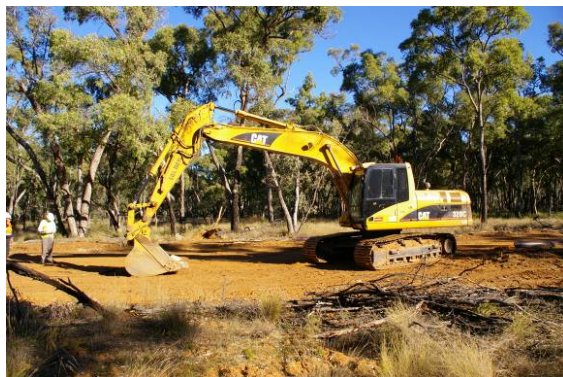
The machine being used to pull the pipe at the time of the incident was a Caterpillar 320C Hydraulic Excavator. It nominally weighed 21 tonnes, had a Drawbar Pull of 196kN (19.98 tonnes) and a bucket crowd force of 128kN (13.05 tonnes).

It appears the excavator had sufficient capacity, under normal operating conditions, to create enough pull force to rupture the chains.

The Cat 320C excavator at the incident scene.

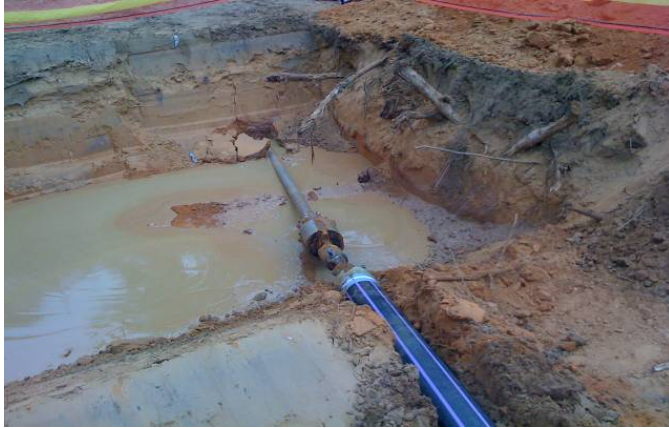
Showing drill string, reamer and pipeline, about to enter the horizontal directional bore, via the pilot hole exit pit.

The incident occurred adjacent to this pit.

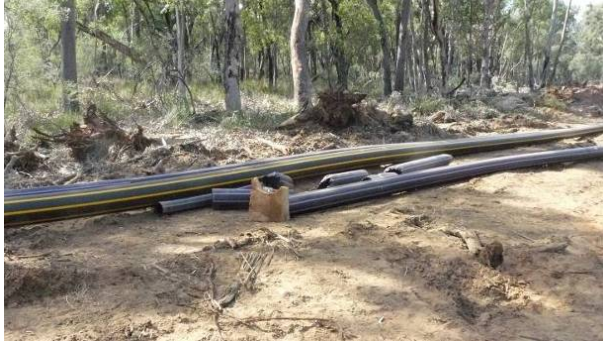
Pulling with the excavator led to the chains breaking near the exit pit. The chains were again attached to the pipe, when pulling recommenced the pipe was crushed by the chains and the pipe was sheared off. Shearing of the pipe was repeated one or more times, leading to Mr Austin suggesting the solution of using a piece of wood.

Showing broken pieces of pipe found near the pit from which the pipeline was being recovered.

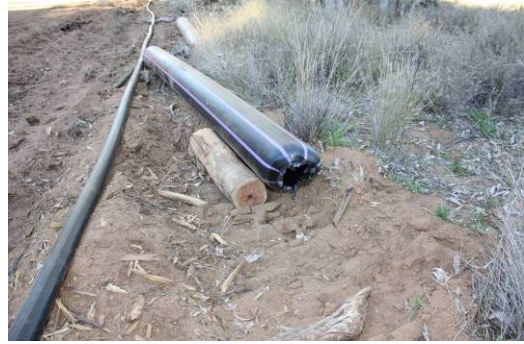
Then a piece of wood was cut and placed inside the pipeline, a better grip with the chain connection was achieved and the pipeline began to move when towed by the excavator.

The piece of wood that was placed in the pipe was found at the scene next to a sheared piece of the pipeline.

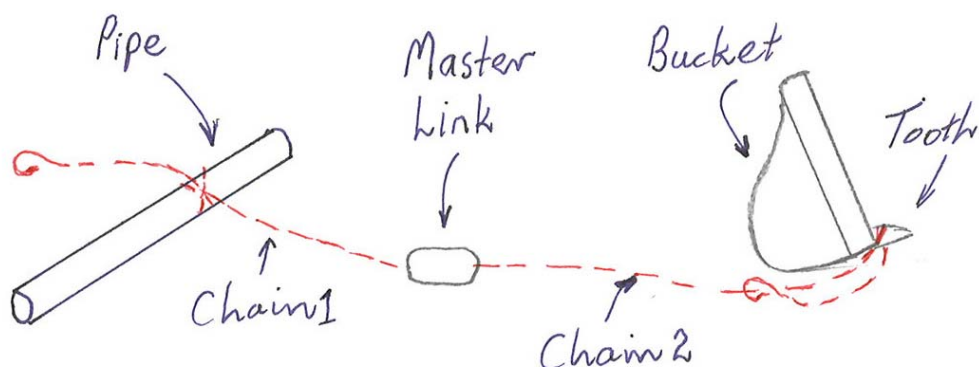
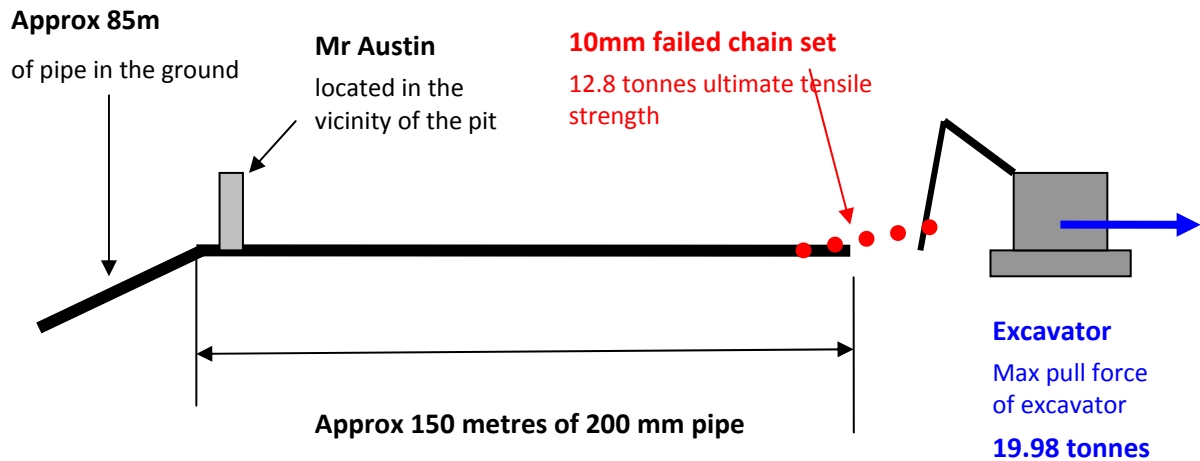
**Reported Rigging Method**

Discussions were held about pulling the pipe and the need to keep clear of it. Mr Austin was operating the excavator when pulling on the pipe at the exit pit commenced. The chains had been connected by an ADDS crew member using a clove hitch knot around the pipe and by placing the other leg of the chains around a bucket tooth.

Diagrammatic representation of the incident – not to scale
