Rubber Tyred Vehicles Technical Bulletin

Bulletin Number: TB0828

Subject: Failure of Explosion Protection of DES

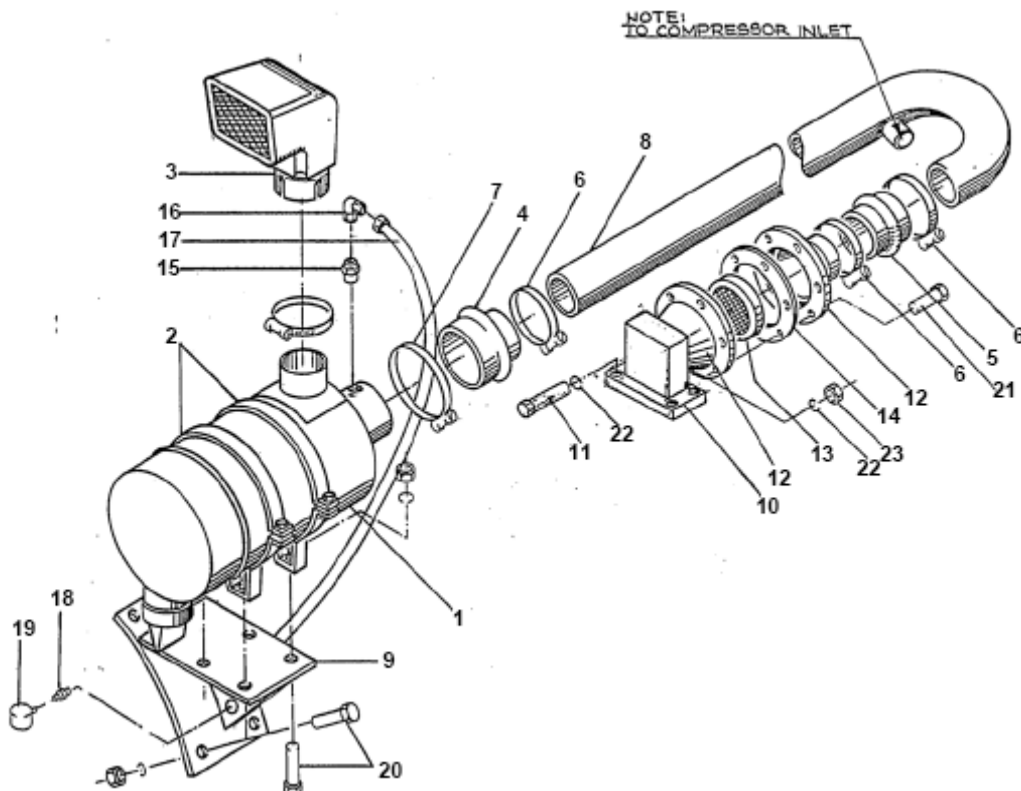
Figure 1 – Typical Sandvik Cat3304 air intake group. Air inlet manifold is item 10, Sandvik Part Number A2U913-241016.

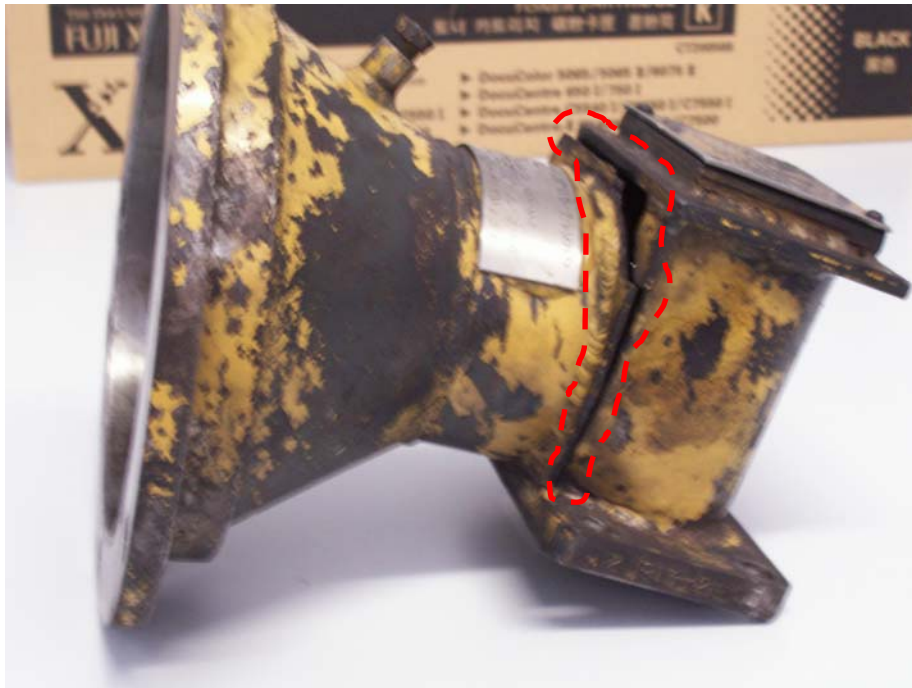
Sandvik have been advised that an incident recently occurred at a NSW colliery where a Sandvik 913 LHD was operated with a cracked air inlet manifold. This failure compromised the explosion protection characteristics of the DES.

Figure 2 – Photo of cracked manifold. Crack is circled.

- a) Conduct an inspection of all Cat3304 and Cat3306 air inlet manifolds in your fleets prior to operation in hazardous zones. For this audit a careful visual examination may be performed, however it is recommended that a dye penetrant crack test is performed.

- a) Visually inspect every 10 hours or daily.
- b) Crack test externally every 500 hours or 3 monthly.
- c) Ensure the manifold is inspected as part of the DES Code D service (every 2000 hrs or yearly), in particular the hydrostatic pressure testing, and internal examination of the component.

Any manifolds showing signs of cracking or deterioration should be replaced.

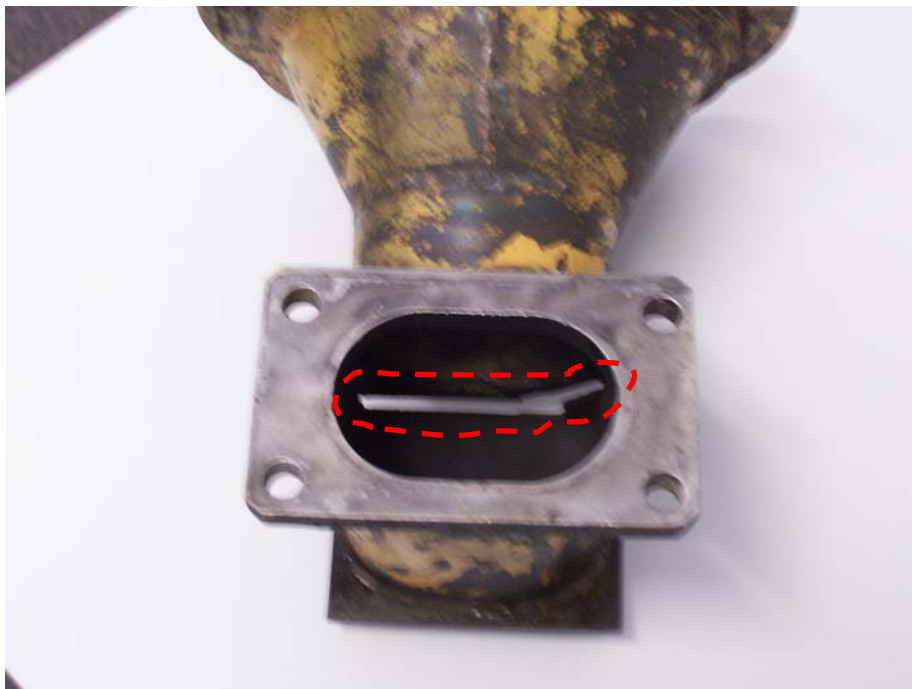
Figure 3 – Photo of cracked manifold. Visible section of crack is circled.
