| <b>EJECTION OF HYDRAULIC VALVE COMPONENT</b> | | |
| <b>2. Exposed product(s) / Part(s) / Serial number(s):</b> | SANDVIK ABM20 SERIES 2 AND ABM25 001 TO 035<br>CONTINUOUS MINERS | | | |
| <b>3. Possible occurrence of topic:</b> | <input type="checkbox"/> Transport <span style="float: right;"><input checked="" type="checkbox"/> Maintenance</span><br><input checked="" type="checkbox"/> <b>Operation</b> <span style="float: right;"><input type="checkbox"/> Spare parts</span><br><input type="checkbox"/> Trimming <span style="float: right;"><input type="checkbox"/> Others:</span> | | | |
| <b>4. Market area:</b> | <input checked="" type="checkbox"/> EU, Others <span style="float: right;"><input checked="" type="checkbox"/> Canada, USA, Australia</span> | | | |
| <b>5. Supplementary safety information including new hazard(s) identified how to avoid the hazard(s) and the potential consequences of not avoiding the hazard:</b> | | | | |
| <div style="background-color: orange; padding: 5px; display: inline-block;">

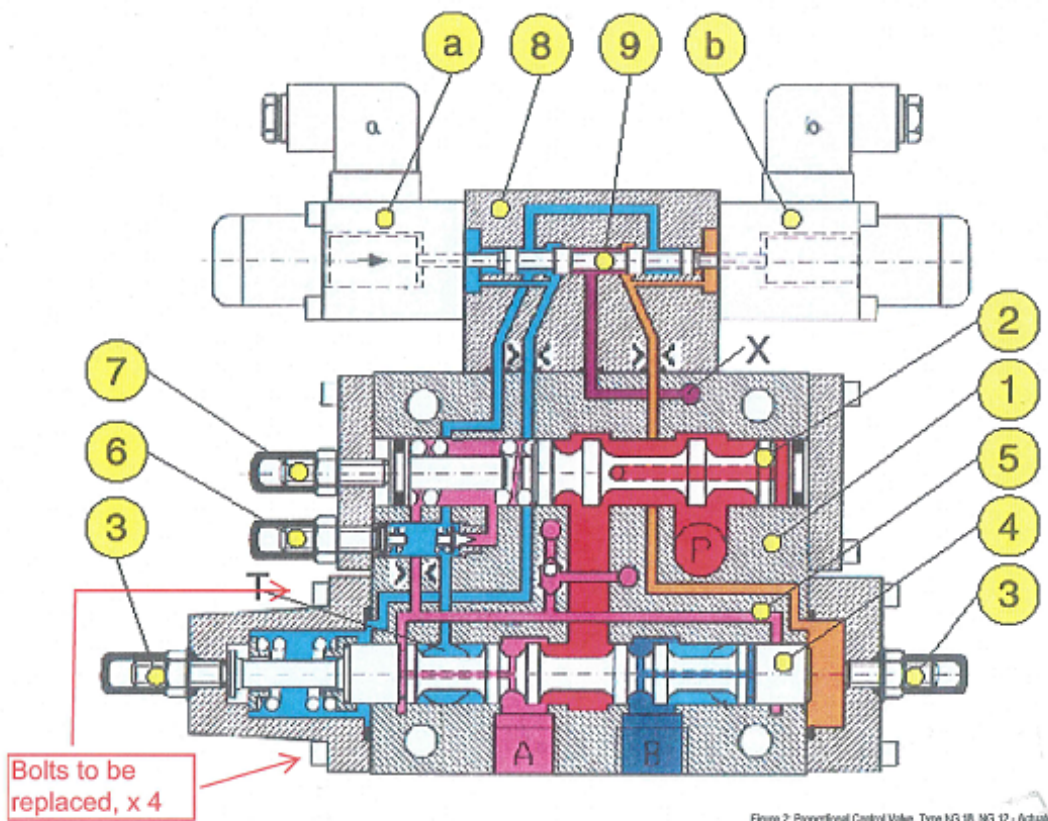
<b>WARNING</b></div>  |   |  |   |   |
| <table border="1" style="width: 100%; border-collapse: collapse;"> <tr> <td style="width: 25%; text-align: center; vertical-align: middle;"> <br/><br/> </td> <td style="padding: 5px;"> <p><b>IMPACT AND HYDRAULIC FLUID RELEASE HAZARD!</b></p> <p>Sandvik has been informed of an incident where the end cap of a hydraulic valve bank was ejected from the valve body and impacted a steel door on the side of the machine.</p> <p>This end cap failure will result in the uncontrolled release of hydraulic fluid.</p> <p>This failure has the potential to injure personnel working in the vicinity of the valve due to impact or uncontrolled release of pressurised hydraulic fluid.</p> <p>The cause of the component failure was identified as corroded end cap bolts.</p> <p>To avoid this hazard, follow the recommendations in section '6. Actions to be taken immediately' and section '8. Recommended Actions'.</p> </td> </tr> </table> | | | <br><br> | <p><b>IMPACT AND HYDRAULIC FLUID RELEASE HAZARD!</b></p> <p>Sandvik has been informed of an incident where the end cap of a hydraulic valve bank was ejected from the valve body and impacted a steel door on the side of the machine.</p> <p>This end cap failure will result in the uncontrolled release of hydraulic fluid.</p> <p>This failure has the potential to injure personnel working in the vicinity of the valve due to impact or uncontrolled release of pressurised hydraulic fluid.</p> <p>The cause of the component failure was identified as corroded end cap bolts.</p> <p>To avoid this hazard, follow the recommendations in section '6. Actions to be taken immediately' and section '8. Recommended Actions'.</p> |
| <br><br> | <p><b>IMPACT AND HYDRAULIC FLUID RELEASE HAZARD!</b></p> <p>Sandvik has been informed of an incident where the end cap of a hydraulic valve bank was ejected from the valve body and impacted a steel door on the side of the machine.</p> <p>This end cap failure will result in the uncontrolled release of hydraulic fluid.</p> <p>This failure has the potential to injure personnel working in the vicinity of the valve due to impact or uncontrolled release of pressurised hydraulic fluid.</p> <p>The cause of the component failure was identified as corroded end cap bolts.</p> <p>To avoid this hazard, follow the recommendations in section '6. Actions to be taken immediately' and section '8. Recommended Actions'.</p> | | | |
| <b>6. Actions to be taken immediately:</b> | | | | |
|

The end cap bolts are identified in the figure below.

| <p>Fully isolate the machine prior to opening the access panel to the valve banks.</p> <p>At the next opportunity, replace the end cap bolts on all valve banks in excess of 3 years old.</p> <p>For all other valve banks, check tightness of bolts.</p> <p>The end cap bolts to be tightened/replaced are shown in Section 9.</p> | | | |
| <p><b>The Owner of machinery has a liability to inform and when necessary to train according to the content of this Bulletin all the personnel (like operators, maintenance personnel) whom this Bulletin concerns.</b></p> | | | | |
| <b>7. List of Attachment(s):</b> | | | | |
| There are no attachments to this Safety Bulletin. | | | | |

Add to the service schedule for the miner to replace the bolts every 3 years. Minimum property class 8.8.  
 Add to the service schedule for the miner to check bolt tightness every 12 months. Maximum torque 18Nm.  
 Notify personnel of the requirement to fully isolate the machine prior to opening the access panel to the valve banks.
