SAFETY ALERT

Defective Restrained Back to Back Couplers

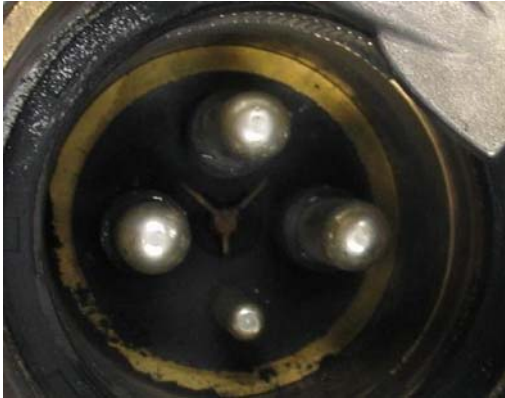
1. A 425 ampere (A) back to back coupler had a 300A interior moulding fitted and arranged in a 425A orientation. This had the potential for arcing between the 300A pins and 425A sockets under load conditions, with a significantly increased risk of initiating a short circuit arcing fault.
2. A 425A back to back coupler had both jacking screws retained in the receptacle body within a brass bush held in position with a grub screw. The bushing was inserted incorrectly and it was possible to pull the jacking screw out (along with the bush).

1. A plug with 425A sockets fitted into a 425A back to back receptacle with 300A pins increased the risk of a short circuit arcing fault to an unacceptable level.
2. Jacking screws were not threaded directly into a receptacle casing presenting an unacceptable risk of compromising explosion protected properties and short circuit arcing faults.

1. The back to back coupler was inspected and 300A pins were found to be fitted and oriented for 425A, illustrated below:

Photo 1.
300A pins and 425A orientation

- 1) Mines using this type of product must immediately inspect all 300A and 425A back to back couplers of this make to ensure the correct pins are fitted and that the pins are in the correct orientation.
- 2) Mines using this type of product must immediately inspect all 300A and 425A back to back couplers of this make. Any back to back couplers with a bushed thread for the jacking screw should be immediately withdrawn from service and measures taken to ensure it will not be used again.
- 3) The manufacturer should immediately advise customers and distributors to remove the equipment from service.
- 4) Cable Repair Workshops and Approved Workshops that may repair this type of receptacle should modify inspection procedures to ensure identification of the two unsafe conditions referred to in this alert.

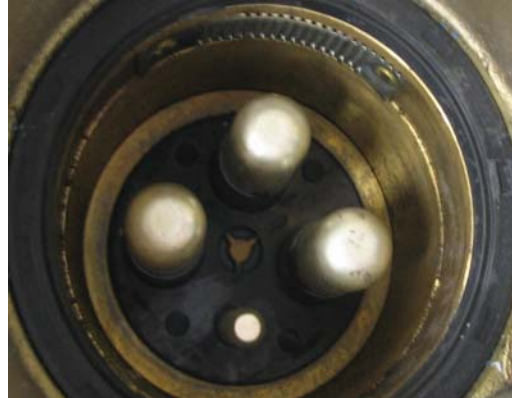
Photo 2.
425A pins and 425A orientation

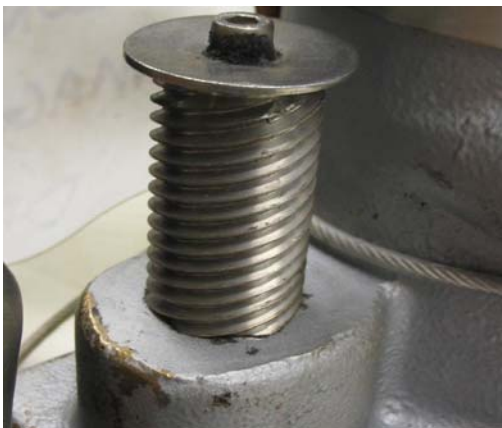
Photo 3.
Jacking screw in a threaded case
- ACCEPTABLE ARRANGEMENT

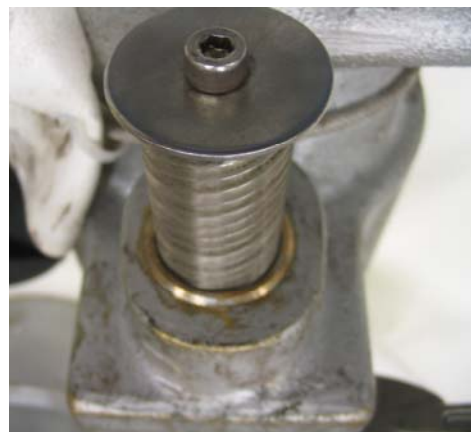
The defective jacking screw arrangement could have enabled an unplanned partial withdrawal of the plug (e.g. when a cable is under tension). This partial withdrawal could have initiated arcing from partially connected pins and sockets.

2. The back to back coupler was inspected and the retention of the jacking screw was found to be inadequate. Photo 3 shows an acceptable arrangement. Photos 4, 5, 6 and 7 show the unacceptable bushing arrangement.

Photo 4.
Jacking screw in a case with a bushing
- UNACCEPTABLE ARRANGEMENT

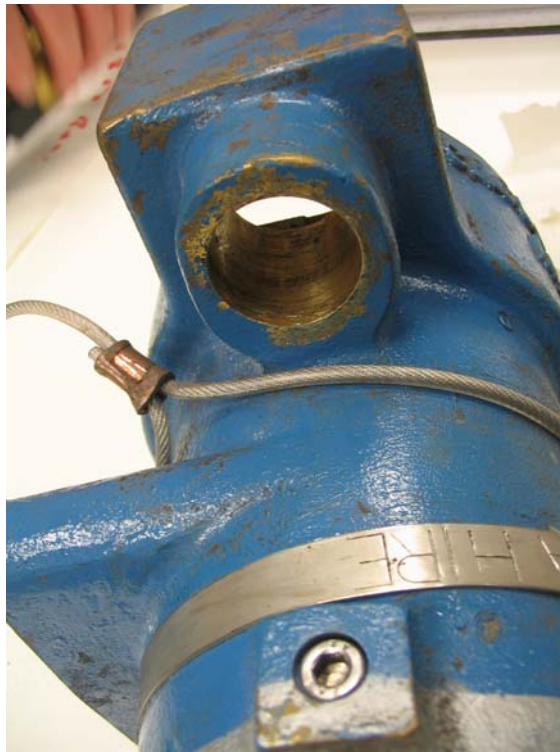
Photo 5.
*Casing bored to accept a bush – **UNACCEPTABLE ARRANGEMENT***

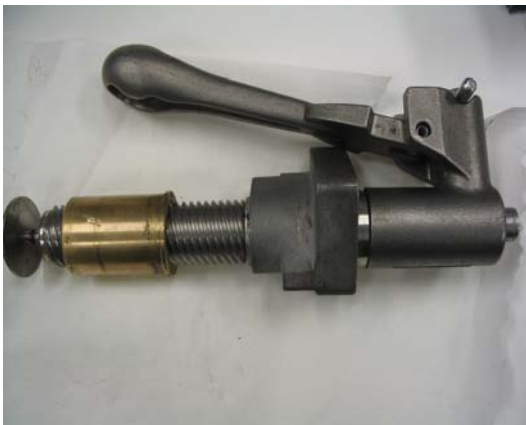
Photo 6.
Jacking screw with a threaded bush dislodged from receptacle body
– UNACCEPTABLE ARRANGEMENT

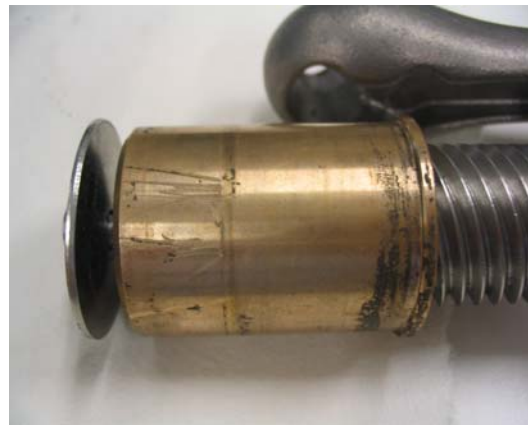
Photo 7.
Bush – showing score marks where the grub screw has failed to retain the bush within the receptacle body.

(Note the bush lip on the right hand side should have been on the left hand side)

– UNACCEPTABLE ARRANGEMENT
