## Investigation Report

Fatality involving  
David Hurst Oldknow  
Ravensworth Underground Mine  
Coal Preparation Plant  
Reject bin 802  
18 February 2009

Report prepared for the Director General of  
the Department of Industry and Investment  
by the Investigation Unit, Thornton

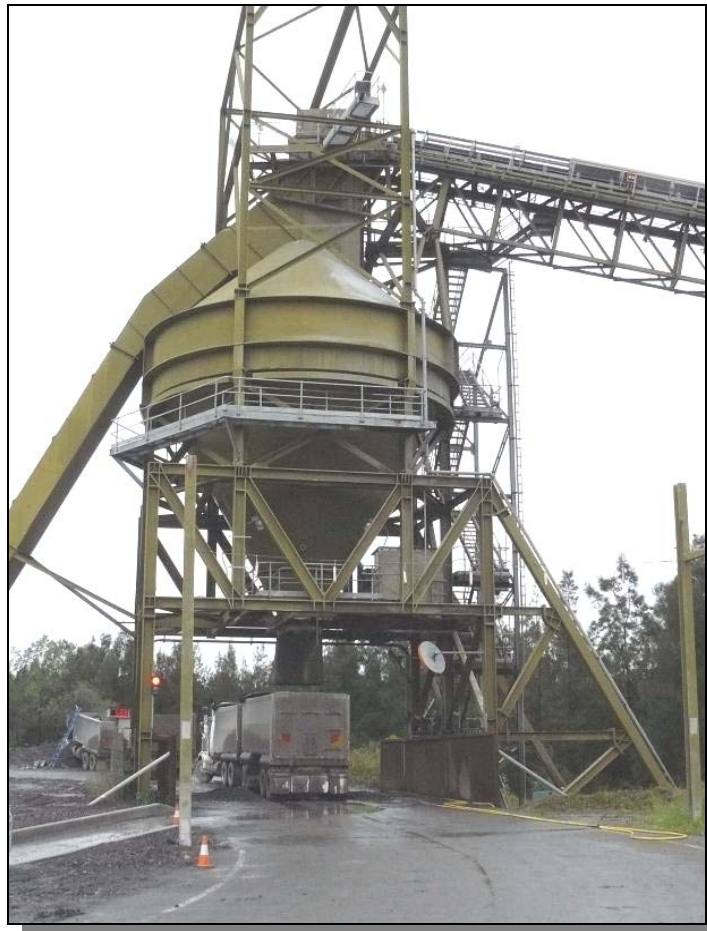
After the inundation the truck continued forward for approximately 30 m before the front wheels encountered a dirt embankment and came to a stop.

View west of the entry road to Reject Bin.

Mr Oldknow's truck can be seen on the embankment beyond the loading zone, while one of the other driver's trucks is parked under the bin.

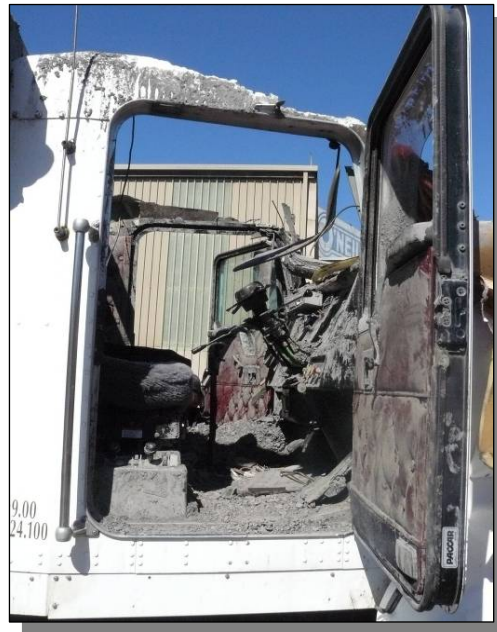
Mr Oldknow received fatal injuries while seated in the driver's seat of his truck cabin. The fibreglass cabin roof collapsed onto him when approximately 10 tonne of reject rock material was inadvertently released from the bin.

Driver's side view of the Kenworth T401 truck cabin showing the damage caused as a result of the incident

Rock material fell from a height of 2m onto the cabin roof which was not designed to carry such a weight.

The dynamic loading event caused the final barrier protecting Mr Oldknow, the cabin roof, to collapse onto Mr Oldknow and ultimately caused his fatal injuries.

Ultimately, the roof of the fibreglass cabin in the Oldknow incident failed to withstand the dynamic loading of the falling reject material from the bin.

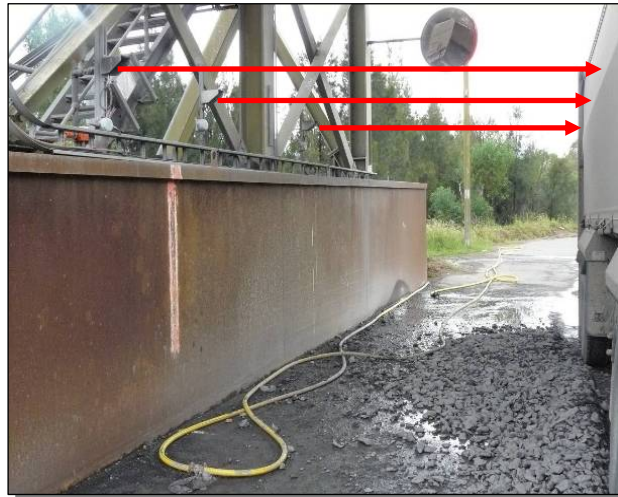
The Reject Bin operating system was designed to detect if a truck was in the correct loading position using three sets of photo electric sensors, comprising both transmitter and receiver sensors.

Three pairs of sensors were mounted at a height of 2.7m from the ground.

Looking east under the Reject Bin. The arrows simulate the infra-red beams from the rows of transmitter sensors being blocked by the truck trailer. One of two sighting mirrors is also visible. The red paint line on the wall is the visual reference for a driver positioning the truck to take the first load.

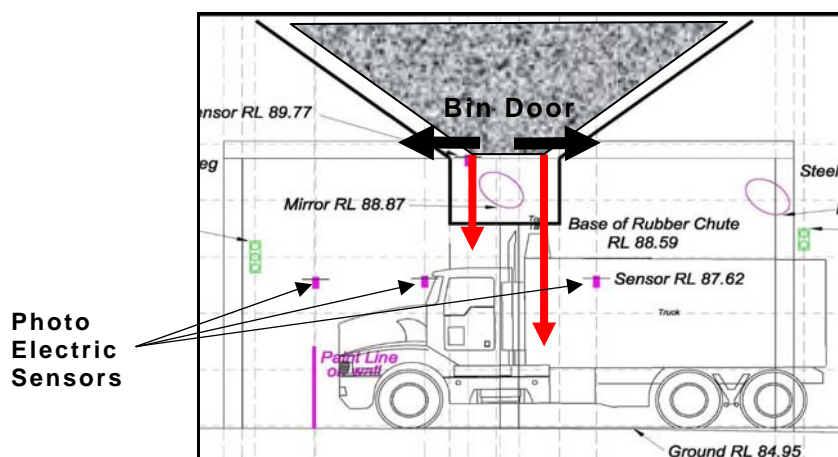
Incident scenario diagram

The following incident scenario diagram shows the approximate position of Mr Oldknow's Kenworth truck at the time the cabin was inundated by the reject rock material.

The material fell approximately 2m onto the cabin as indicated by the left red arrow. Some rock material also fell into the front section of the truck tipper behind the cabin as indicated by the right red arrow.

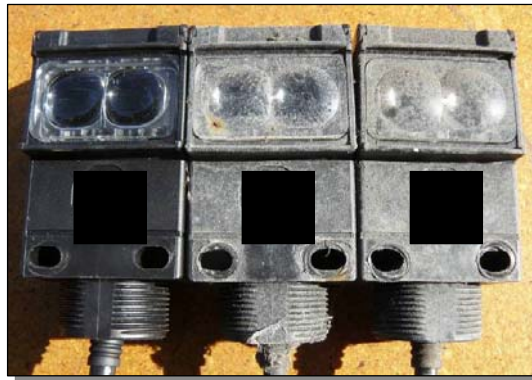
**Row 1** sensor signal was 17.64% more degraded by dirt than the new (control) sensor

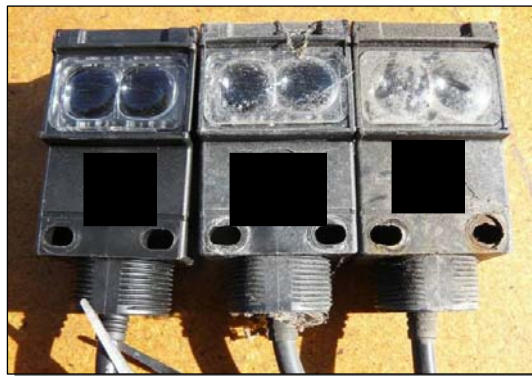
An inspection of the Reject Bin and loading area after the incident identified that the transmitter sensor in the second row of sensors was blocked due to a build up of dirt on the lens.

With the second row sensor blocked by dirt and not detected the PLC logic code enabled the system to remain active and not reset to the start of the permissive code sequence.

The investigation identified that the PLC system could not differentiate between a photo electric sensor blocked by a truck or blocked by dirt covering the lens and remained active.

**Row 2** sensor signal was observed to be operational but constantly blocked by dirt during post incident inspection.

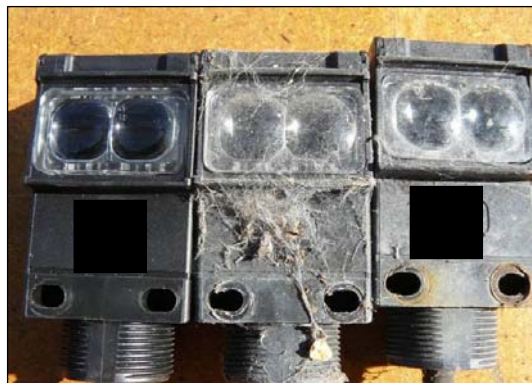
**Row 3** sensor signal was 0.63% more degraded by dirt than the new (control) sensor.
