## Opal mining on the alluvial soils at Lightning Ridge

Report on a visit to Lightning Ridge conducted on  
29 November 2012

Soil Issues: Opal mining on the alluvial soils at Lightning Ridge

Author: John Friend, Technical Leader, Agricultural Land Management, Port Stephens

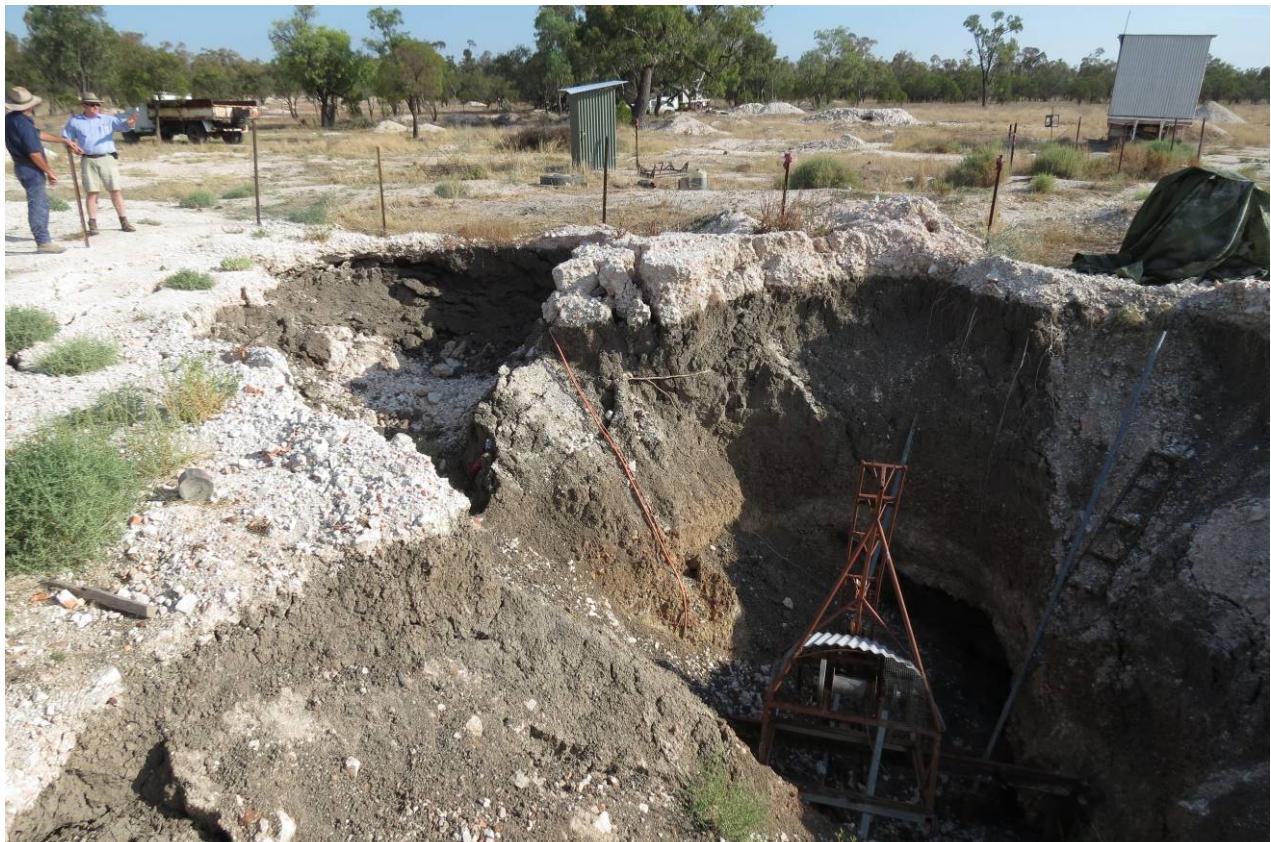
Figure 2. A worked mine at Knightlife opal field suffering collapse after inundation

Figure 2 shows a mine which has collapsed after inundation of the site with water. It can be seen in the photo that the mining equipment has collapsed into the hole. The soil has been flowing into the existing mine space.

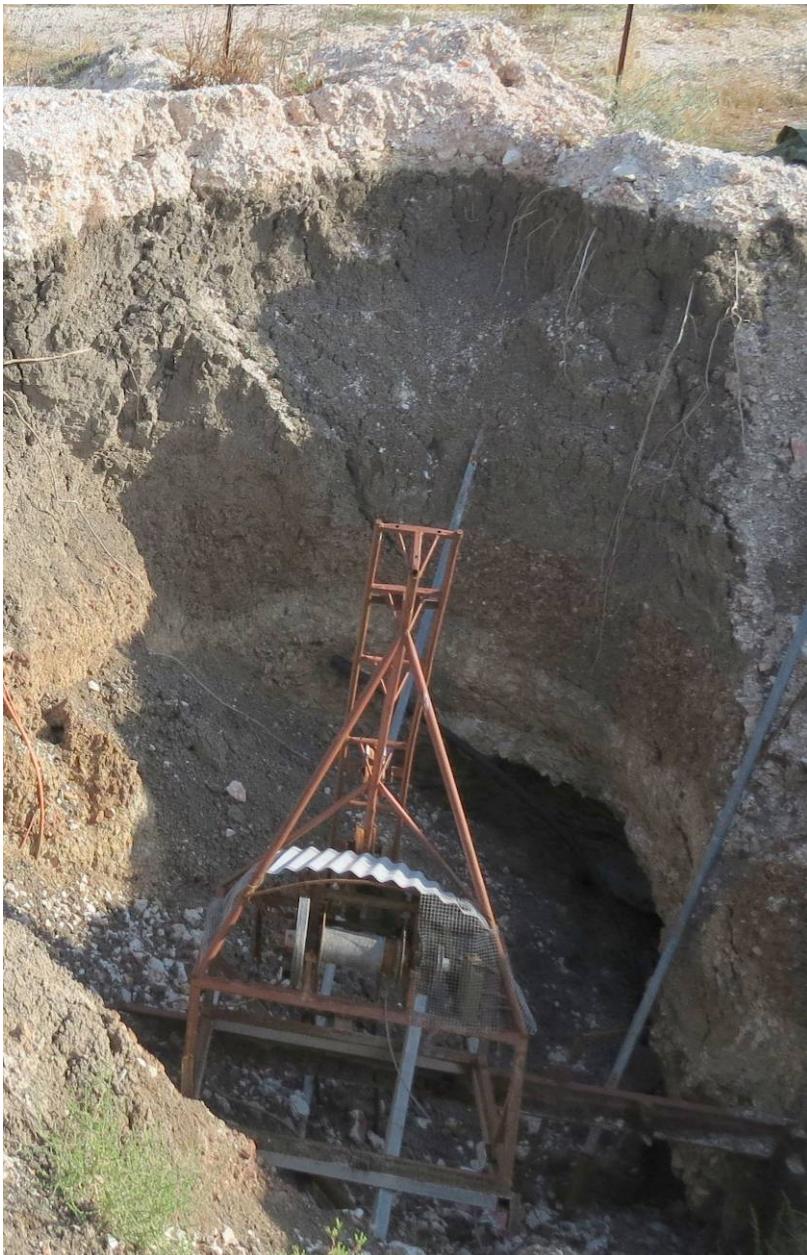
Figure 3. A close crop of Figure 1 showing the void into which the soil is moving

Figure 3 provides detail of the void into which the soil is moving. This photo also clearly shows the delineation of the two soil types, with a narrow band of ridge soil underneath the alluvial soil. During inundation, a significant amount of soil from the roof of the void may have fallen in so the thickness of the ridge soil is not necessarily indicative of the thickness of these soils when they are mined.

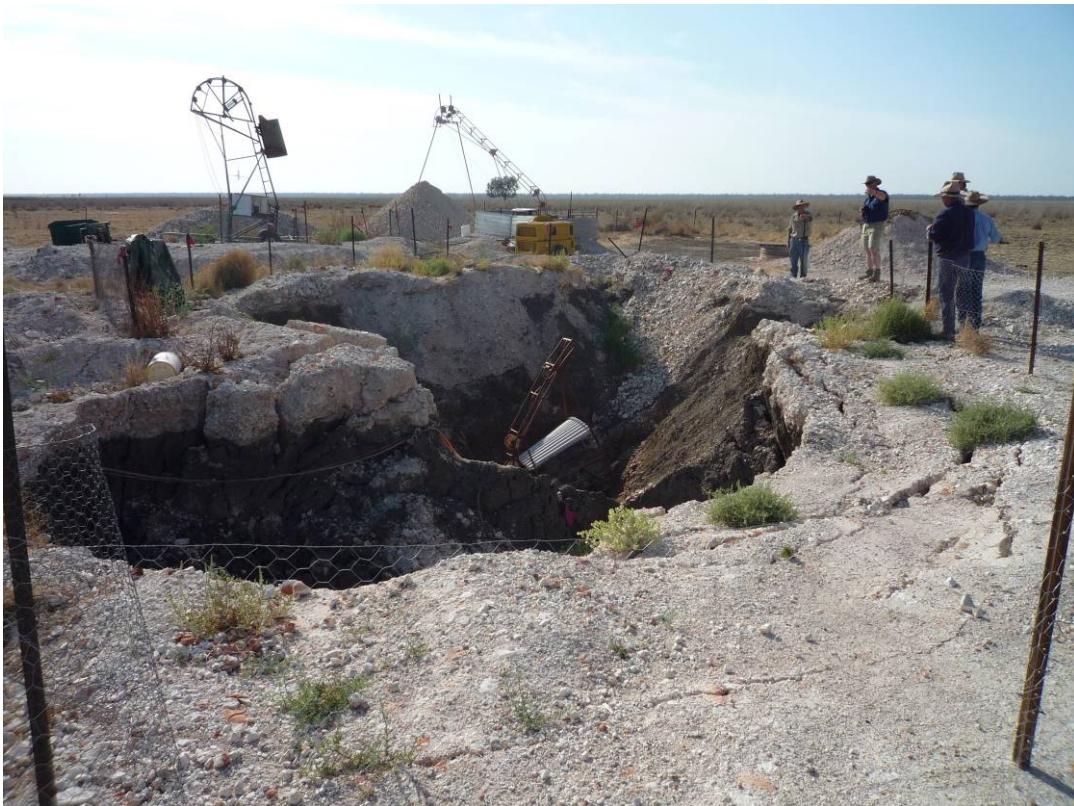
Figure 4. The same site viewed from a different angle.

Figure 4 shows the same mine site from a different angle. In this photo, you can clearly see cracks from unstable soil in the foreground. This indicates that, if left to its own devices, this site would continue to erode significantly over time. This collapse is likely to continue until the slope of the soil is slight enough that it is able to withstand further erosion.

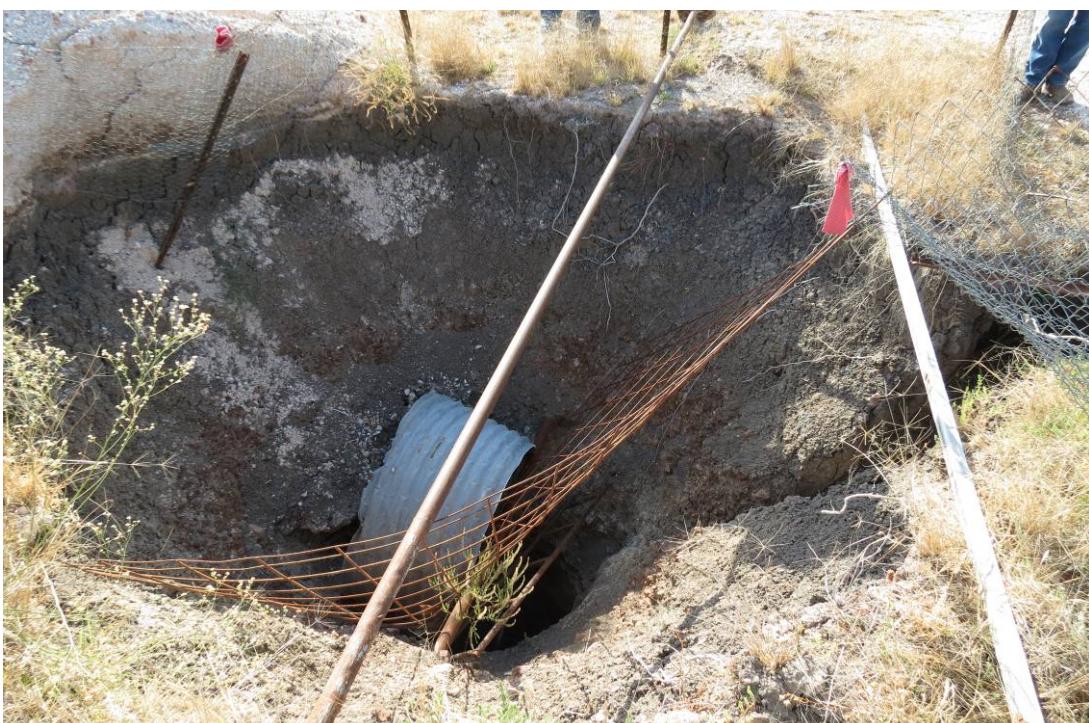
Figure 5. Another mine failure at Knightlife opal field

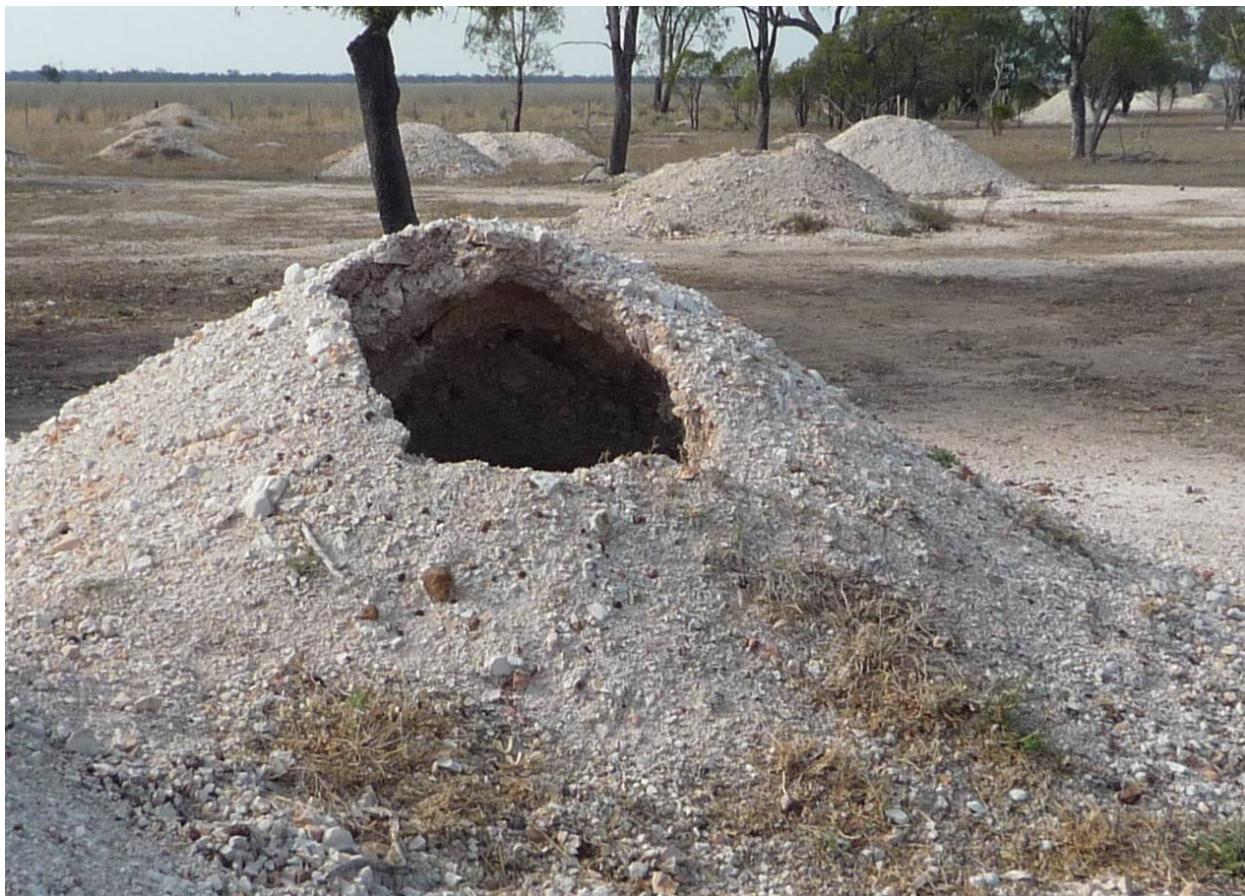
Current practices involve filling in the existing mine shaft with dirt then covering it with a pile of mine spoil. While this works on mines in the ridge soils, the continued degradation of the soil below in the mine void causes collapse of the soil at the surface.

Figure 6. Collapse and instability of a mine void which had been covered over

Again, this would be expected to be an ongoing process until the soil in the mine reaches equilibrium. Without remediation, this site will continue to slump, forming a crater and causing danger to the landholder and their livestock.

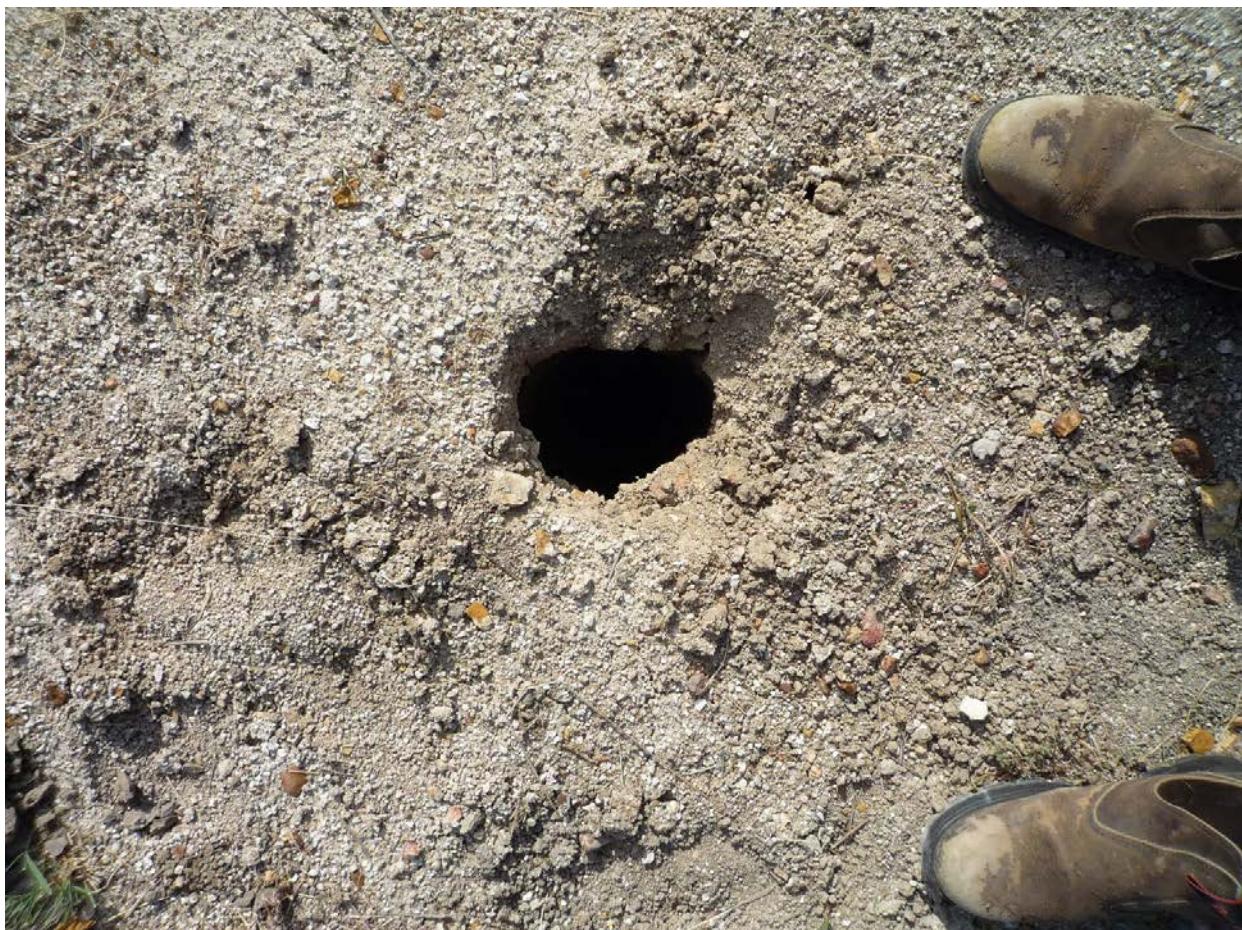
In addition to the mines, nine inch (229 mm) pilot holes are also regularly drilled. This practice is covered under existing prospecting conditions. Although there are no lateral drives to create voids, once covered, these holes can subside much like the mines except at a much smaller scale. This can result in small holes which could break the legs of cattle or horses if they stepped into them.

Figure 7. Example of collapse of a rehabilitated nine inch exploration hole

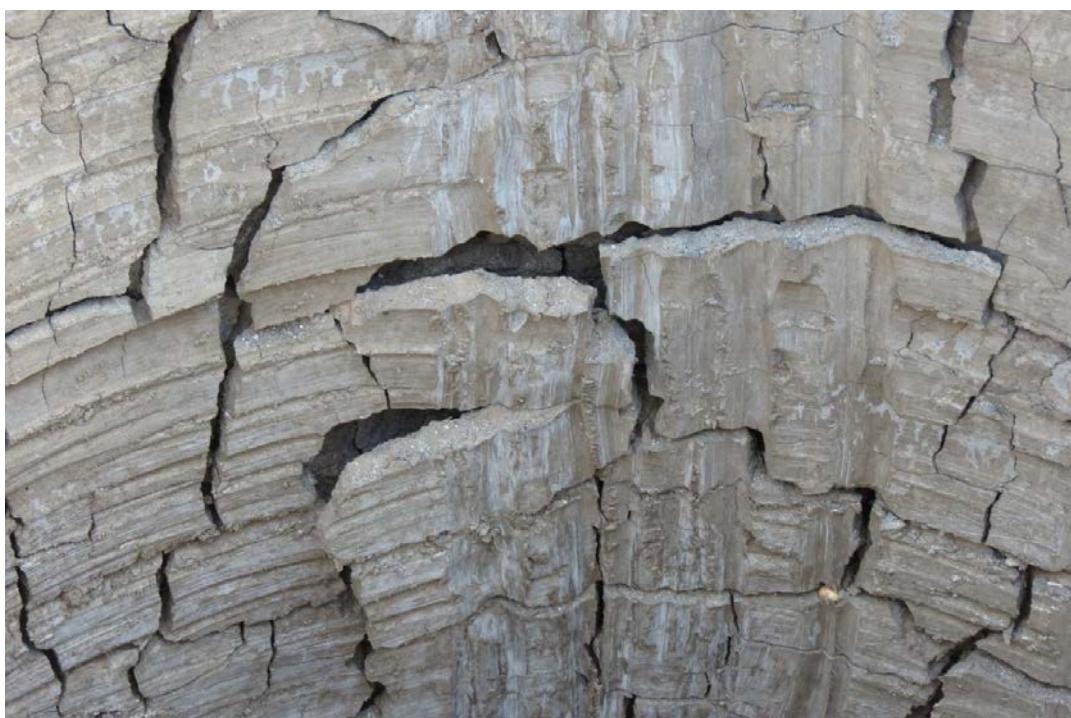
Due to the cracking nature of these soils, when a mine shaft is augured, the sides of the shaft dry out when exposed to air. The soil on the side of these shafts goes through the same shrinkage process as the surface of the soil. This results in the soil breaking off in layers. It appears that there are two processes occurring, firstly, the breaking off of the initial layer which has been compacted by the auger. This can crack off in relatively small (20-30 cm squared) pieces. After this breaks off, larger pieces, up to 70cm long and 30 cm wide seem to proceed to break off.

Figure 8. Inside of an augured mine shaft showing clay shrinkage and pieces ready to fall off

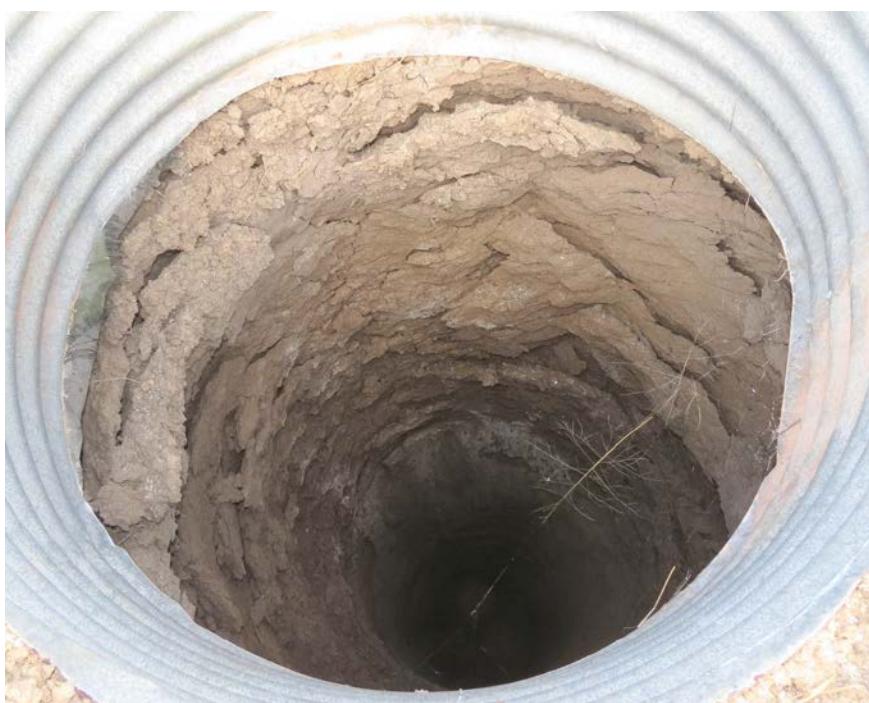
Figure 9. Larger pieces of soil falling away in layers once the compacted inner layer has gone. As new soil is exposed, this process could conceivably continue for an extended period of time

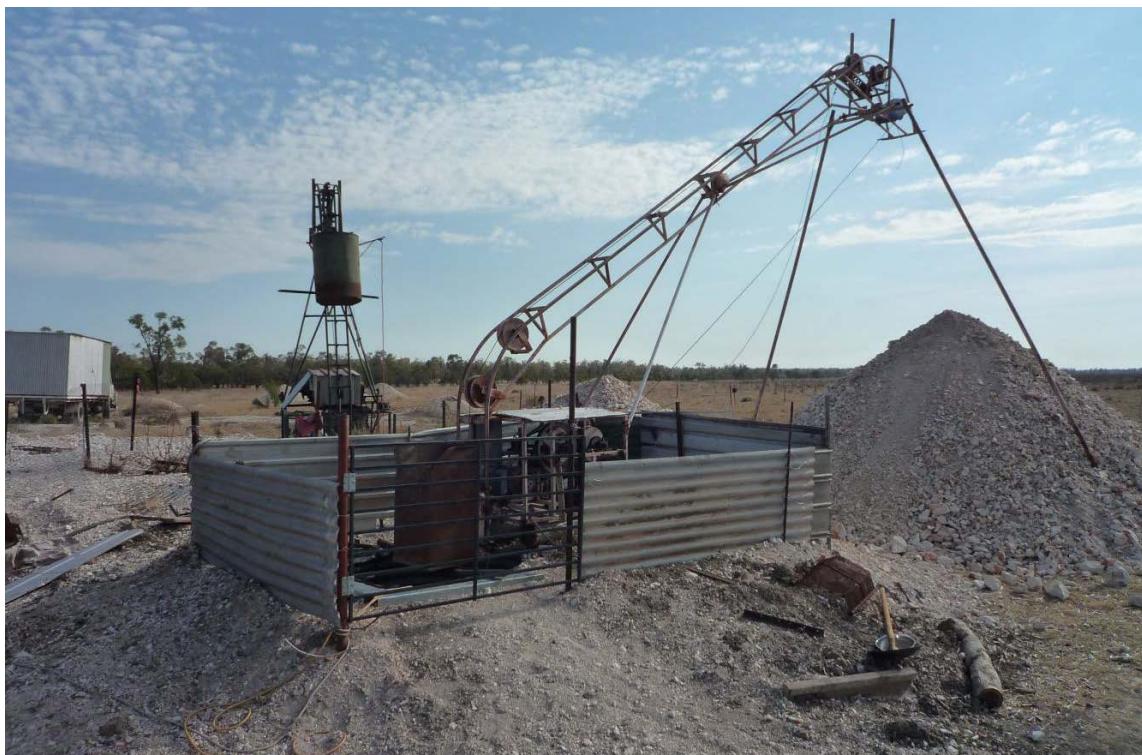
While inspecting the sites, there were examples of what looked like stable mine sites. These sites were built on a pad of stable mine spoil, raising the entrance of the mine to above inundation level and ensuring that free water could not access cracks for several metres away from the mine shaft.

Figure 10. An apparently stable mine entrance at Knightlife opal field

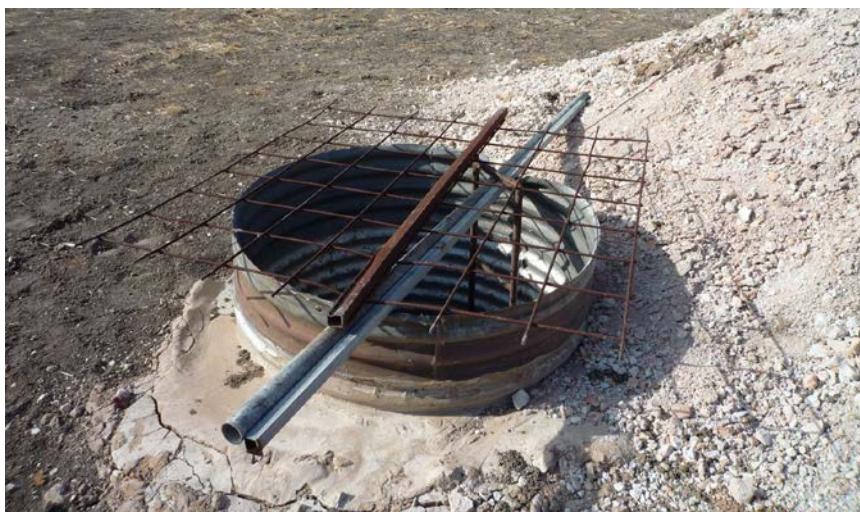
There were also examples where corrugated iron collars extended all the way down the shaft in an attempt to prevent the cracking and gradual collapse of the alluvial soils. There were also cases where the collar was raised and a cement slurry had been installed around the collar in an attempt to stabilize the surrounding soil (figure 11).

Figure 11. Raised collar with a surrounding concrete slurry to stabilize the surrounding soil

While these methods appeared to provide stability to the mineshaft, the subsurface instability due to slickenslides remains. It remains to be seen how well this innovative improvement would stand up to an inundation event where the ground is submerged for an extended period of time. Also, when subjected to wetting and drying cycles, these soils will move, making the foundations for surface structures unstable.

With respect to the instability of Vertosols as an overbearing soil, this is a question which would be best put to an engineer proficient in dealing with Vertosols. It should be noted that there are many instances experienced engineers competent in engineering on soils other than Vertosols who have designed structures which have been catastrophic failures on these soils. An engineer experienced in working on this type of soil is needed to make these recommendations.
