# SAFETY ALERT

## Electric Shock Results from Ineffective Earthing

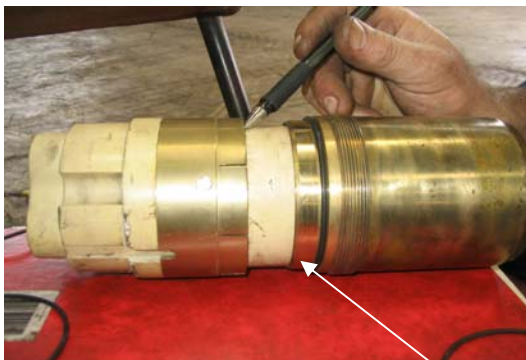
The cable plugs were disassembled and the earth sleeve was found to have an unreliable contact with the earth ring attached to the moulded interior.

*Earth contact points shown separated*

1. Mines need to immediately implement a program of returning cables with this product attached, to an approved cable repair facility and have defective earth termination rings and earth sleeves identified and replaced.
2. The program must be completed as soon as possible.
3. Mines need to review the implementation of the recommendations contained in SA06-05

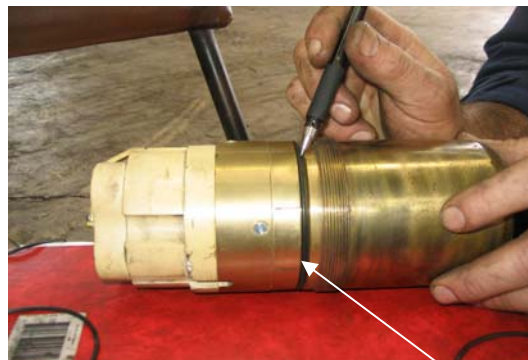
*Earth contact points shown joined*
