## **Investigation Report**

Incident involving  
Bruce Slessor

Cadia Valley Operations  
South Waste Dump Extension

24 August 2008

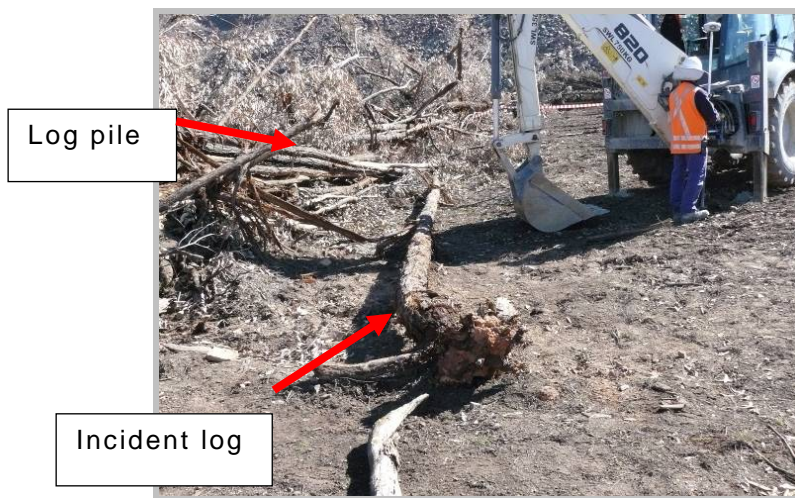
This photo shows the root ball of the incident log on the ground in front of the backhoe and the timber pile.

Person in the photo taking measurements post the incident

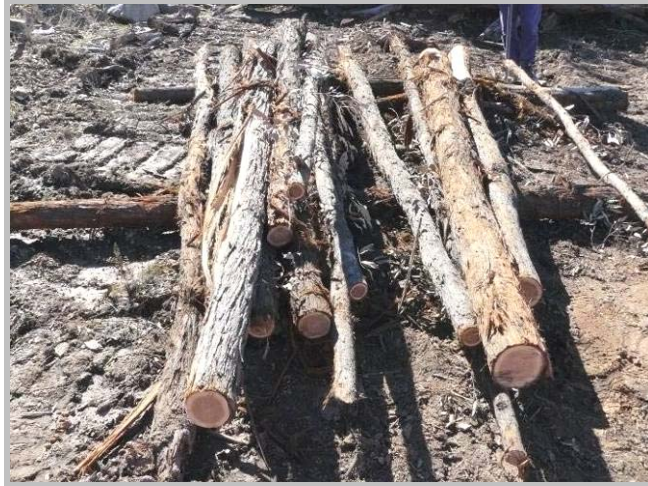
The photo shows one of the two cut log stockpiles created by Mr Slessor on Saturday 23 August 2008

The stockpile was located approximately 80m from the incident site.

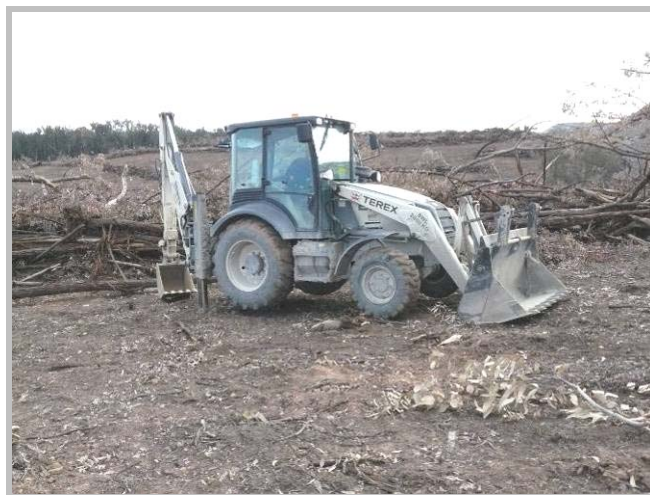
The photo shows the backhoe position in relation to the pile of wood.

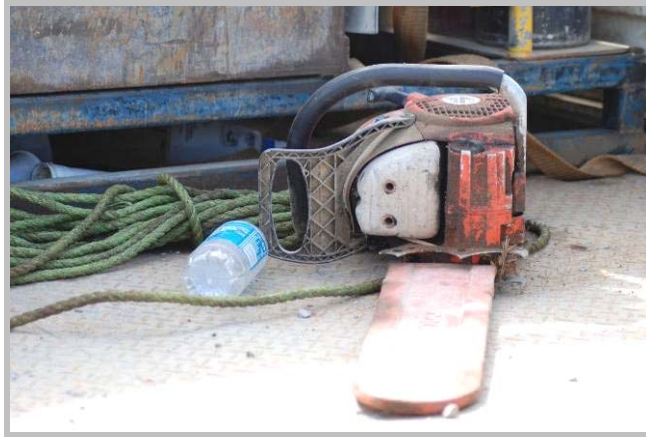
The photo shows a green rope and a chainsaw found in the tray of a CVO vehicle allegedly used by Mr Slessor.

At the time when the photo was taken the vehicle had been relocated from the incident scene to the CVO main office.

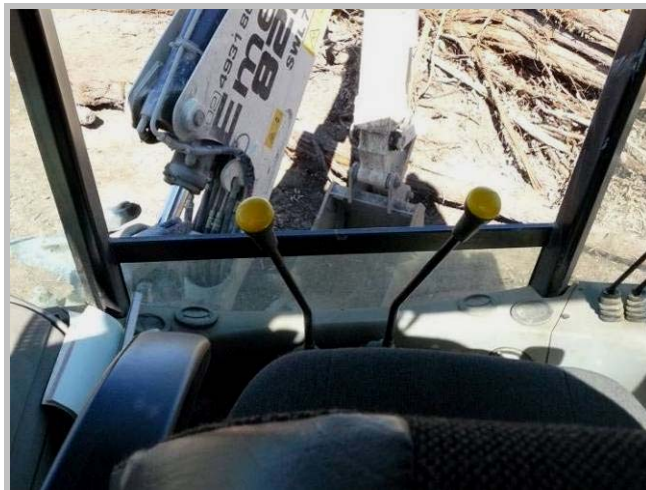
The photo shows the view from the backhoe seat position showing the relation of the log pile, the backhoe bucket and the incident log on the ground.

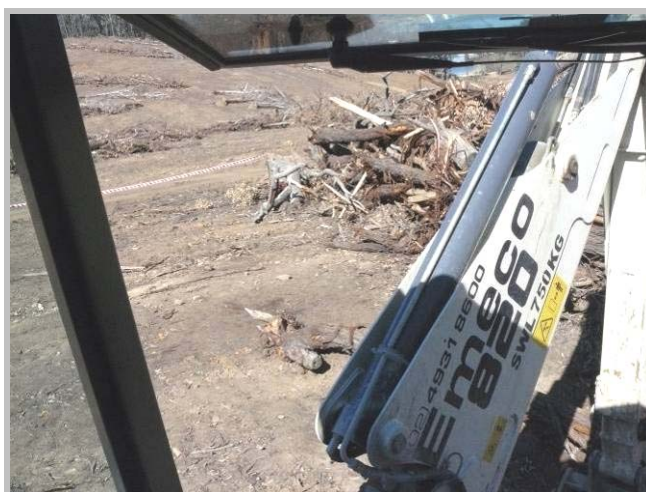
The photo shows the left hand side view from inside the backhoe cabin.

The incident log stump end is visible on the ground.

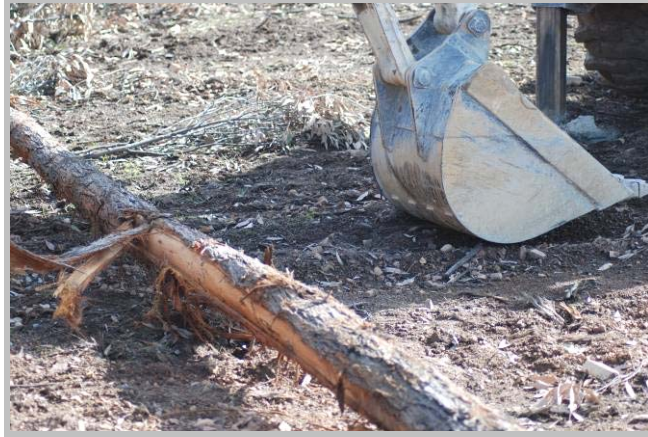
The investigation of the scene by Industry and Investment NSW Inspectors saw bucket teeth marks and ripped bark on the middle section of the incident log. The marks observed on the log were consistent with the account that has been provided.

The photo shows the marks and ripped bark on the incident log in relation to the backhoe bucket.

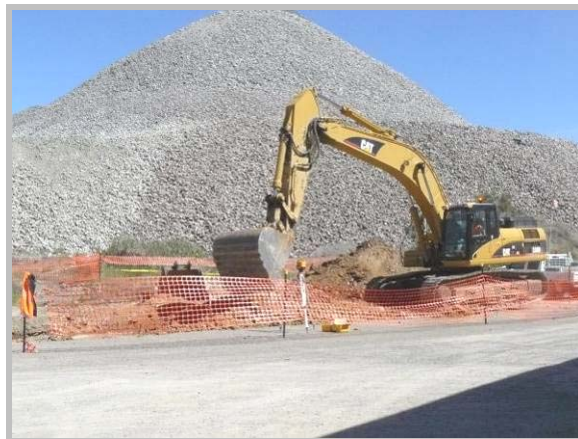
The photo shows a construction zone using mesh barrier tape erected around an operating excavator at CVO site.

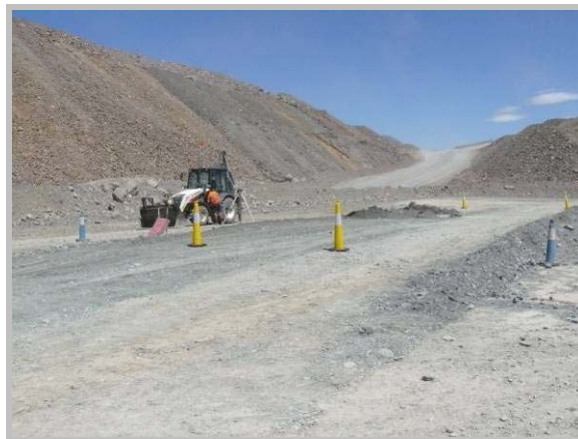
The photo shows yellow coloured cones placed around an operating backhoe at CVO site.

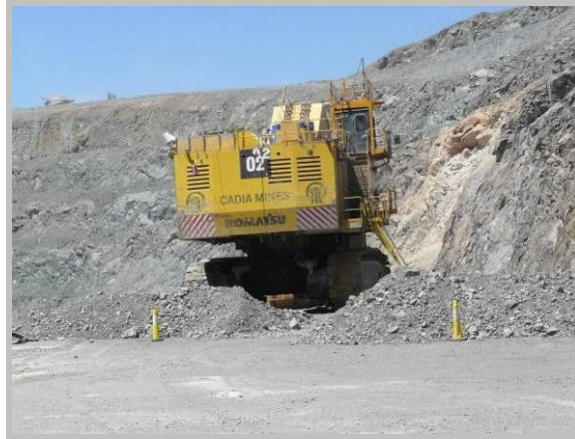
The photo shows yellow coloured cones placed at the rear of a mining excavator at CVO site.

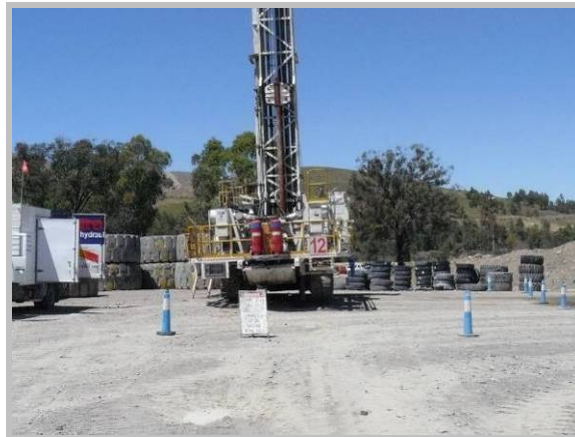
The photo shows a machine under maintenance control with blue coloured cones and radio notification signage board in place.

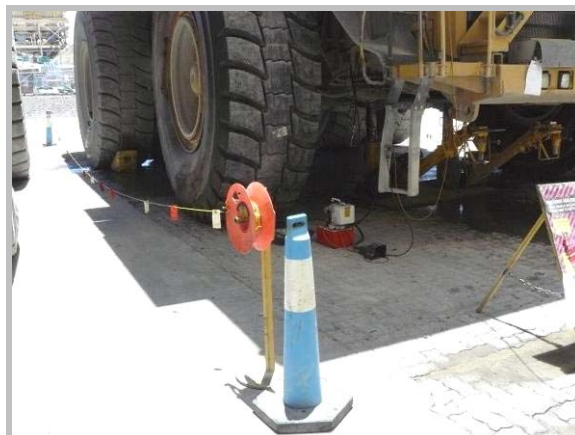
The photo shows a haul truck under maintenance control with blue coloured cones, rope barrier and a notice board in place.

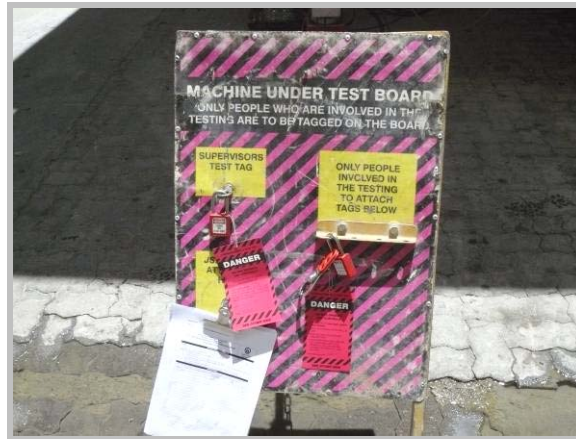
The photo shows the notice board placed for a maintenance task.

Attached were machine isolation lock and tag and personnel sign on documentation.

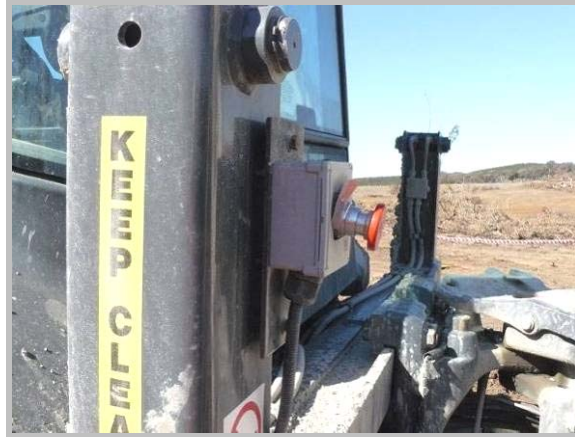
The photo shows the damaged emergency stop button located near to the swing arm of the backhoe bucket.

Following inspection and testing of the incident backhoe on 8 September 2008, NML required the backhoe owner to replace the broken left hand tail light and to relocate the emergency stop button on the rear of the backhoe that potentially may have been damaged by the swing arm of the excavator bucket.
