## **Case Study: Coral Avenue, Mullumbimby**

Adapted from NSW Department of Primary Industries (2005) *Reducing the impact of road crossings on aquatic habitat in coastal waterways – Northern Rivers, NSW*. Report to the Northern Rivers Catchment Management Authority. NSW Department of Primary Industries, Wollongbar, NSW.

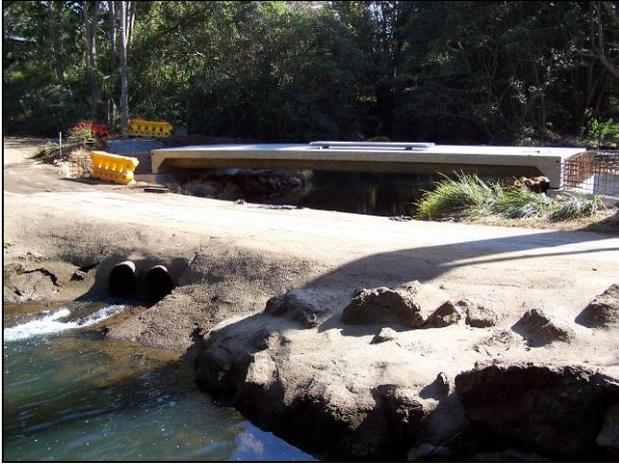
a)

Coral Avenue crossing, which traverses the Brunswick River near Mullumbimby, was characterised by a piped causeway 19 m in length and 8 m wide with two low-flow pipes. The outlets of both low-flow pipes were raised above the bed of the waterway by approximately 800 mm, which prohibited fish from migrating upstream during low-flow conditions. During moderate to high flow events, excessive water velocity through the pipes further restricted fish passage until the structure drowned out. Prioritisation of road crossing barriers in the Northern Rivers CMA highlighted Coral Avenue as the top priority waterway structure for remediation due to the following factors:

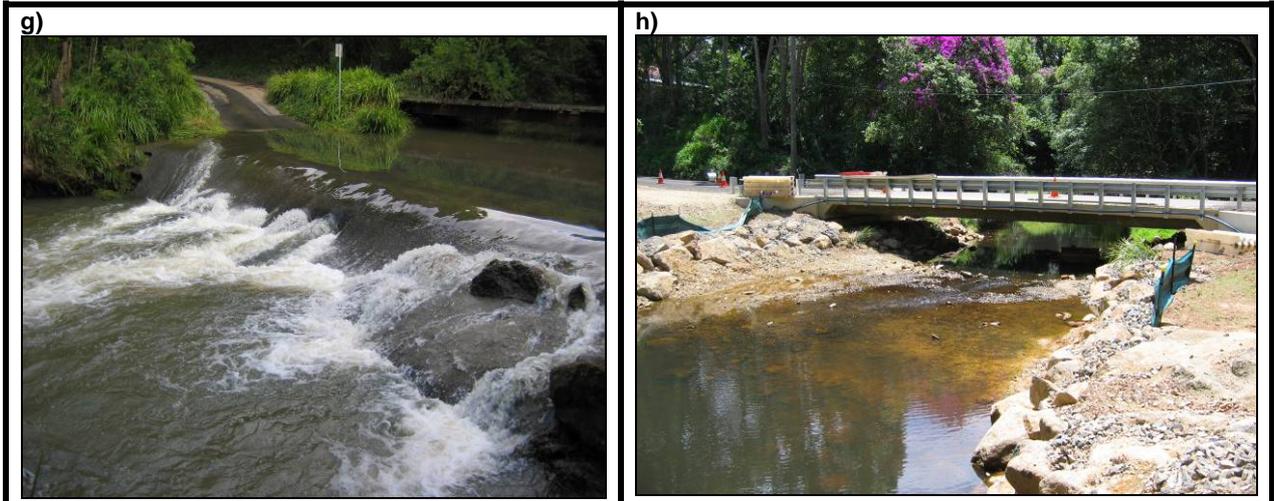
- Improved stream connectivity for fish species such as the freshwater mullet (*Myxus petardi*) and Australian Bass (*Macquaria novemaculeata*);
- Improved safety and reliability of the crossing for local residents relative to flood inundation (**Plate g-h**). Nineteen properties benefit from the proposed works; and
- Reduced liability to Byron Shire Council resulting from vehicle and recreational accidents.
