Report produced for
Department of Primary Industries and
Regional Development - Fisheries

Bellinger-Kalang River Estuary NEAP Bank Erosion and Riparian Condition Assessment Report

20 December 2024

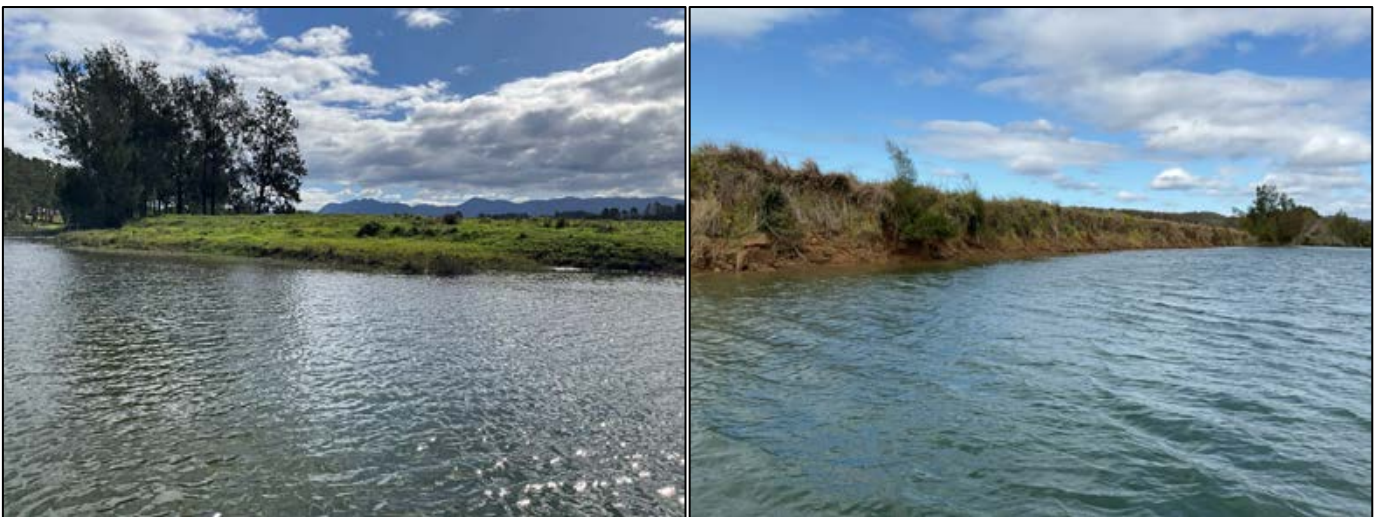
Plate 1 Inset benches and low floodplains on the Bellinger River estuary in the Fluvial Dominated A process zone are generally stable despite riparian vegetation clearing (left), whereas outside bends are commonly eroding with evidence of both fluvial scour and post flood slumping processes (right, Reach 120).

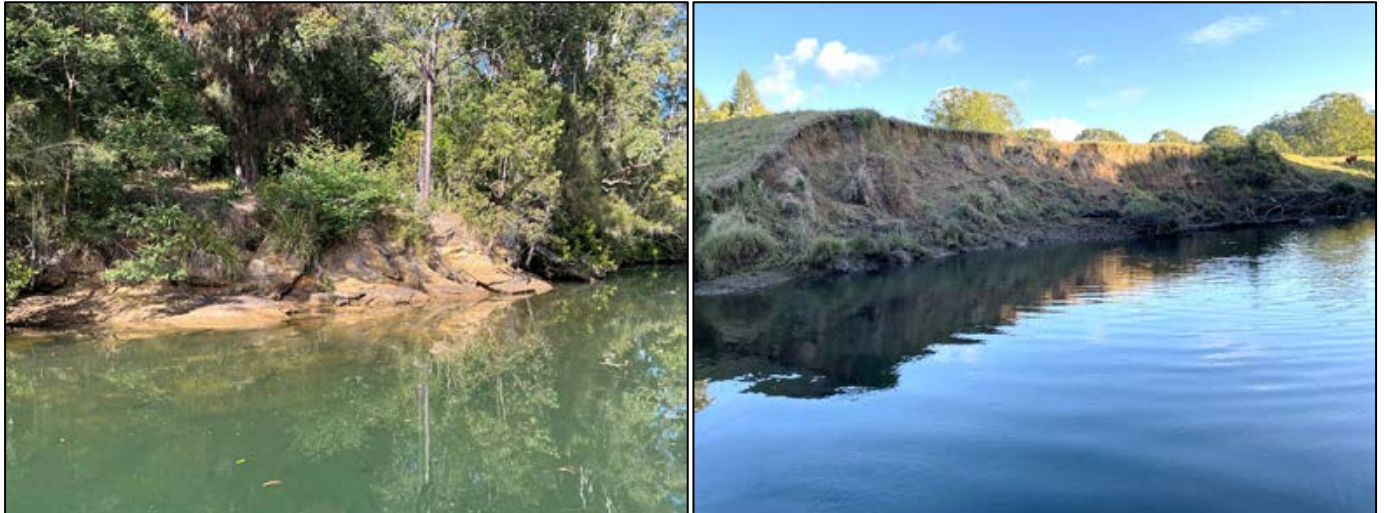
Plate 2 Bedrock outcropping is common in the fluvial dominated reaches of the Kalang estuary (left) as is bank slumping post flood as a result of draw down processes (right, Reach 634).

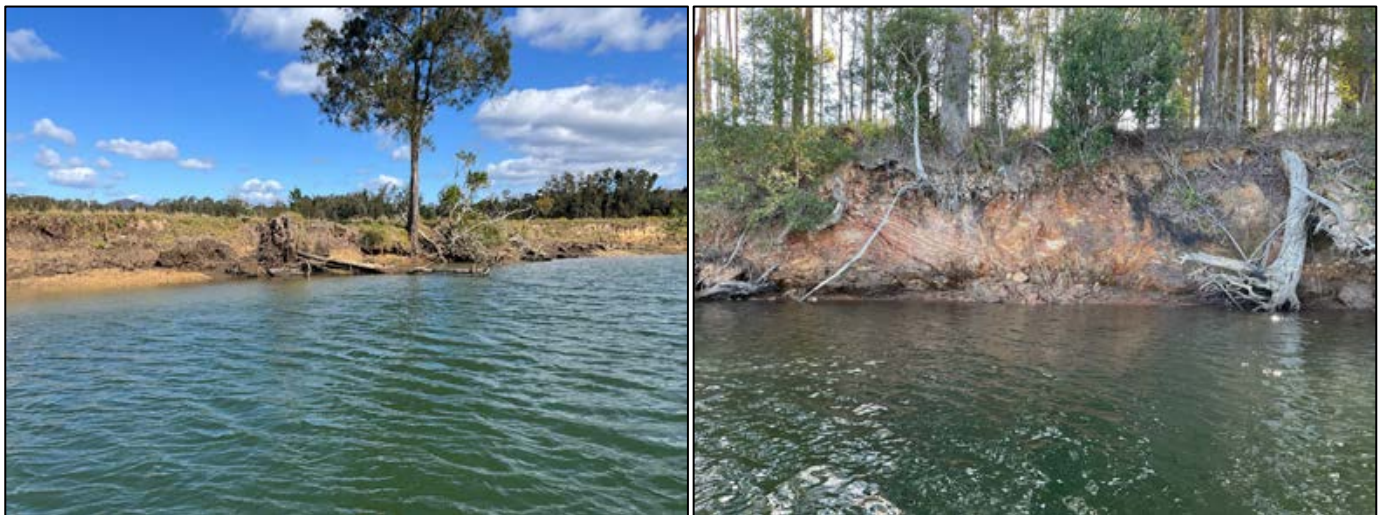
Plate 3 More recent floodplain deposition (chocolate layer in the top third of the bank profile) overlying the more resistant orange-yellow Pleistocene-aged terrace materials on Newry Island (left) and bedrock outcropping in the north branch of the Kalang River (right).

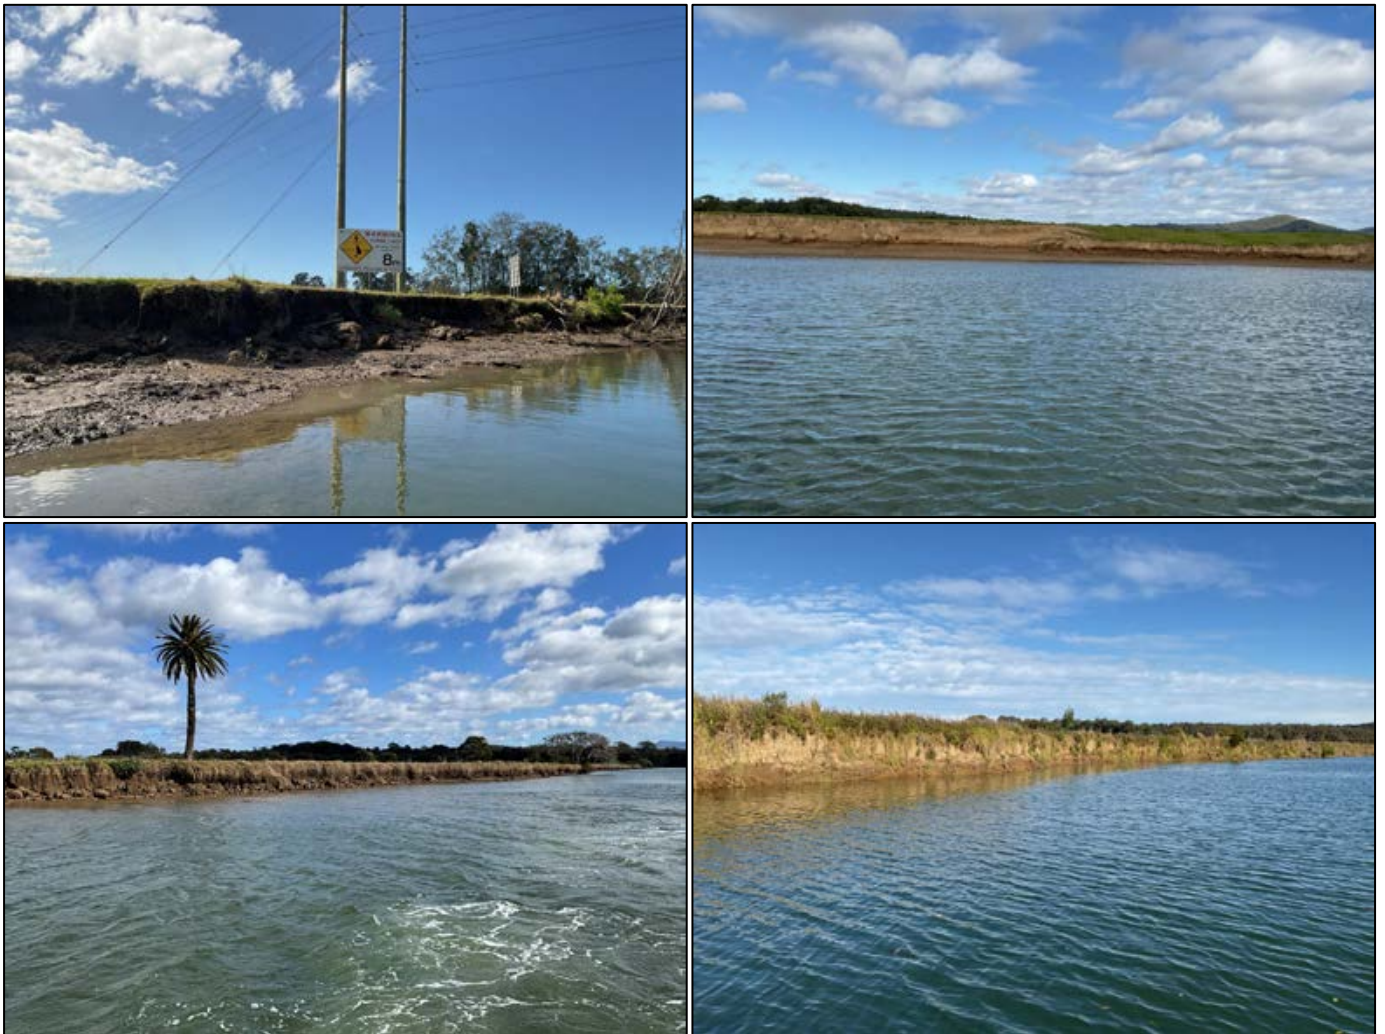
Plate 5 Examples of Extreme erosion severity: clockwise from top left, Kalang River Reach 687; Bellinger River Reach 131; Bellinger River Reach 120; Back Creek Reach 292.

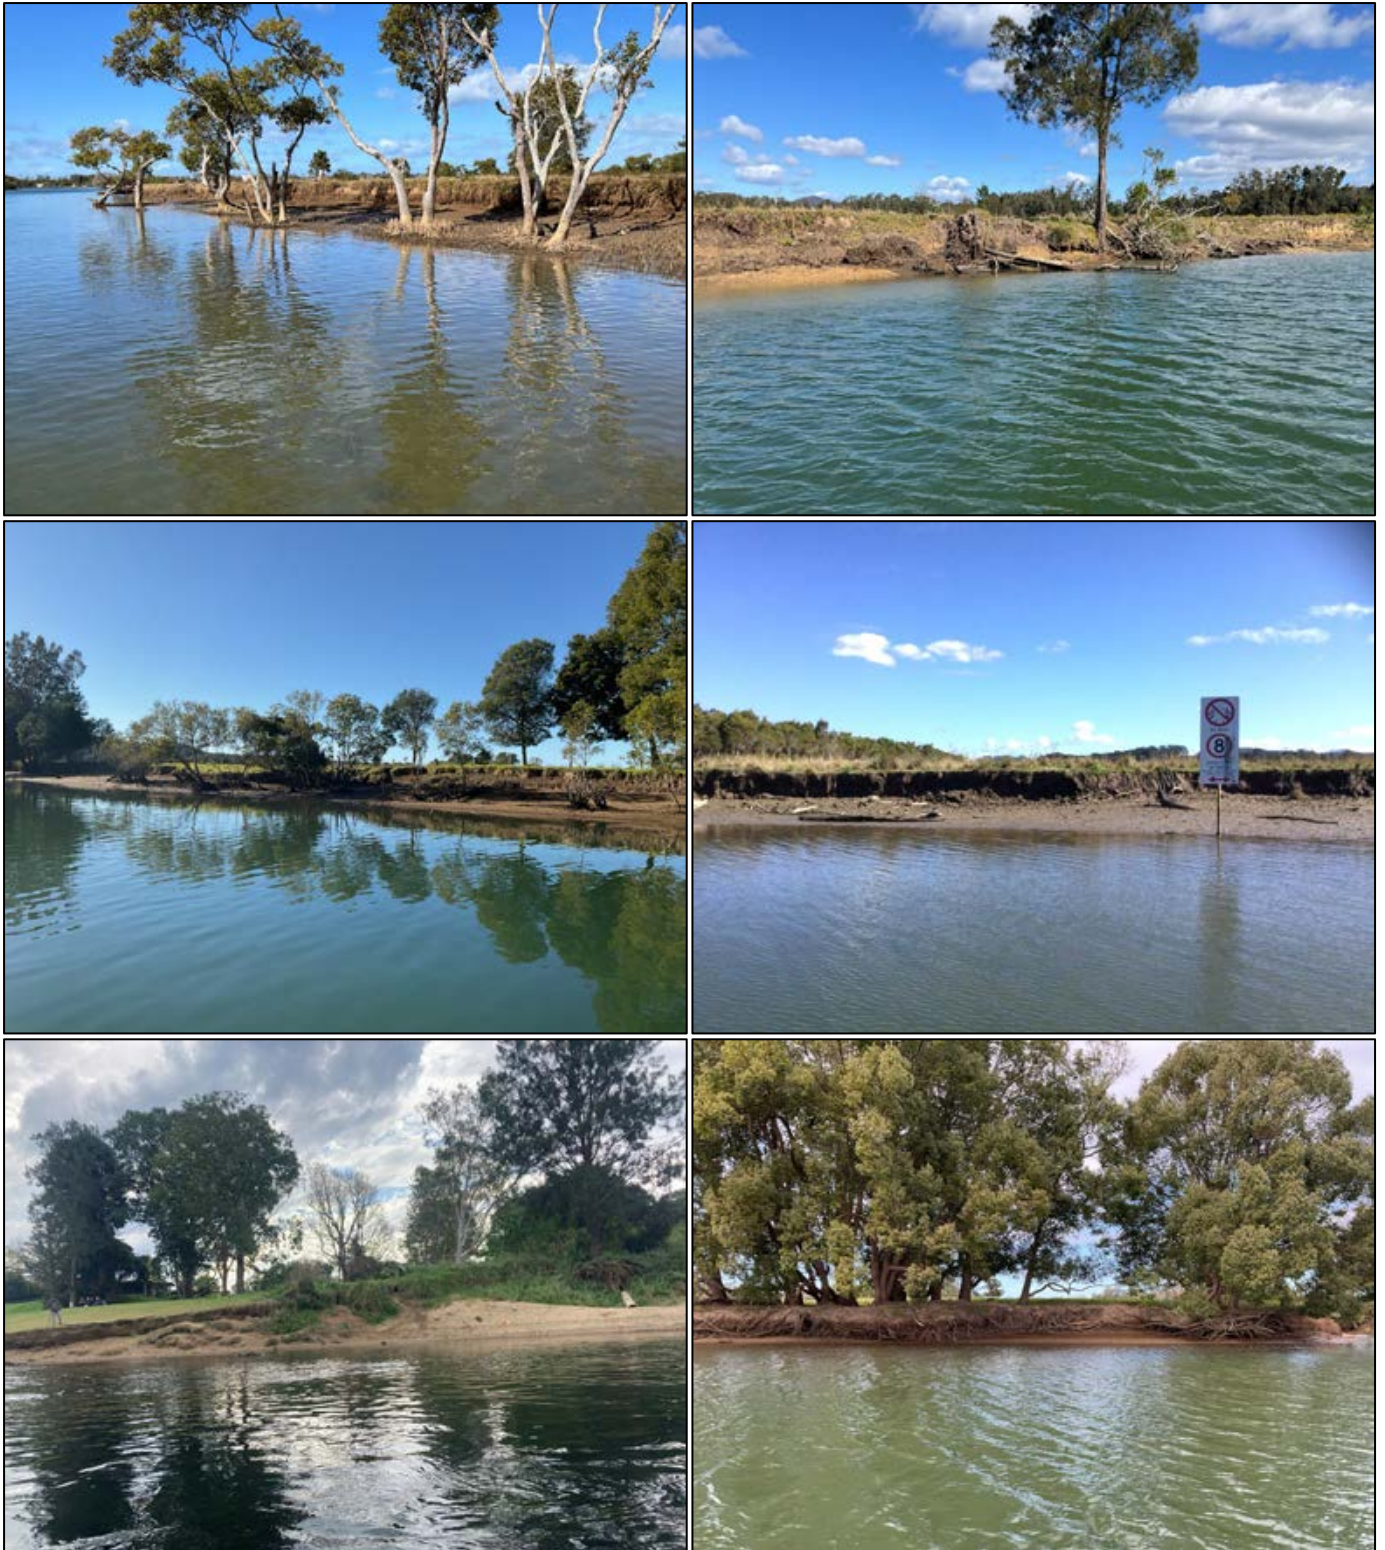
Plate 6 *Examples of High erosion severity: clockwise from top left, Back Creek 296; Kalang River Reach 428; Kalang River Reach 669; Bellinger River Reach 118; Bellinger River Reach 752; and Bellinger River Reach 3.*

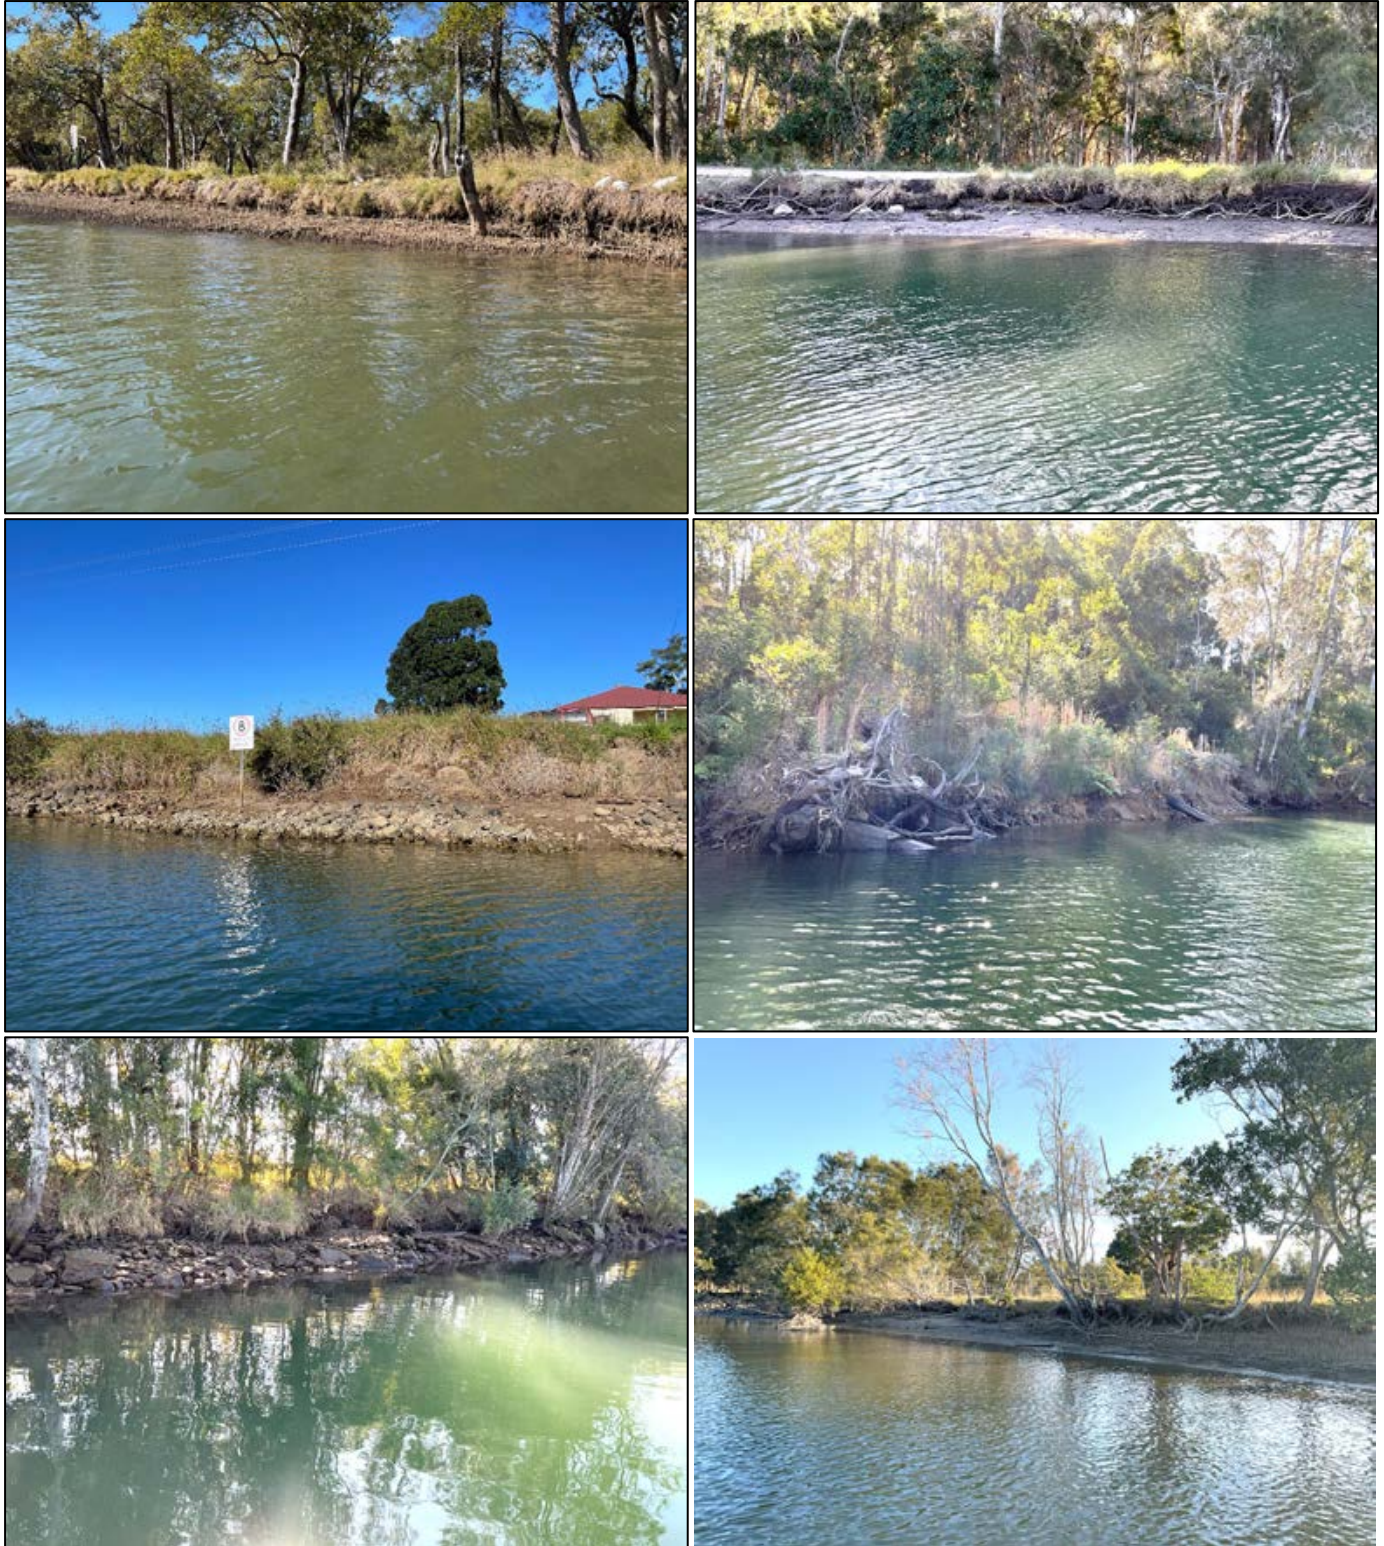
Plate 7 Examples of Moderate erosion severity: Clockwise from upper left, Back Creek Reach 301; Back Creek Reach 347; Kalang River Reach 399; Kalang River Reach 737; Bellinger River Reach 13; and Bellinger River Reach 52.

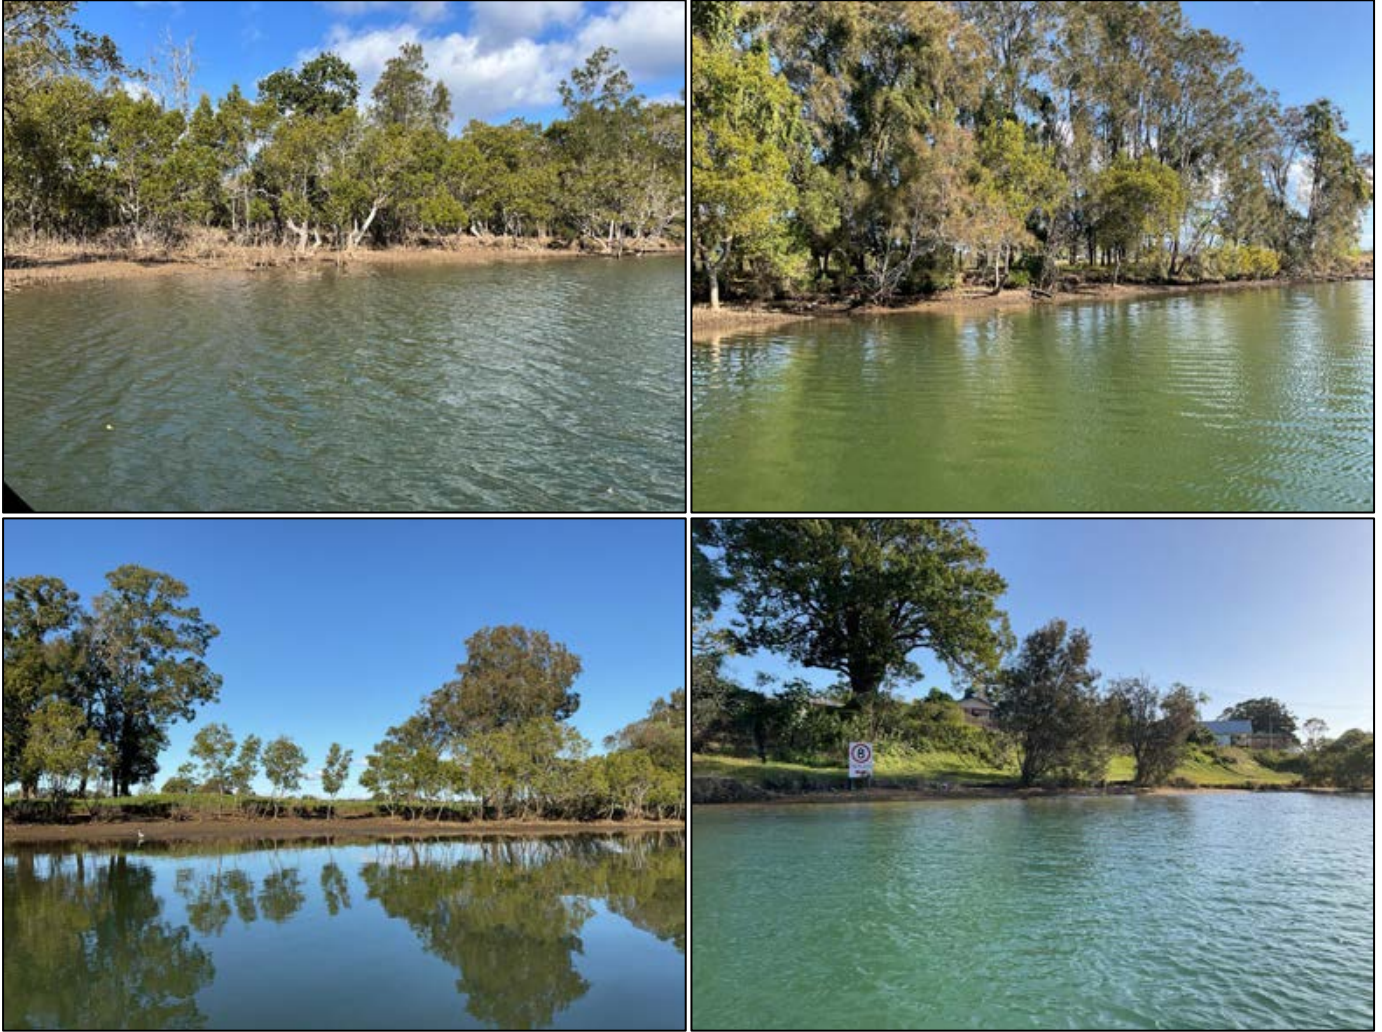
Plate 8 Examples of Low erosion severity: Clockwise from left, Back Creek Reach 306; Kalang River Reach 704; Kalang River Reach 261; and Bellinger River Reach 4.

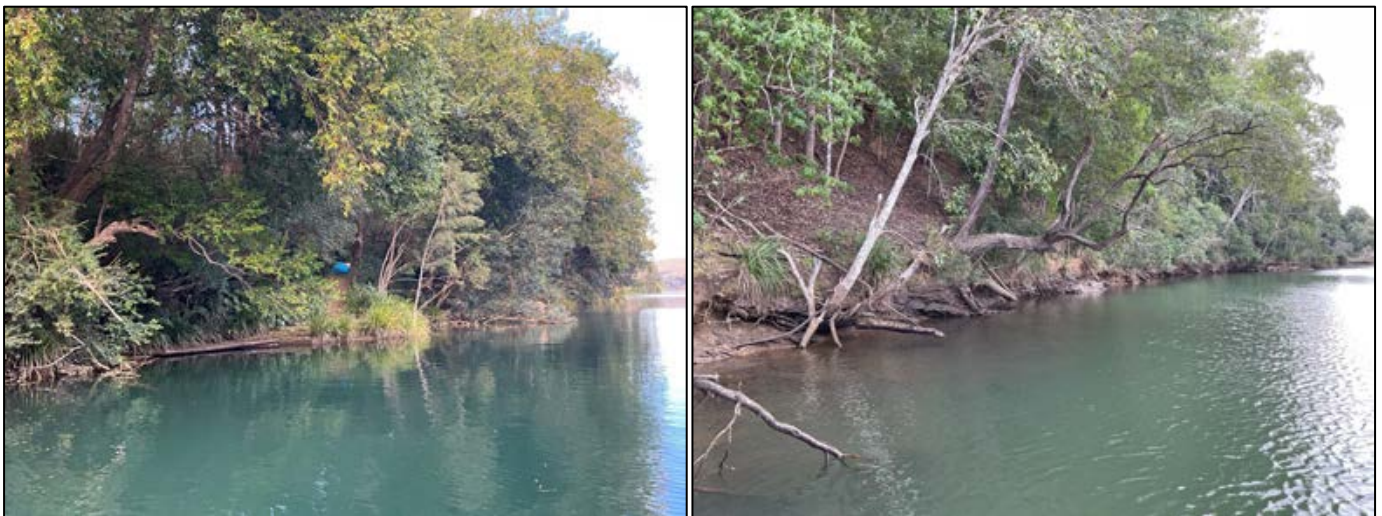
Plate 9 *Examples of Very Good condition riparian vegetation: Left to right, Bellinger River Reach 234, Kalang River Reach 565.*

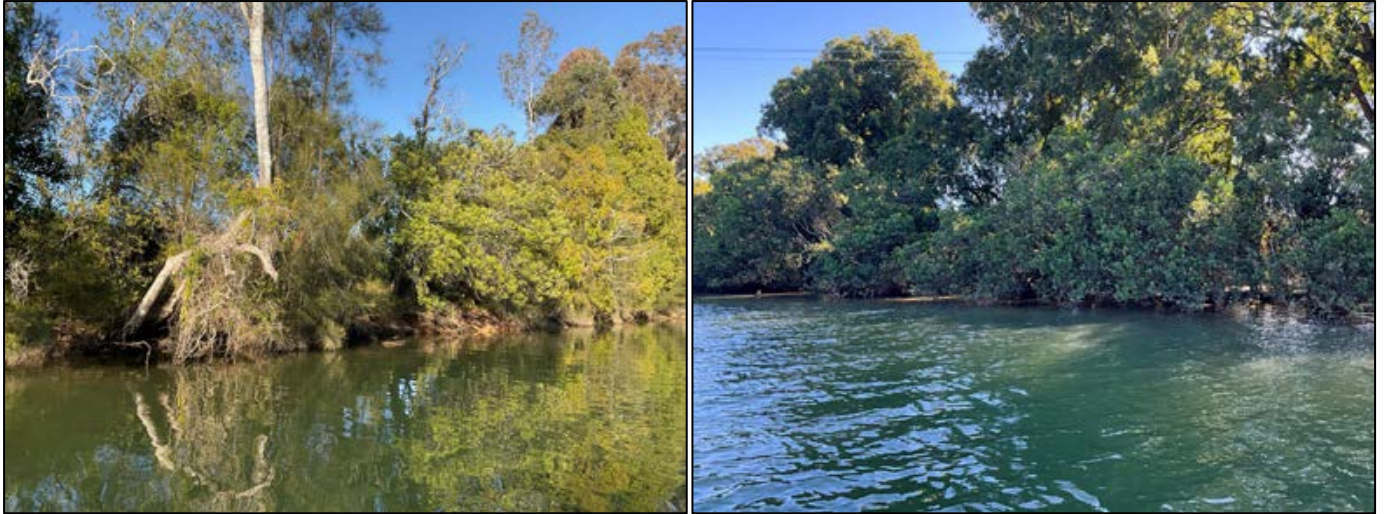
Plate 10 *Examples of Good condition riparian vegetation: Left to right, Kalang River Reach 367, Bellinger River Reach 87.*

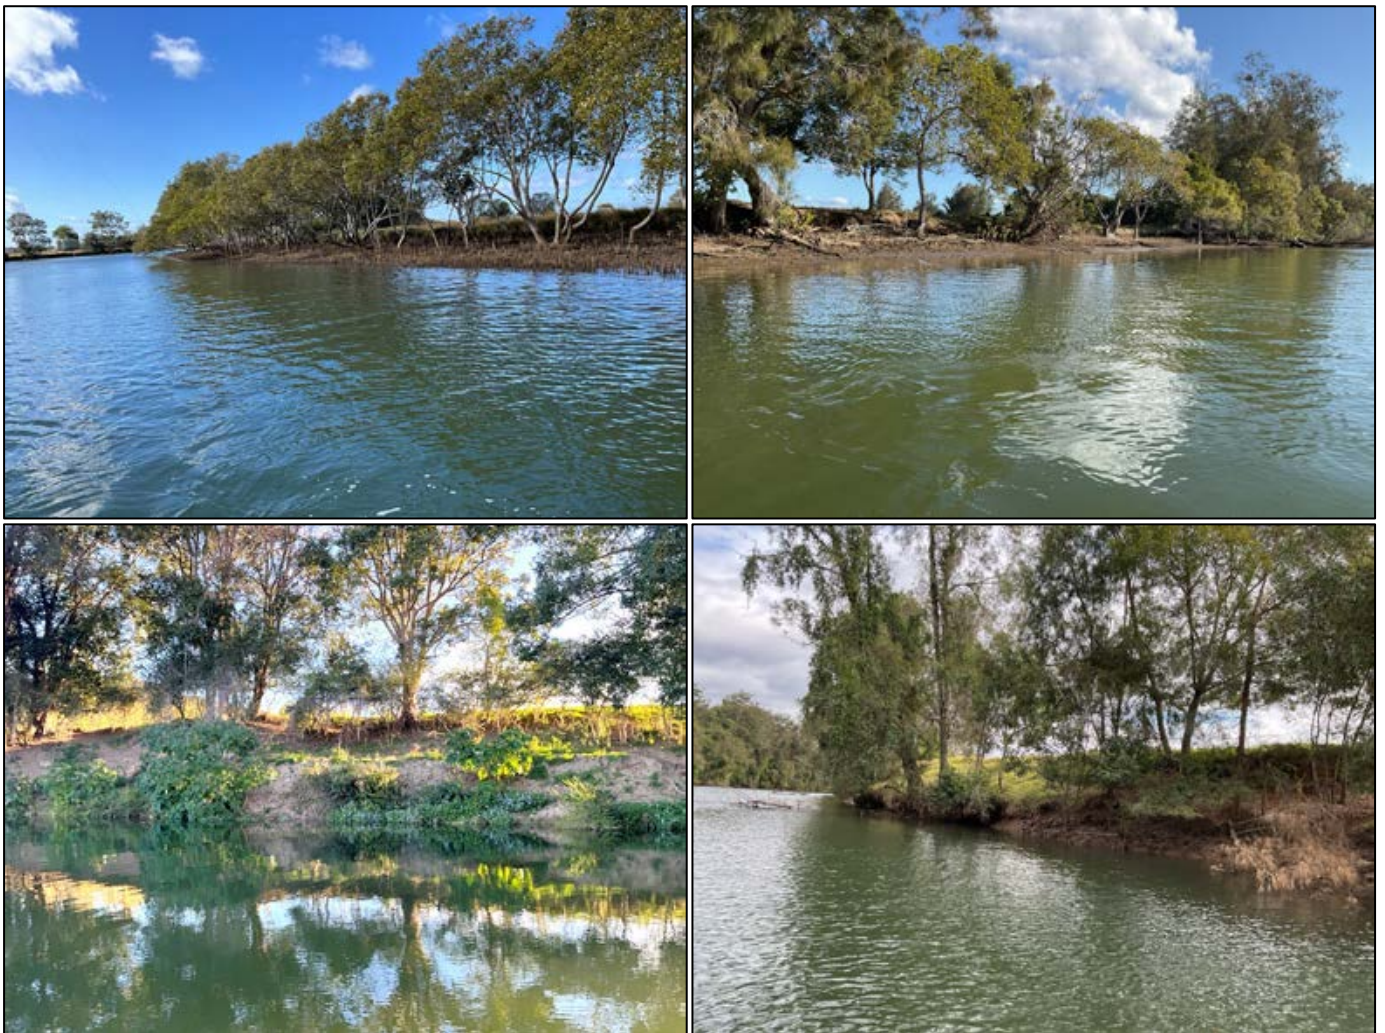
Plate 11 *Examples of Moderate condition riparian vegetation: Clockwise from top left, Back Creek Reach 298; Kalang River Reach 711; Kalang River Reach 571; and Bellinger River Reach 245.*

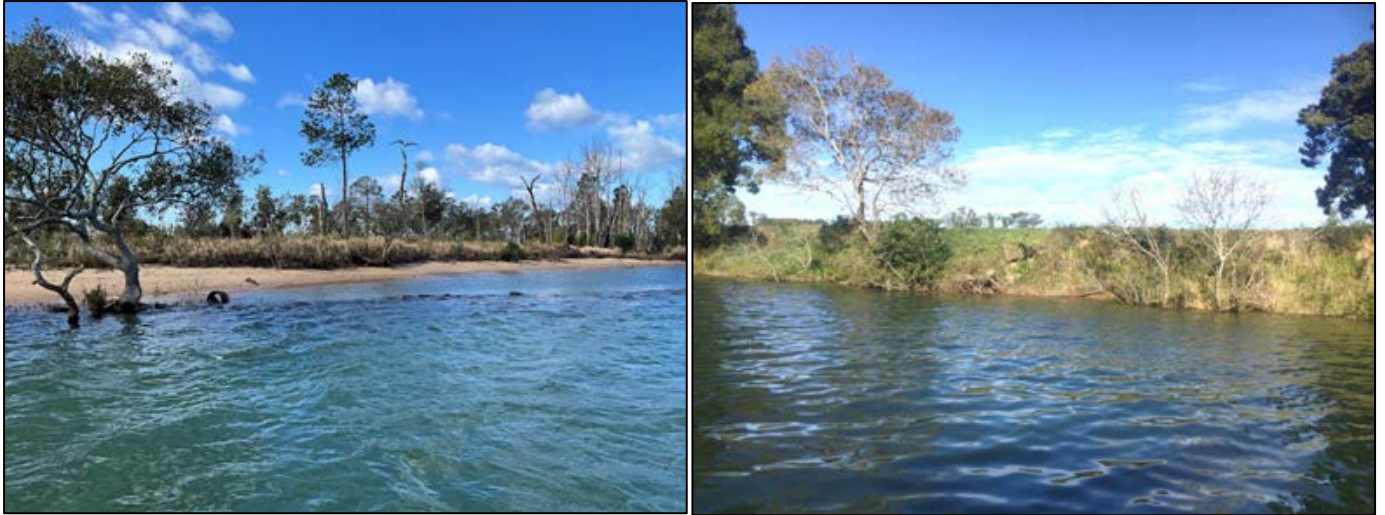
Plate 12 Examples of Poor condition riparian vegetation: Clockwise from top left, Kalang River Reach 331, Bellinger River Reach 125.

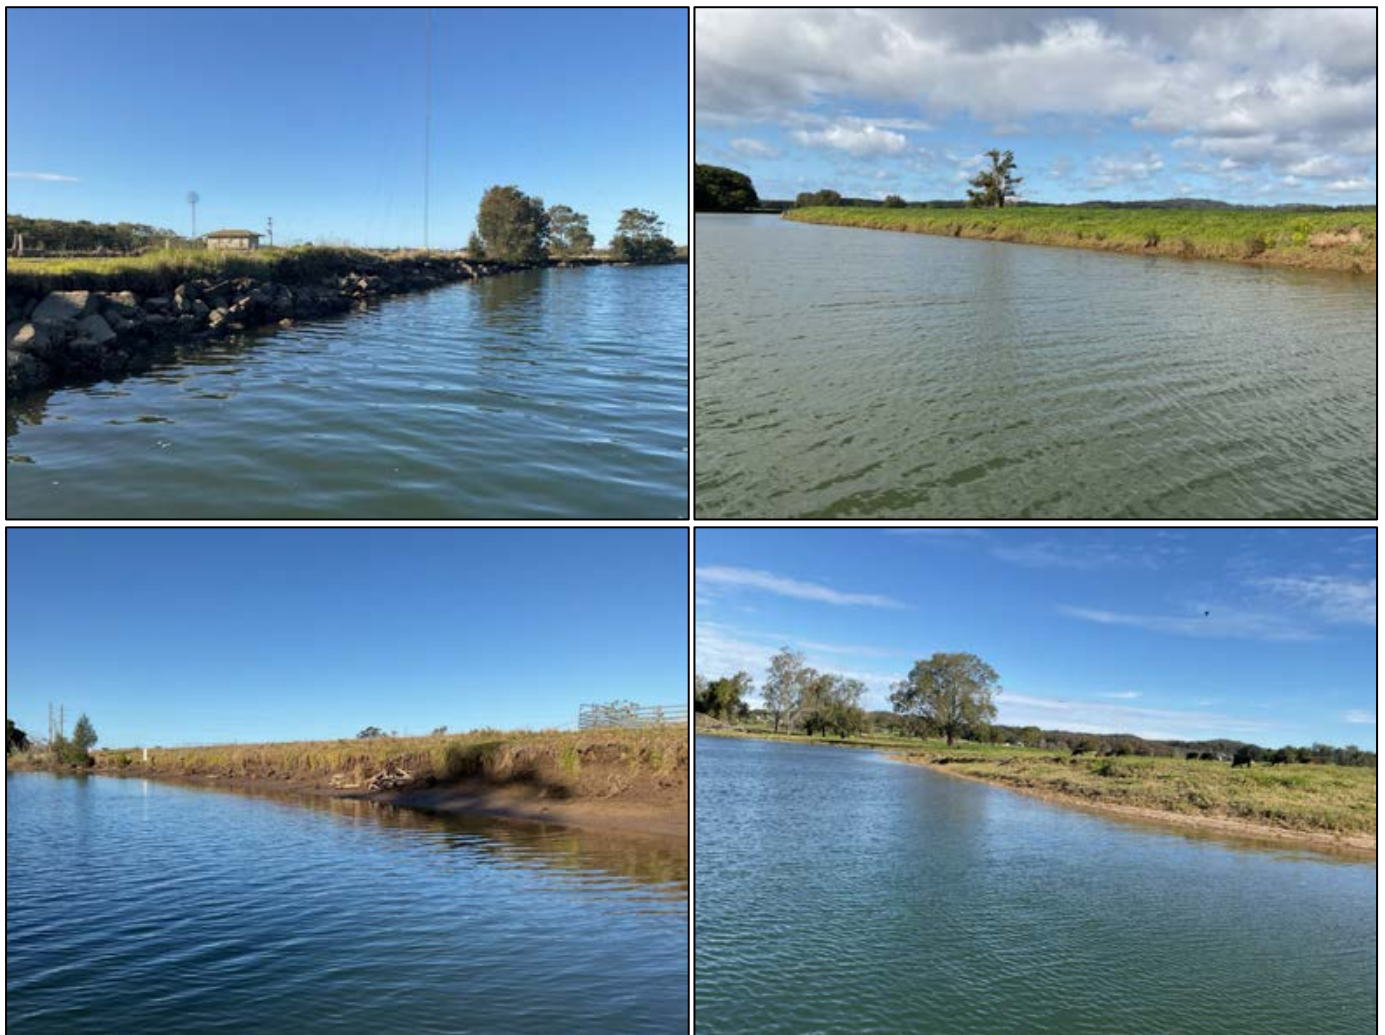
Plate 13 Examples of Very Poor condition riparian vegetation: Left to right, Back Creek Reach 723, Bellinger River Reach 190; Bellinger River Reach 117; and Kalang River Reach 717.

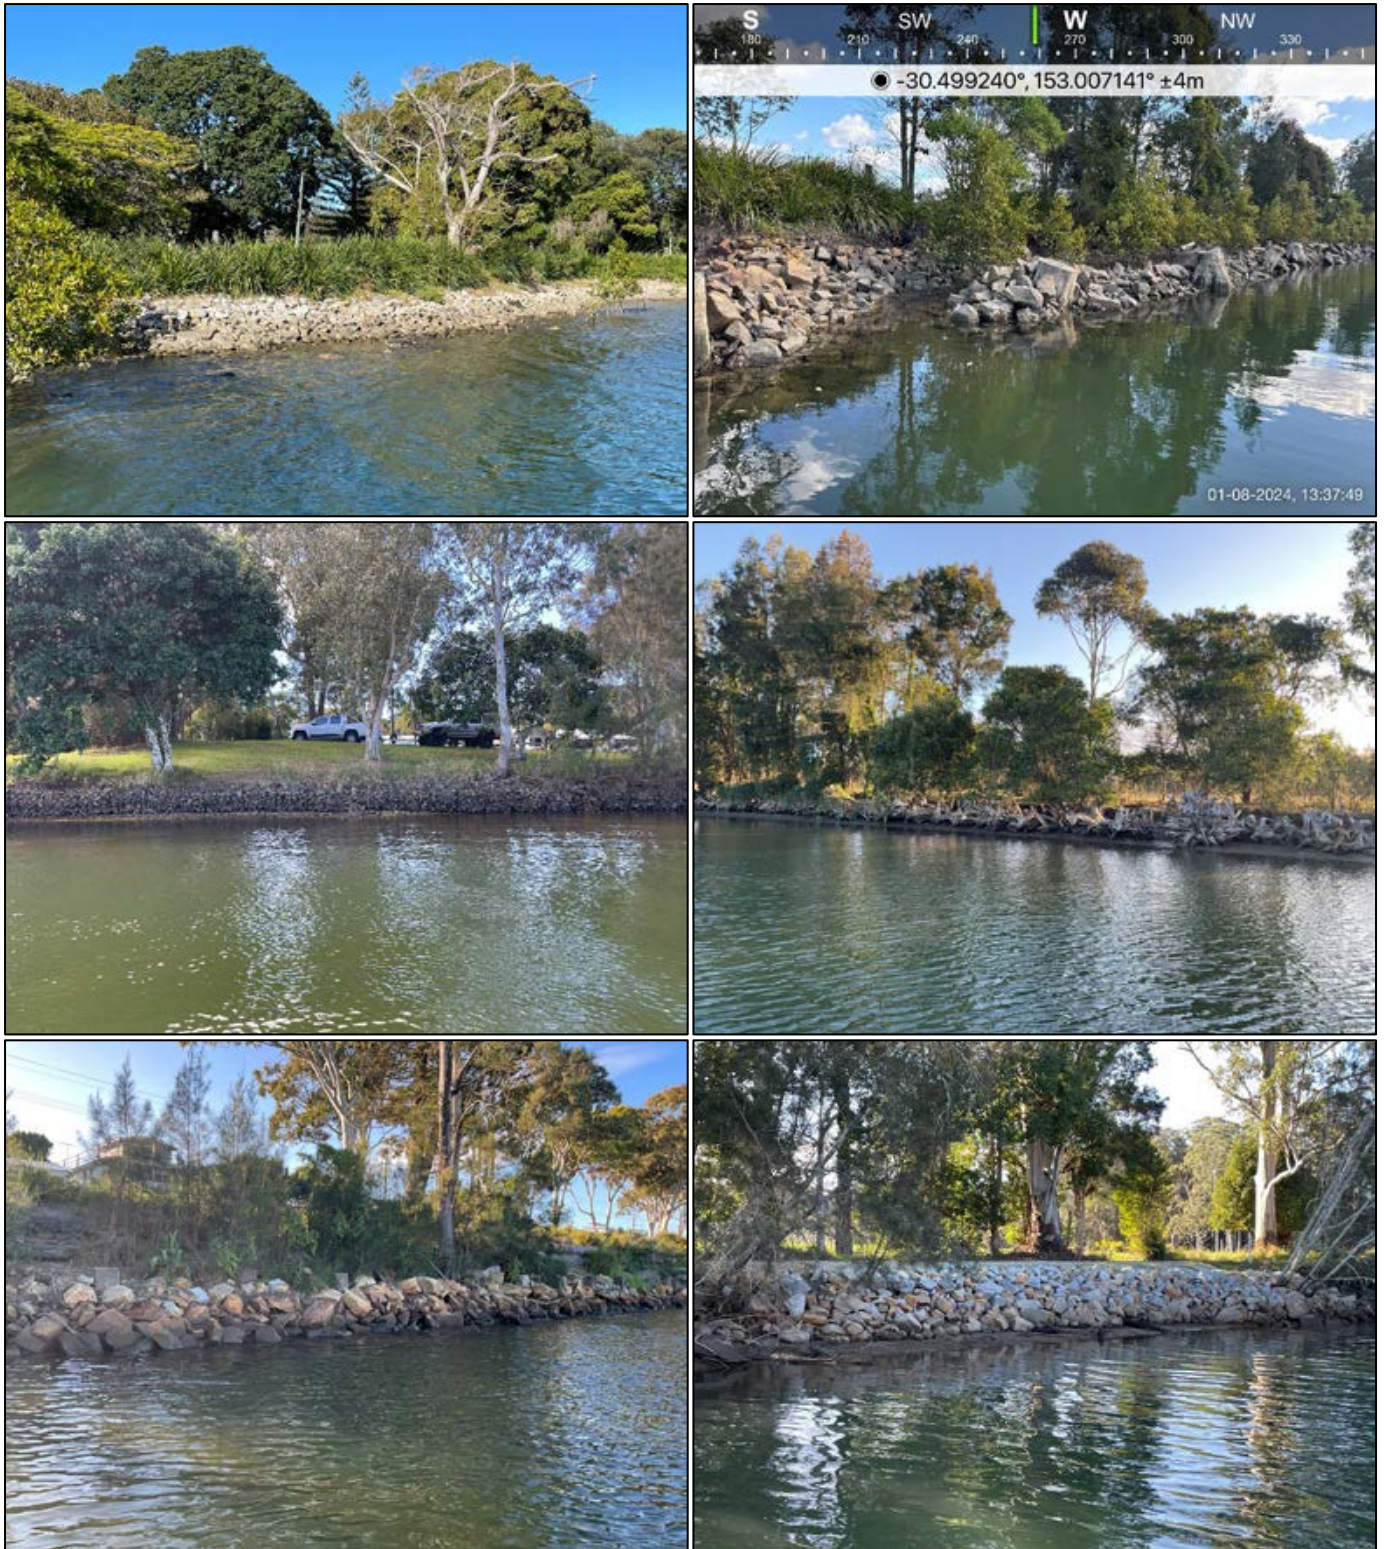
Plate 14 Examples of effective bank protection works in the study area, clockwise from top left: Cobble beaching in lower Kalang River Reach 268; Rock fillets at Newry Island, Kalang River Reach 662; Large woody debris/rootballs in the lower Kalang Reach 739; Rock armouring adjacent to Yellow Rock Road on Back Creek Reach 353; Rock armouring and logs at Mylestom on Bellinger River Reach 355; Gabion wall at Mylestom on the Bellinger River Reach 29.

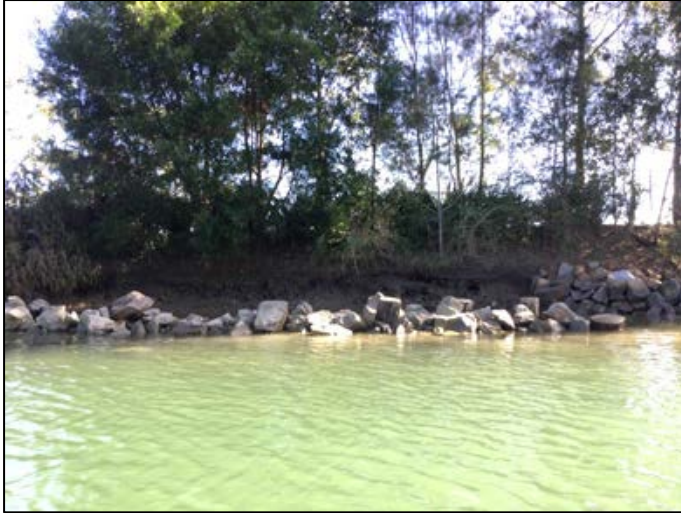
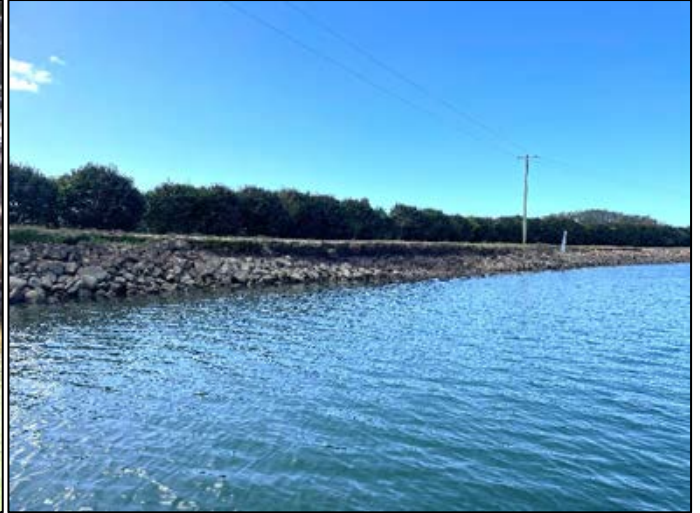
Plate 15 Examples of partially effective bank protection (design) in the study area, from left to right: insufficient rock fillet height and subsequent erosion of the mid bank on the Kalang River Reach 654; failure of the bank toe and subsequent subsidence of rock armouring on the Kalang River Reach 660.

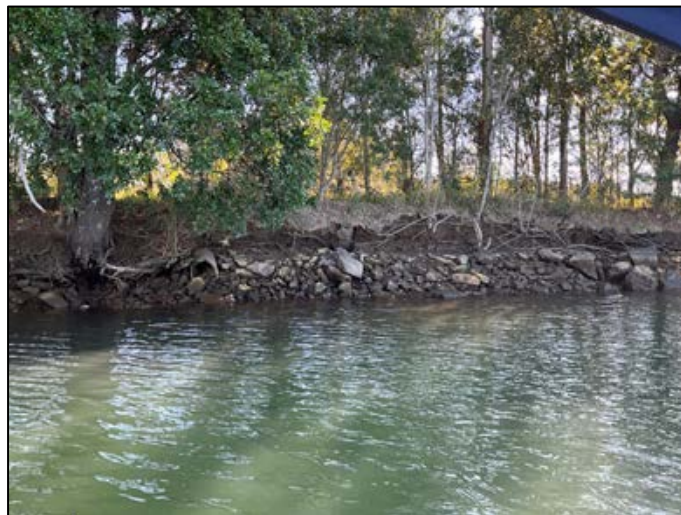
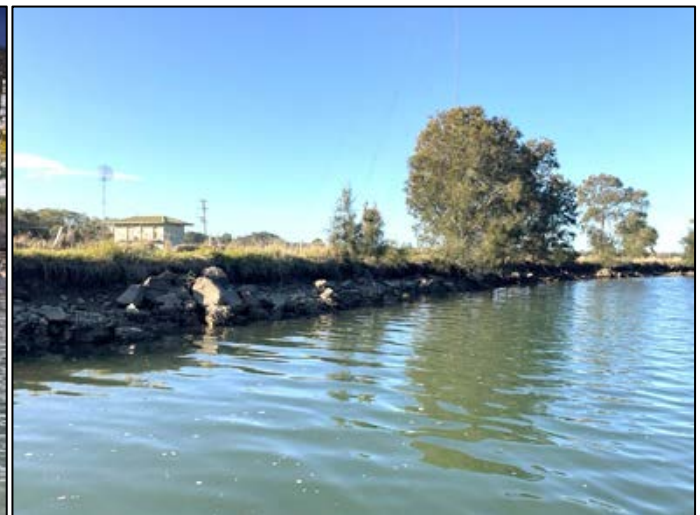
Plate 16 Examples of partially effective bank protection works (condition) in the study area, from left to right: erosion of the mid bank above slumped rock armouring in the lower Bellinger River Reach 57; subsiding rock works on Back Creek exposing upper bank to erosion, Reach 723.

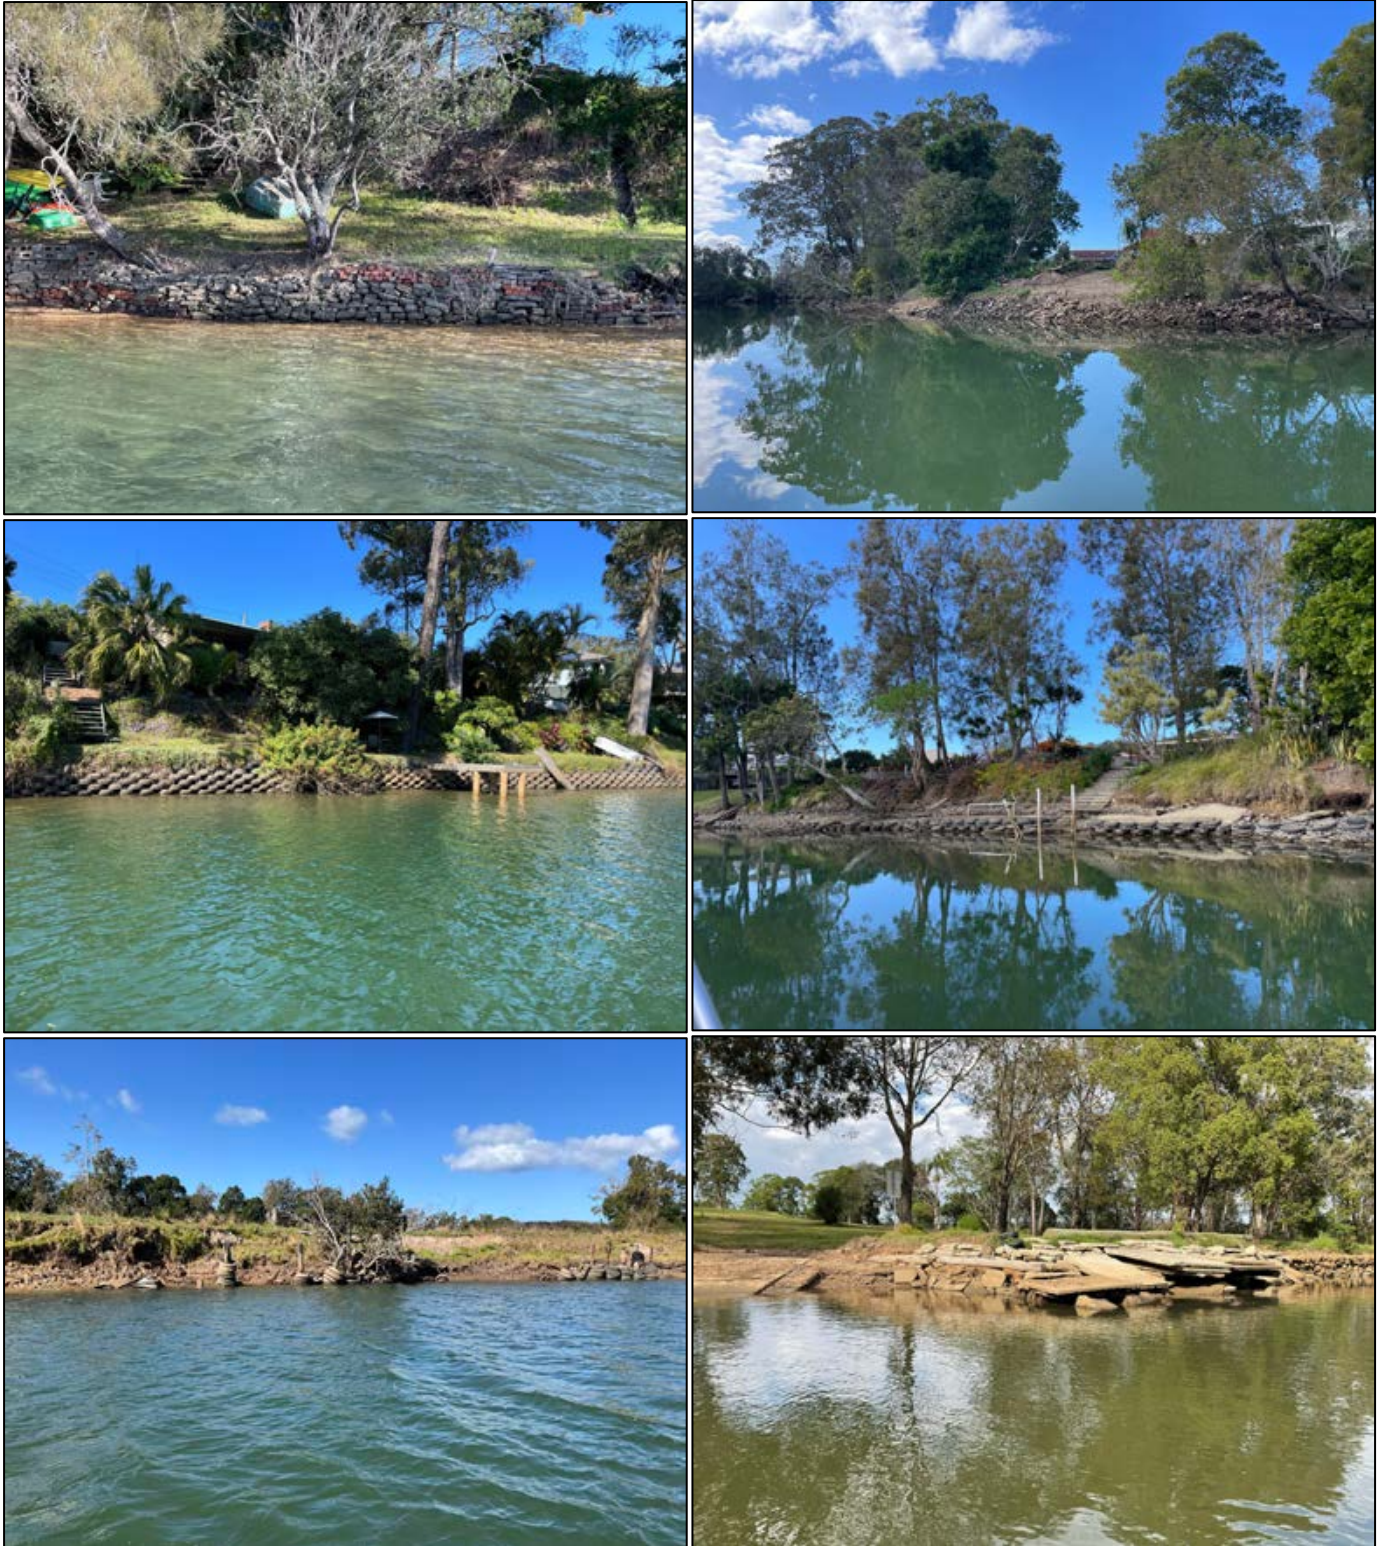
Plate 17 *Examples of inappropriate bank protection works in the study area, clockwise from top left: building rubble dumped over the bank at Reach 261 Kalang River; building rubble pushed over the bank on the Council reserve at Reach 333 Kalang River; tyre wall in the Council reserve area behind Burrawong Pde Kalang River; Concrete debris and building waste on the Kalang River; deteriorating tyre wall Kalang River Reach 425; tyre wall on the Bellinger River at Raleigh Reach 77.*

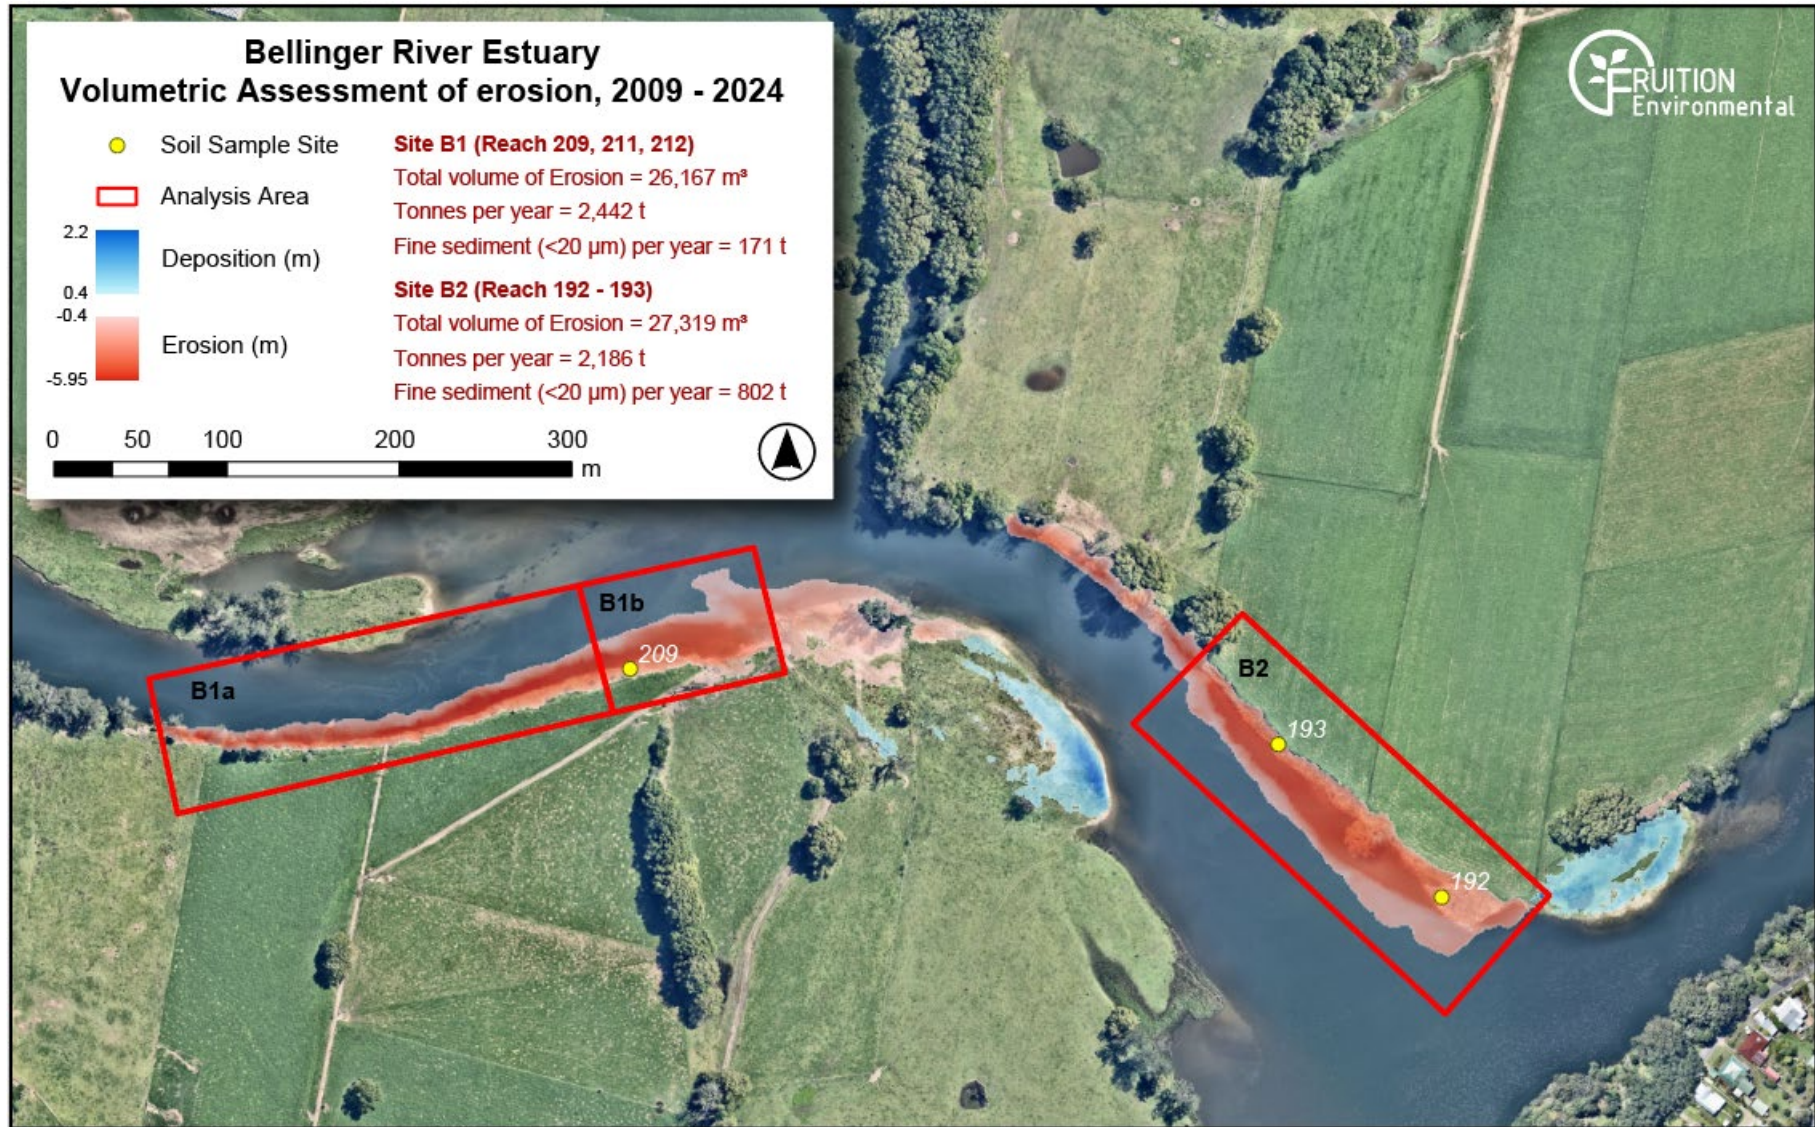
Figure 22 Erosion and deposition heatmap for Sites B1 and B2 in the upper estuary of the Bellinger River, based on lidar-derived DEM of Difference. Erosion rates and fine suspended sediment entrained into the estuary and marine environment also indicated.
