Report produced for
Department of Primary Industries and
Regional Development - Fisheries

Bellinger-Kalang River Estuary NEAP Bank Erosion and Riparian Condition Assessment Report

20 December 2024

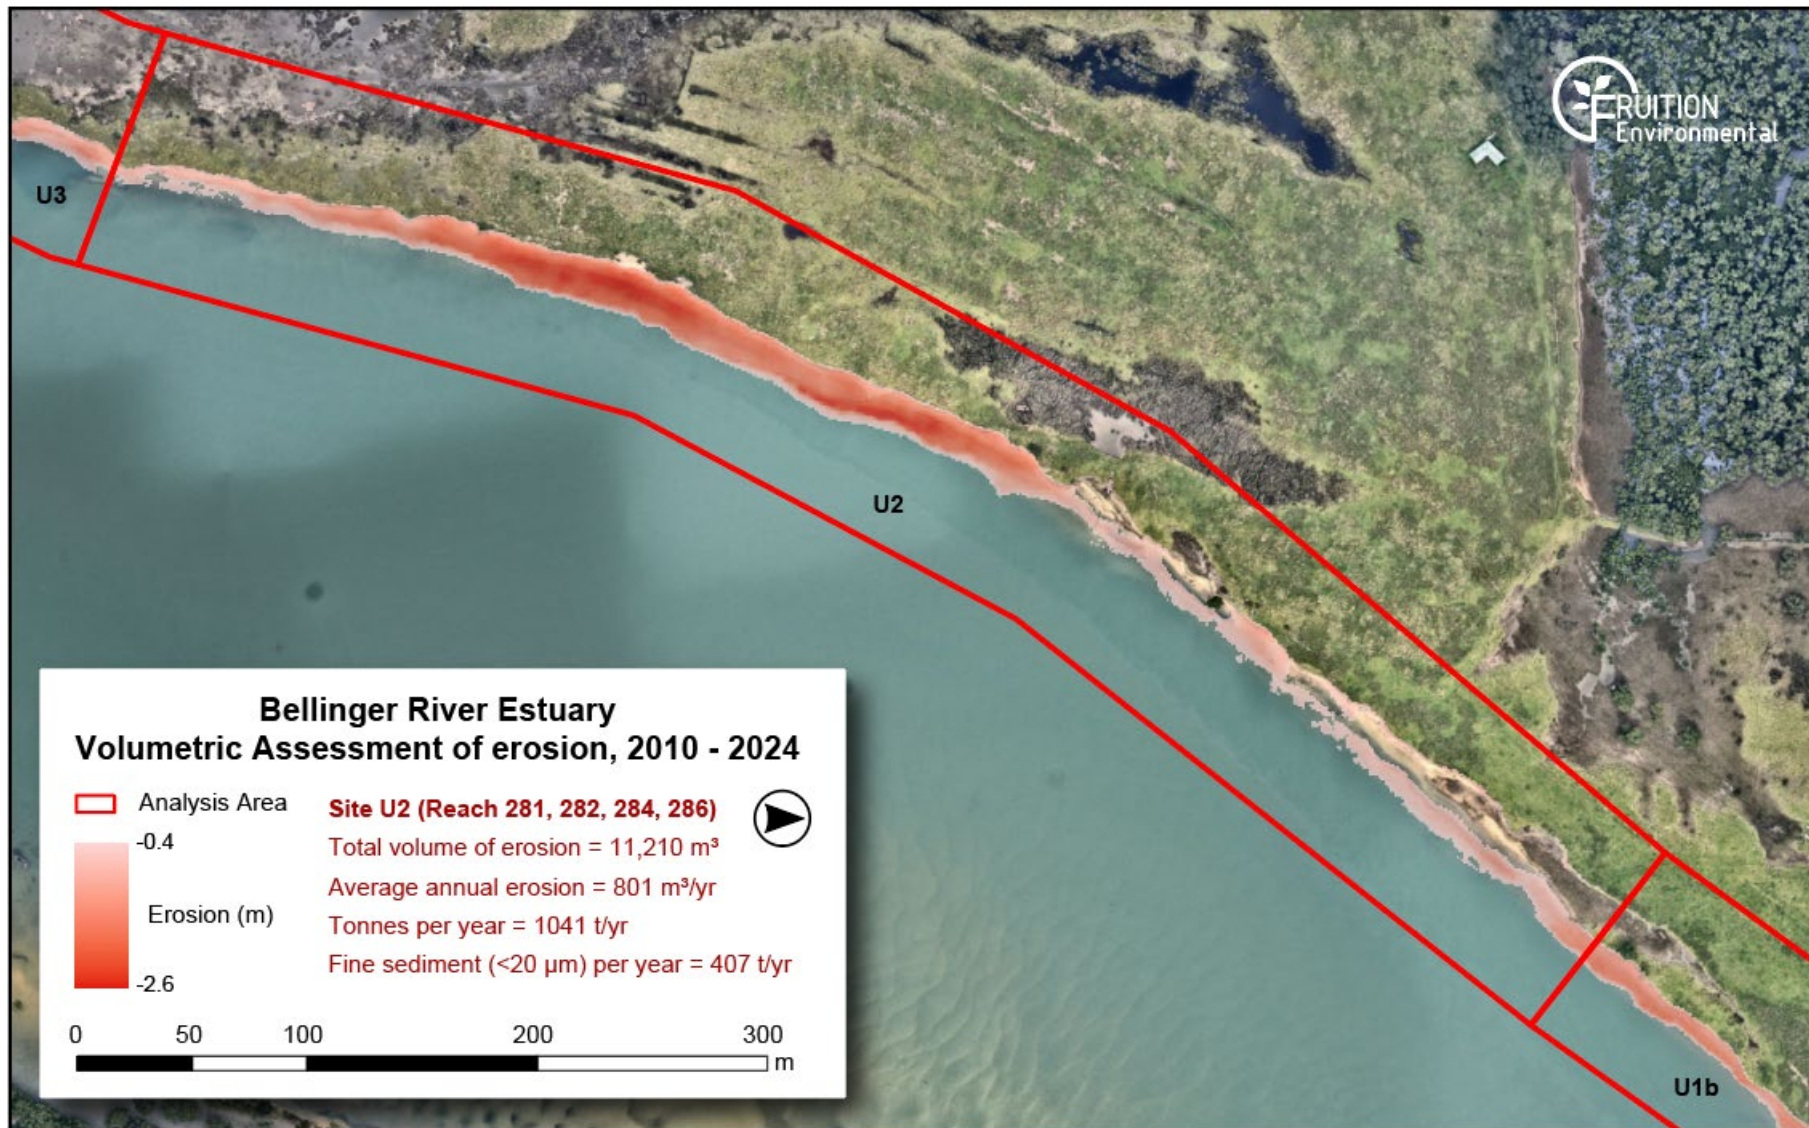
Figure 23 Erosion and deposition heatmap for Site U2 along Urunga Island on the Bellinger River, based on lidar-derived DEM of Difference. Erosion rates and fine suspended sediment entrained into the estuary and marine environment also indicated.

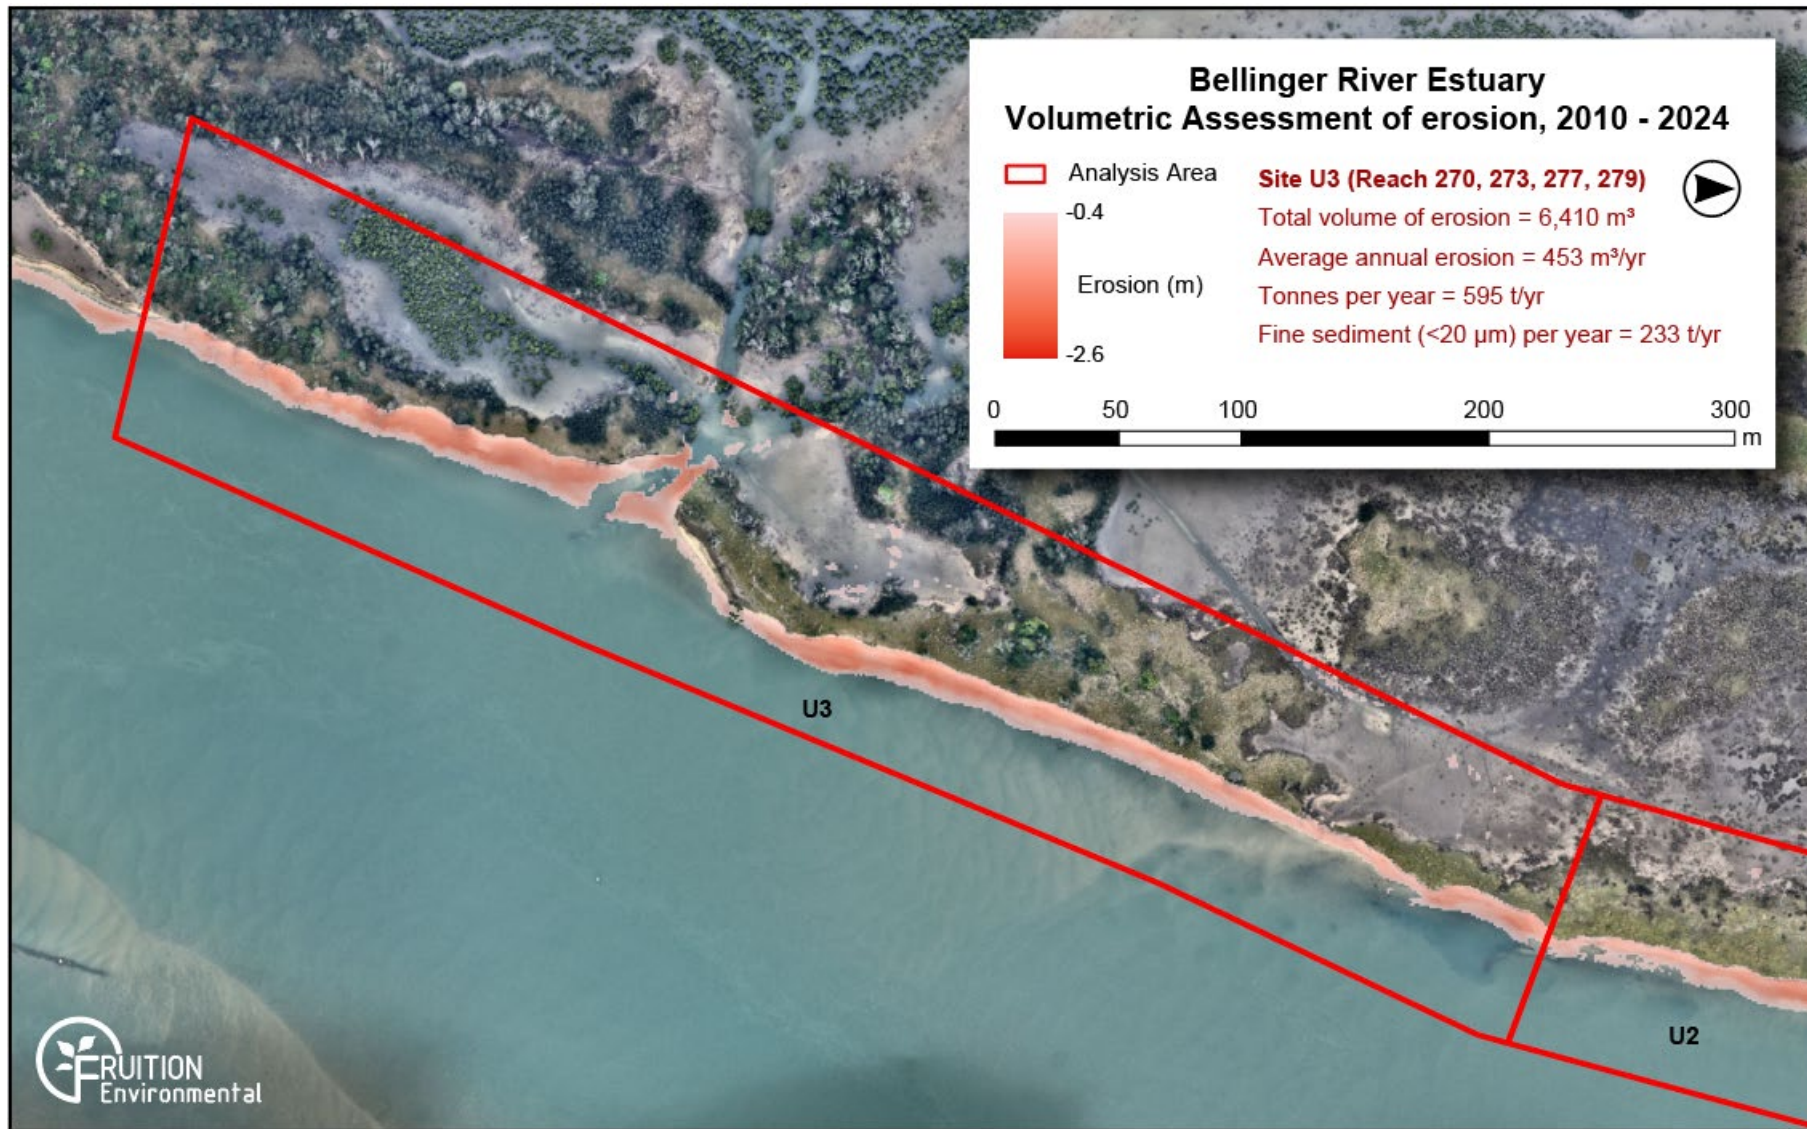
Figure 24 Erosion and deposition heatmap for Site U3 along Urunga Island on the Bellinger River, based on lidar-derived DEM of Difference. Erosion rates and fine suspended sediment entrained into the estuary and marine environment also indicated.
