SAFETY ALERT

COAL MINE SHUTTLE CAR CABLE REEL

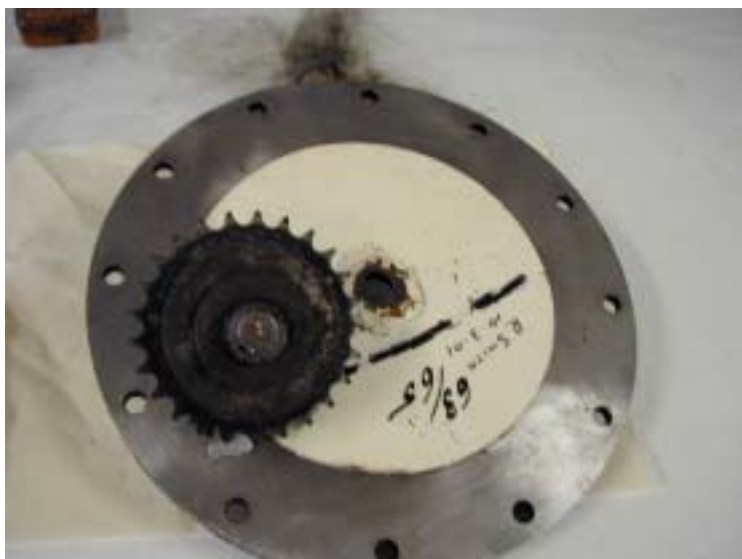
There have been a number of separate incidents of failure of a weld between the slip ring cover and the sprocket shaft. These failures compromised the explosion protected characteristic of the cable-reel slip ring cover of JOY shuttle cars. In a number of cases the cable reel covers had been inspected by an approved workshop within the previous 12 months.

This failure mode of the shaft was previously advised to JOY customers in a JOY service bulletin Number ASB 232 dated 14/9/1992. The bulletin advised customers that the cover assembly (p/n 577446) had been replaced by cover assembly part number 01756742 0000. The redesign provided for a headed stub shaft that is fully welded to the interior face of the cable reel cover.

The picture shows a slip ring cover, internal side up. The sprocket and parallel shaft also shown was able to break free from the centre locating hole because of the lower strength

design. The redesigned shaft with a larger diameter head fully welded to the cover is intended to increase the strength of the assembly.

1. As a result of the recent failures, collieries and approved workshops are urged to examine each cable reel cover, and to replace or repair any that do not have the improved sprocket shaft. In case of any doubt, the Original Equipment Manufacturer, Joy Mining Machinery Pty Ltd, should be consulted.
2. The Department also draws the attention of Mine Managers to the requirements of Clause 51, Coal Mines(General) Regulation 1999.
