Tilligerry Creek Floodgate Assessment

Report to the Hunter-Central Rivers
Catchment Management Authority

Project number HCR07_106

January 2009

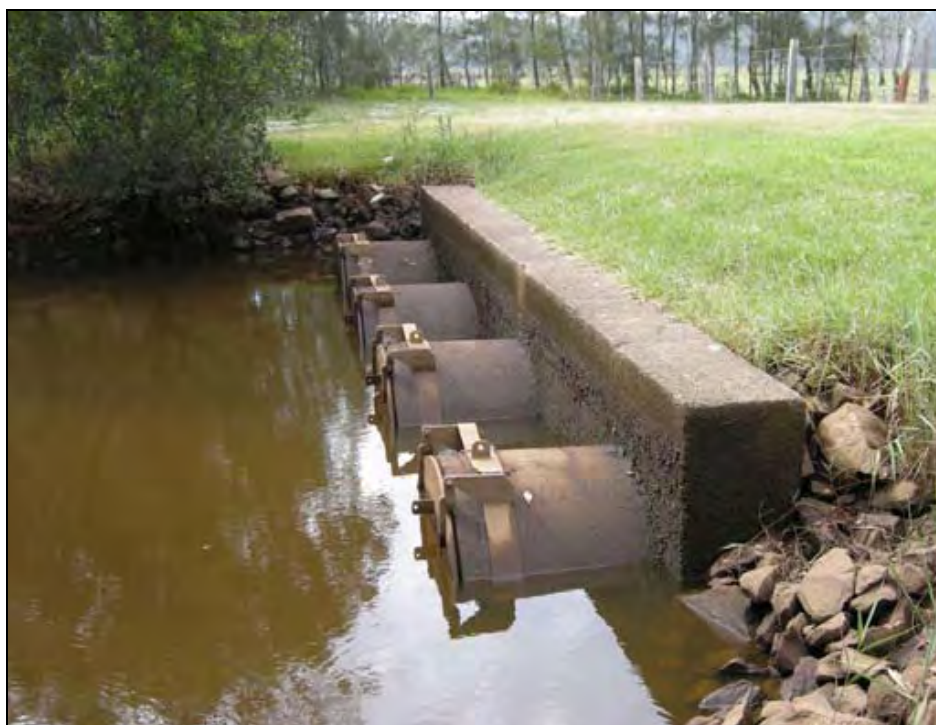
Figure 2 Tilligerry Creek Floodgates, adjacent to Nelson Bay Road, Salt Ash.

Landholders have reported saltwater on their properties in the past when the gates have been leaking due a blockage or corroded seals. In these cases tidal water has moved upstream unimpeded, increasing water levels in the drain and overtopping low points in the levy banks.

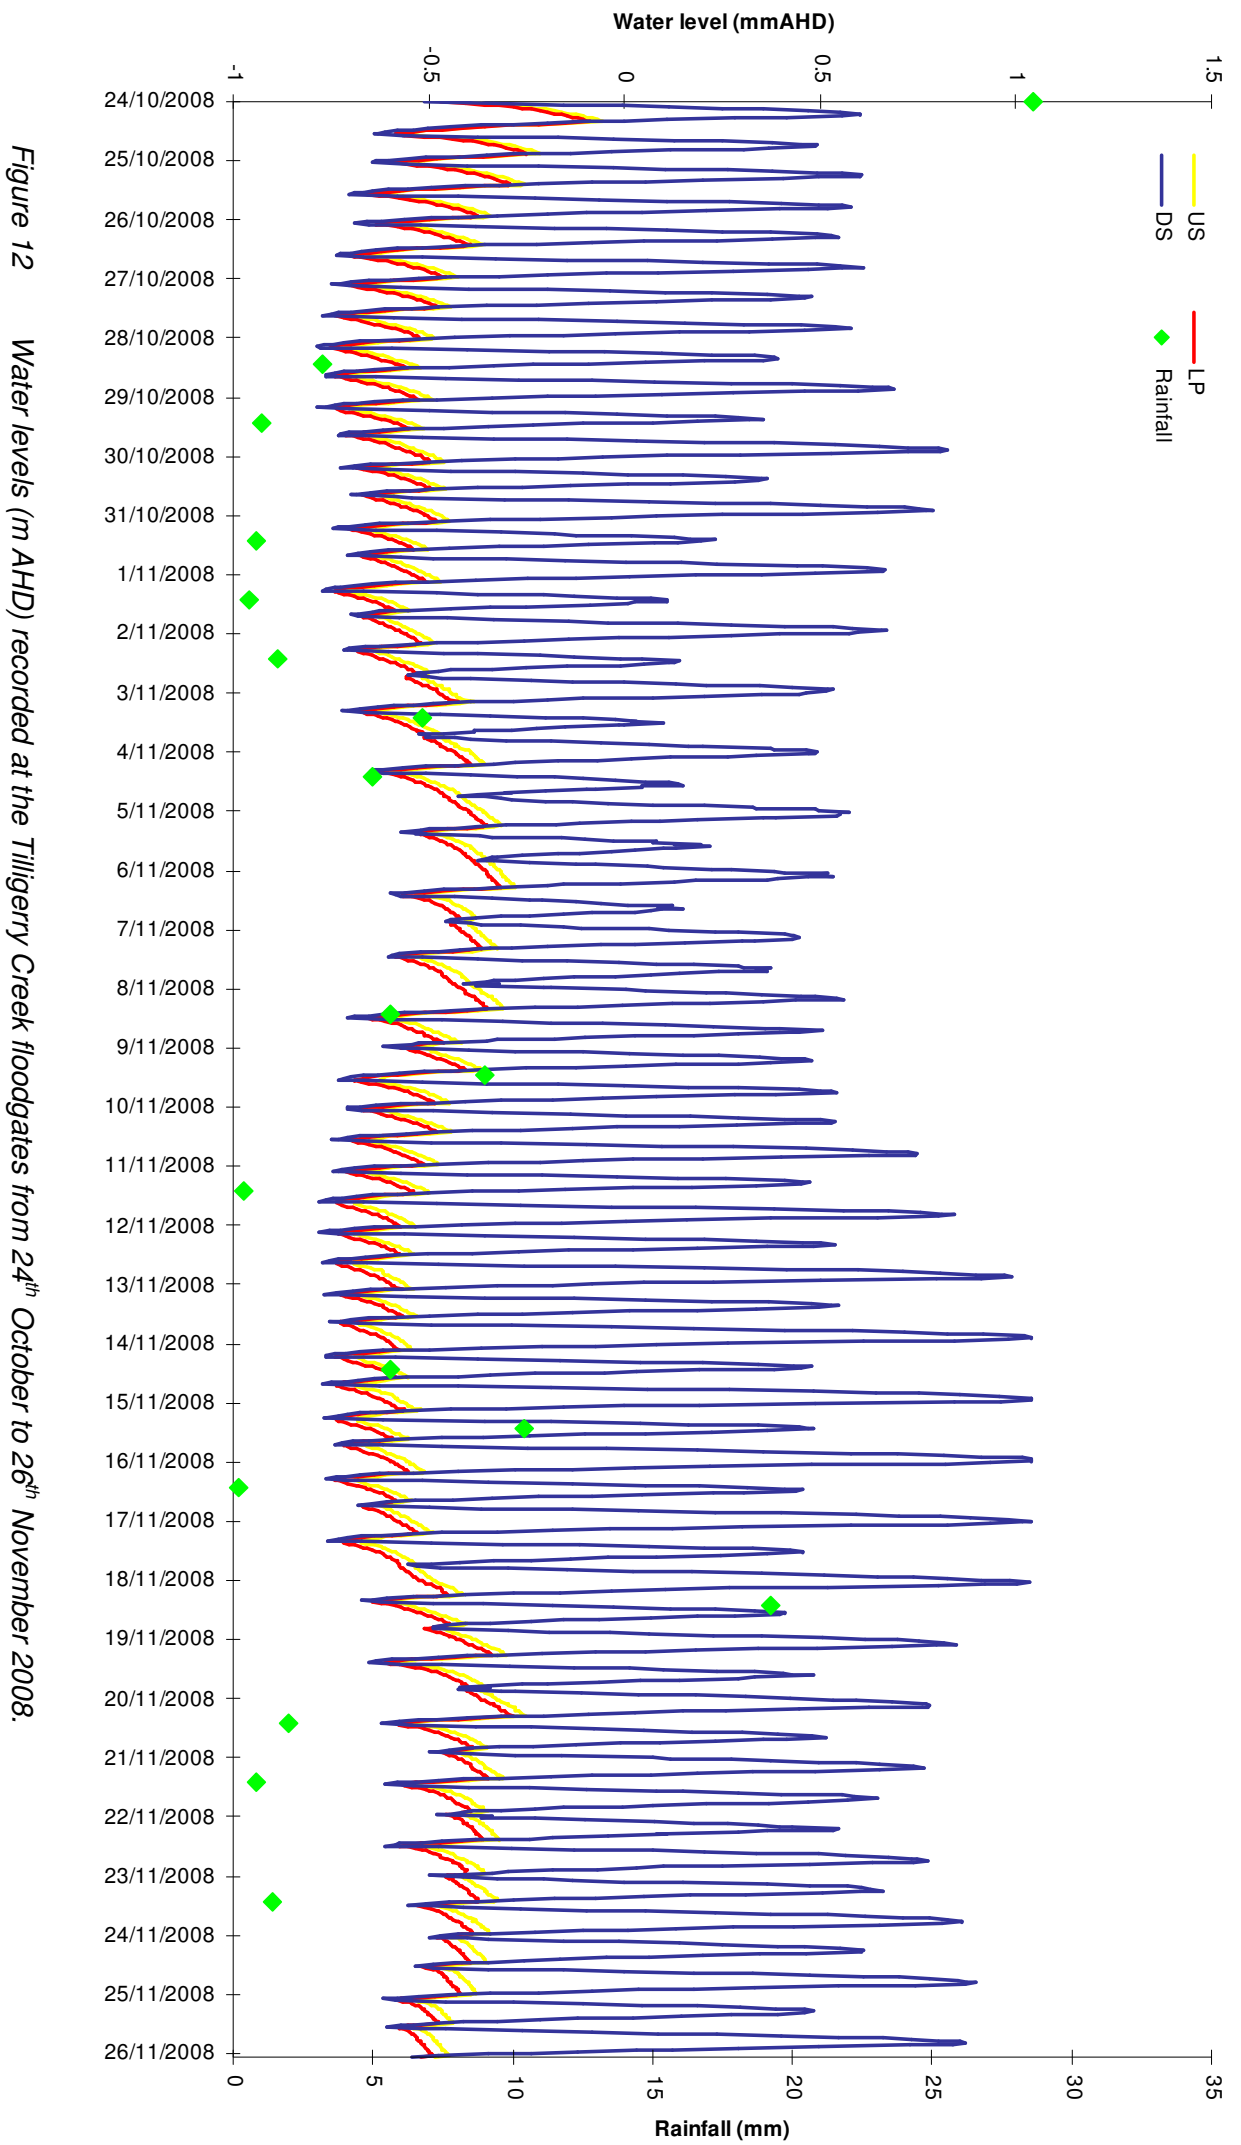
Figure 12 shows the tidal variations recorded by all three in-stream probes. At high tide both the upstream and low point recorders appear to show tidal influence. While the floodgates allow some leaking, this is not significant and does not reach the low point. The fluctuations in water levels observed for the upstream and low point probes occurs while the gates are forced shut during the in-coming tides. During this time, water backs up in the drain at least as far as the low point until the out-going tide allows the gates to open and the system discharges.

Immediately downstream of the floodgates, the highest tide reached 1.041m AHD and a minimum of -0.782m AHD. The highest water levels measured upstream of the gates were much less than downstream. Immediately upstream of the gates recorded a maximum of -0.054 m AHD and the low point reaching -0.082 m AHD. The lowest water levels were similar at these locations to the downstream water level, with upstream recording -0.719m AHD and the low point recording -0.752m AHD. Water levels downstream of the gates were observed overtopping the floodgate headwall during a high tide but not the levy between upstream and downstream.

Figure 12 Water levels (m AHD) recorded at the Tilligerry Creek floodgates from 24th October to 26th November 2008.

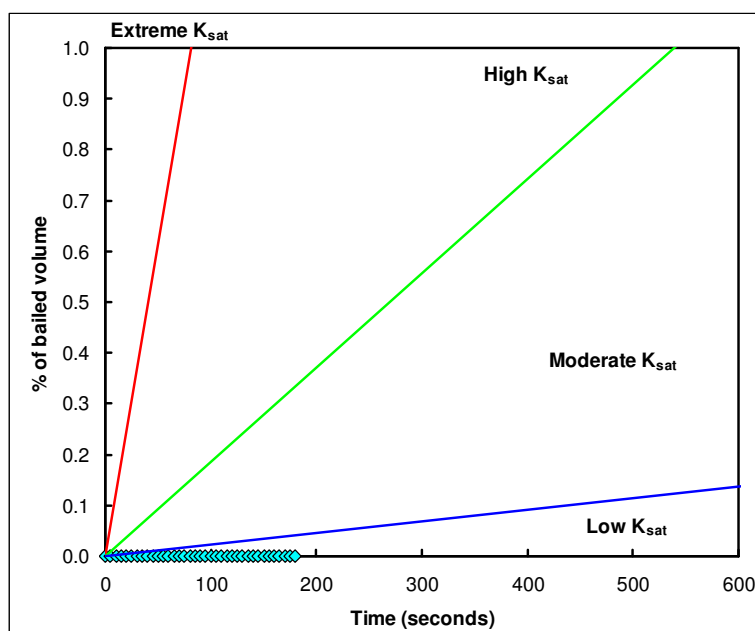
Hydraulic conductivity (K_{sat}) testing was conducted in two locations where land elevations are low. Results of testing indicate the soils at pit 1 have low conductivity with lateral seepage expected to be less than 1.5m a day, possibly due to the sandy nature of the soils (Fig 13). Sandy soils can often lack the macropores (old tree roots) found in clay soils that give the latter high hydraulic conductivities (Hirst, pers comm.). This is expected as the drain is less than 1km from the Stockton dunes and as such the soil is predominately sandy and underlaid by marine and estuarine mud and sands (Environmental & Earth Sciences, 2000).

The low hydraulic conductivity recorded in pit 2 could not accurately show the conductivity of the soil as K_{sat} testing relies on reaching the groundwater at a maximum depth of 0.5m. This was not achieved at this site and retesting after a period of heavy rainfall could have different results when the groundwater level has increased to a sufficient level for testing. Heavy rainfall was experienced in the catchment in the days prior to the testing, though sufficient time may not have passed to affect the groundwater level.

Figure 13 K_{sat} pit results showing low hydraulic conductivity.

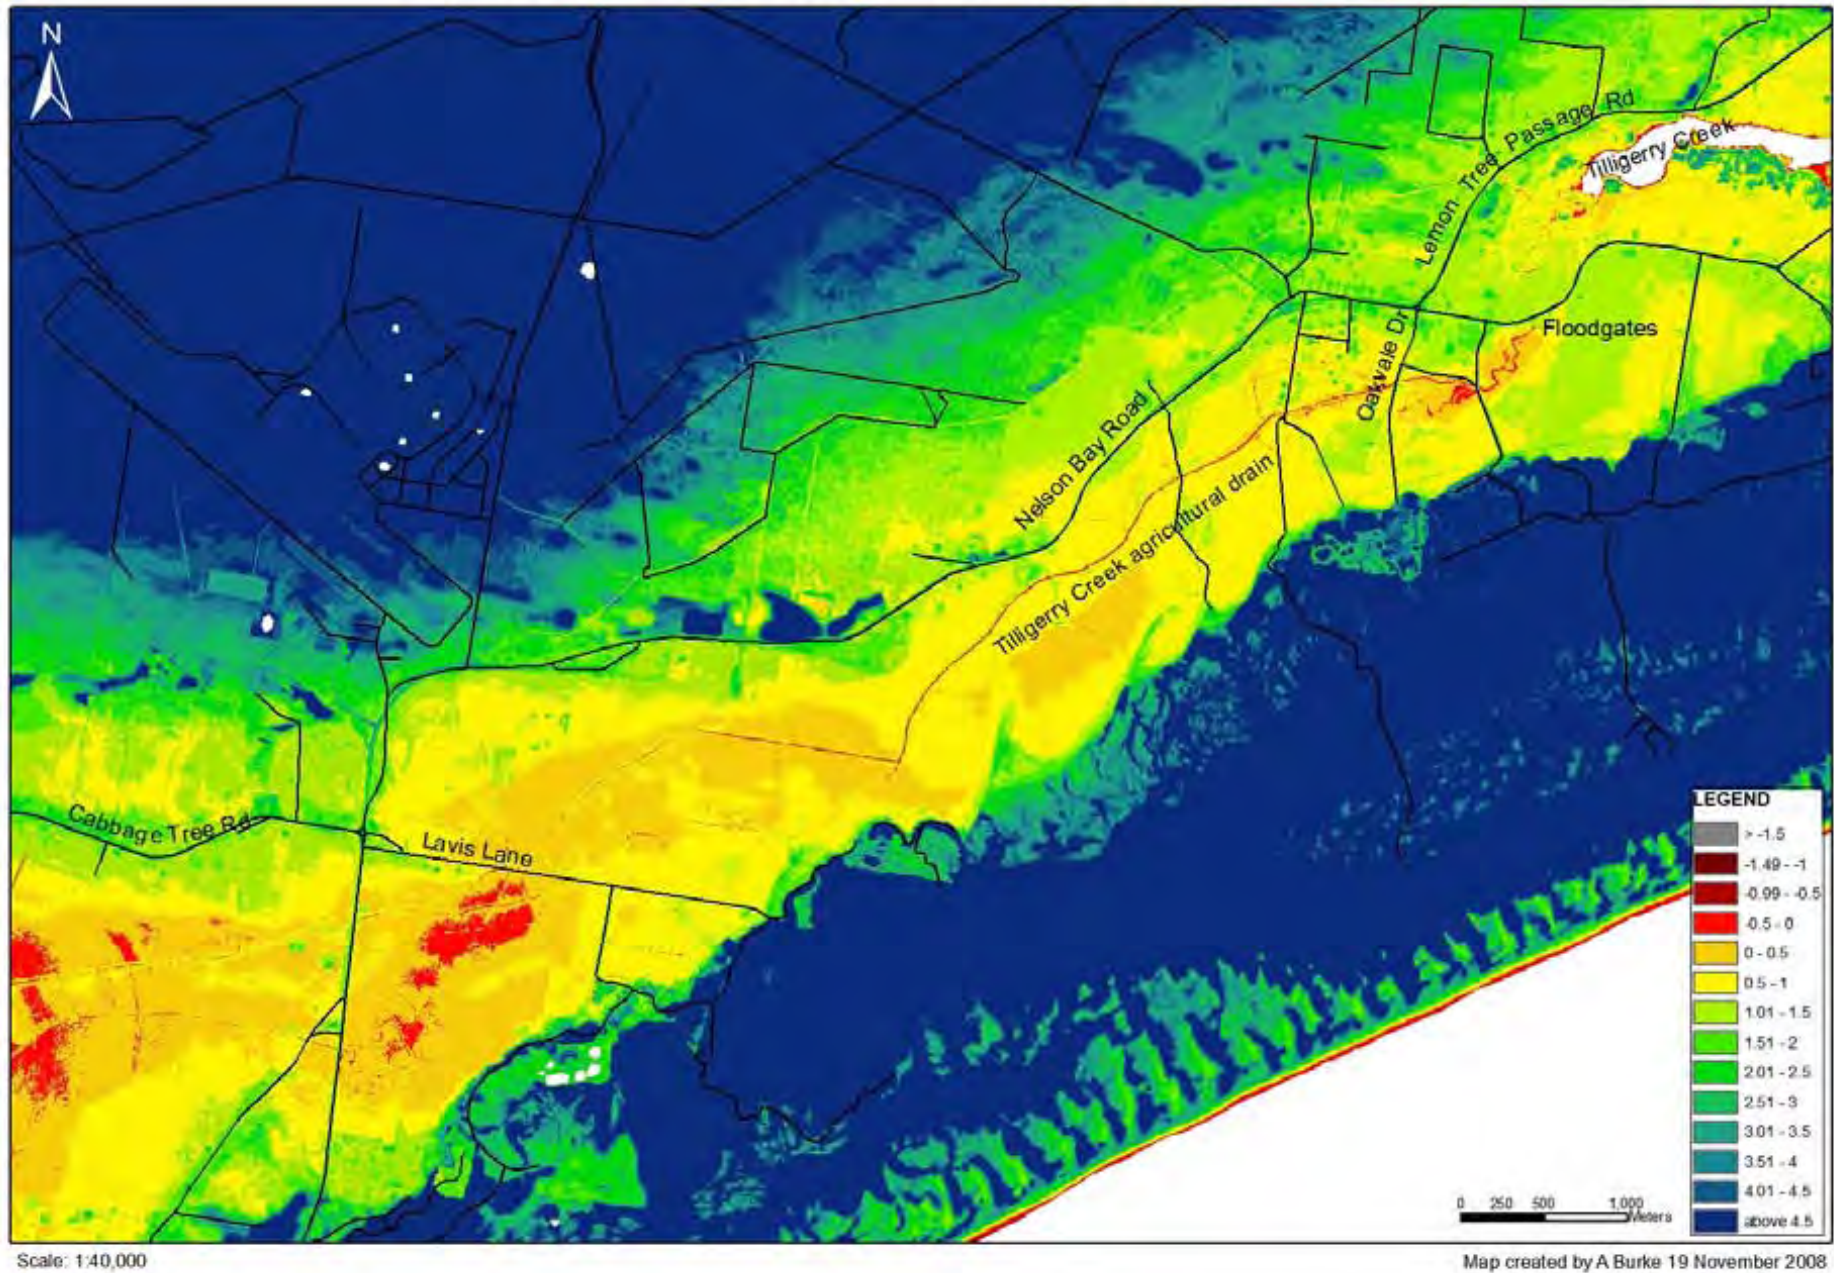
Analysis of the LiDAR data revealed that the catchment is very low-lying with elevations generally between 0 and 2m AHD (Figure 14). Land between Oakvale Drive and the floodgate is particularly low, between -0.5 to 0.5m AHD and increasing up to only 1m AHD further up the catchment towards Fullerton Cove. The levee banks along the drain are also very low, between 0 and 0.5m AHD between the floodgates and Oakvale Drive and 0.5 and 1m AHD further up the drain.

Figure 14 Digital Elevation Model of the Tilligerry Creek catchment
