Report produced for Department of Primary Industries and Regional Development - Fisheries

Brunswick River Estuary NEAP Bank Erosion and Riparian Condition Assessment Report

18 November 2024

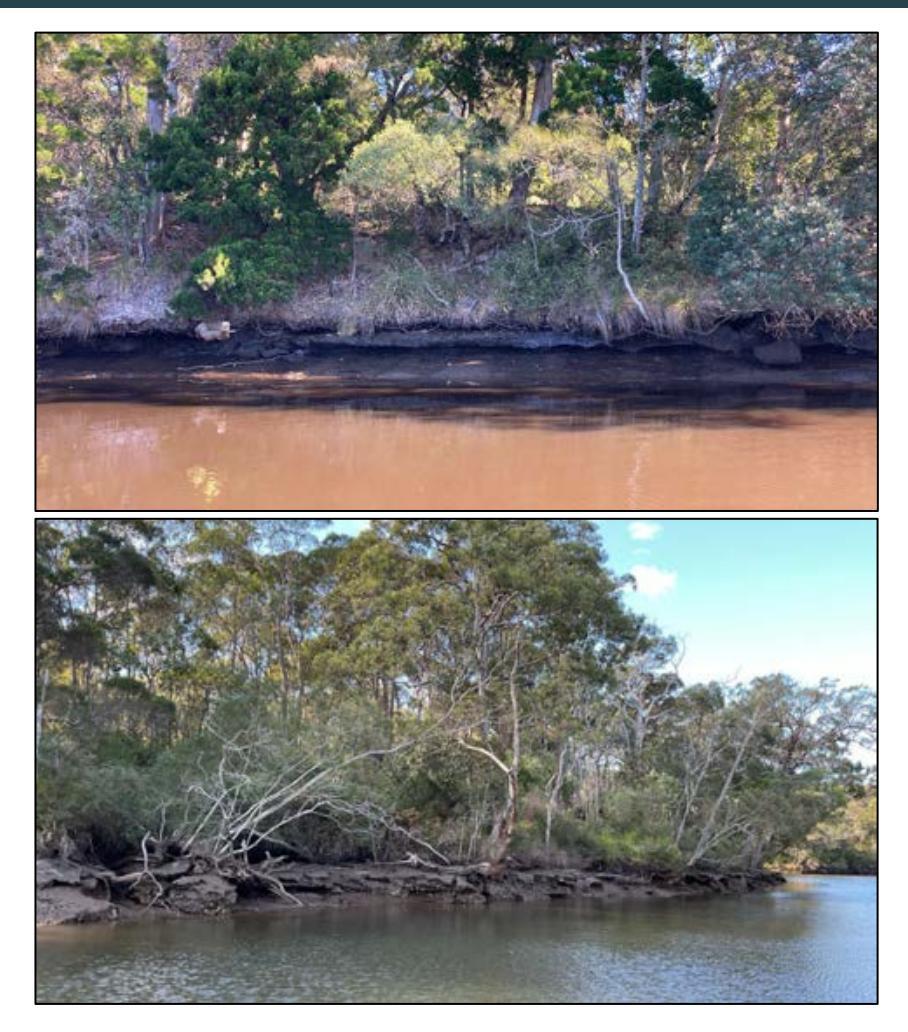
Plate 1 Indurated sands or coffee rock outcrops in both Simpsons Creek (top image) and in the main arm of the Brunswick River (lower image).

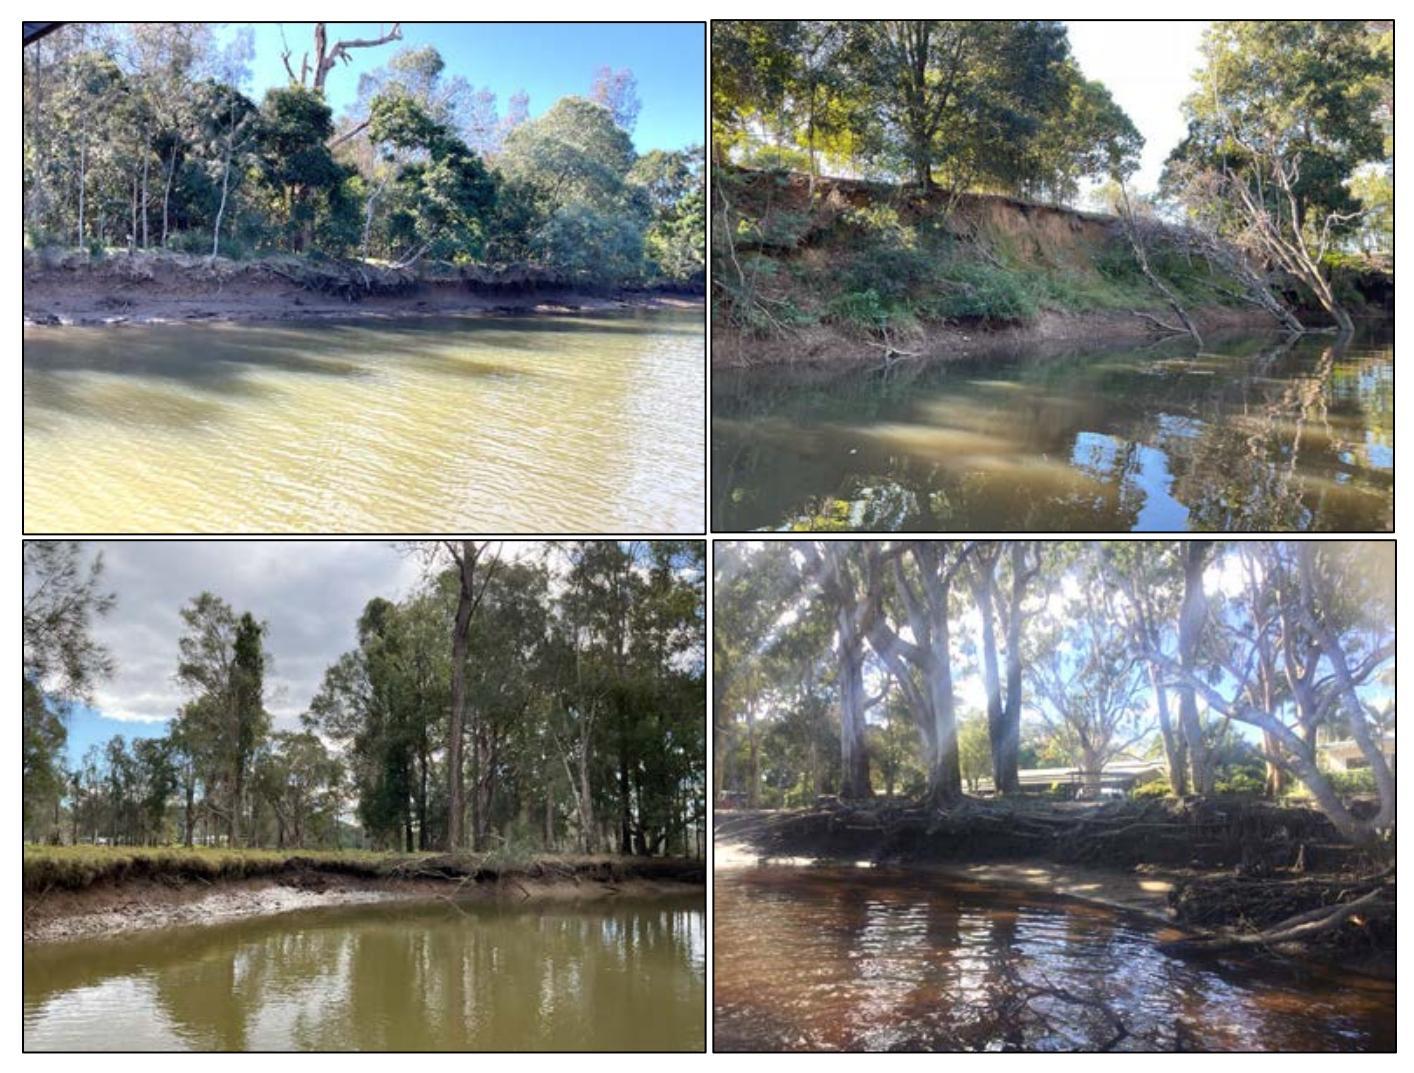
Plate 3 Bank scour and slumping post flood are the dominant erosional processes in the Fluvial Dominated Process Zone in the Brunswick River estuary. Scour is generally concentrated on the outside meander bends, for example clockwise from top left: the Brunswick River Reach 310, Brunswick River Reach 227, Marshalls Creek Reach 318, and Kings Creek Reach 56.

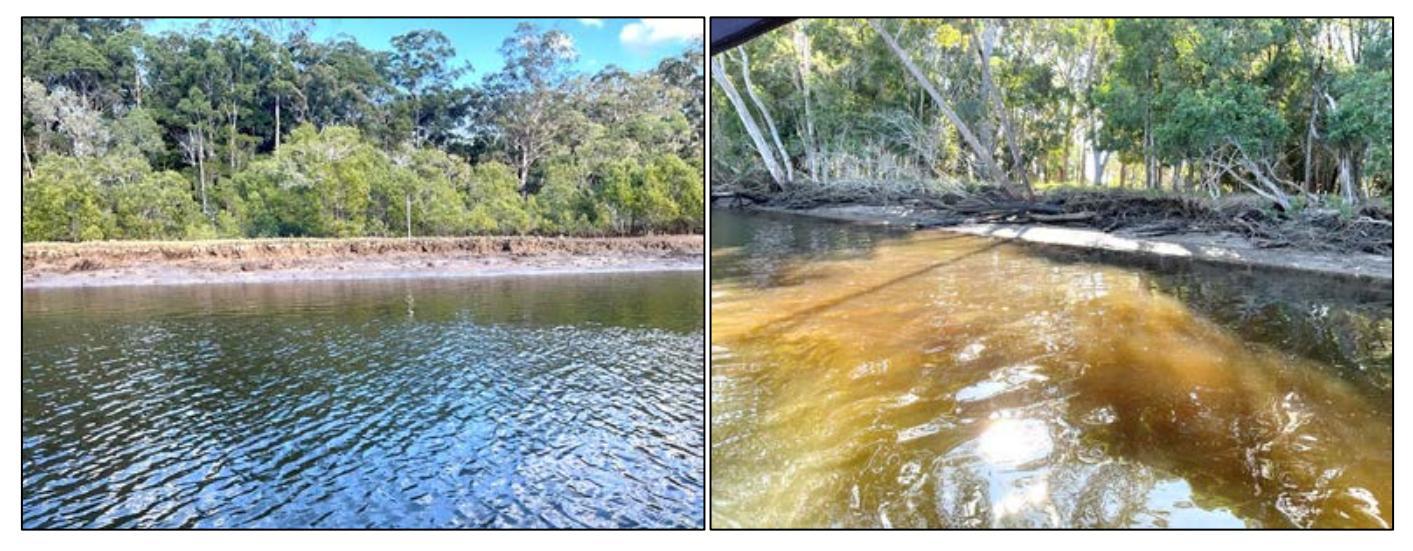
Plate 5 Wave wash erosion in the Fluvial Transition Process Zone in the Brunswick River Reach 12 (left) and Brunswick River Reach 19 (right).

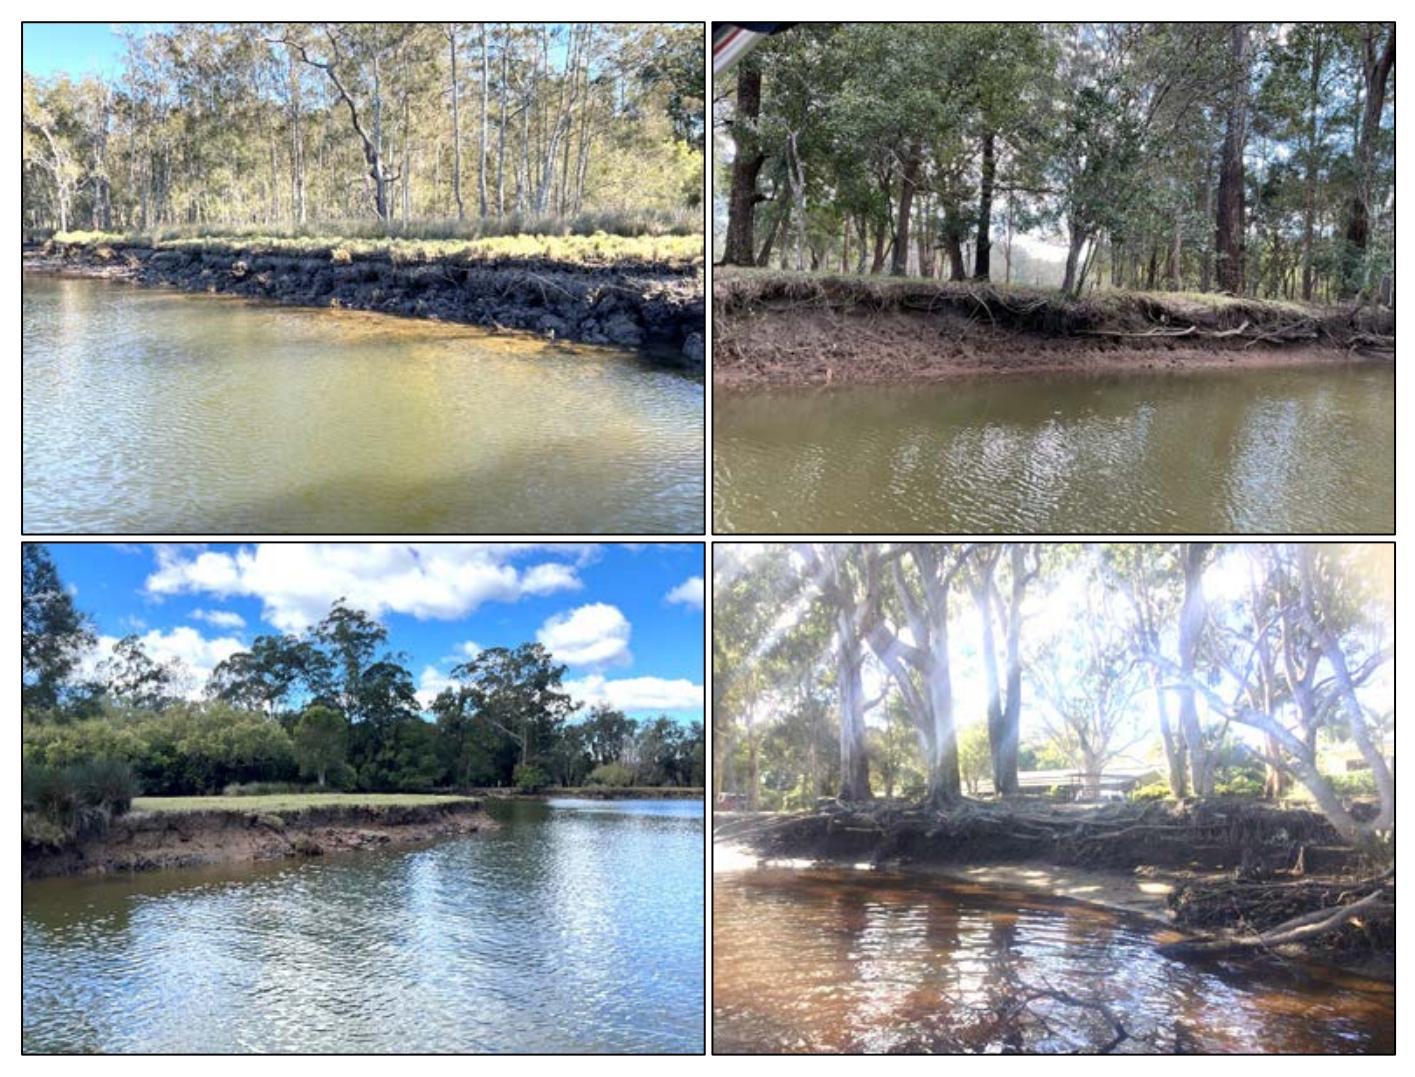
Plate 7Examples of high erosion severity: clockwise from top left, Brunswick River Reach 134; Kings CreekReach 56; Marshalls Creek Reach 318; Brunswick River Reach 59.

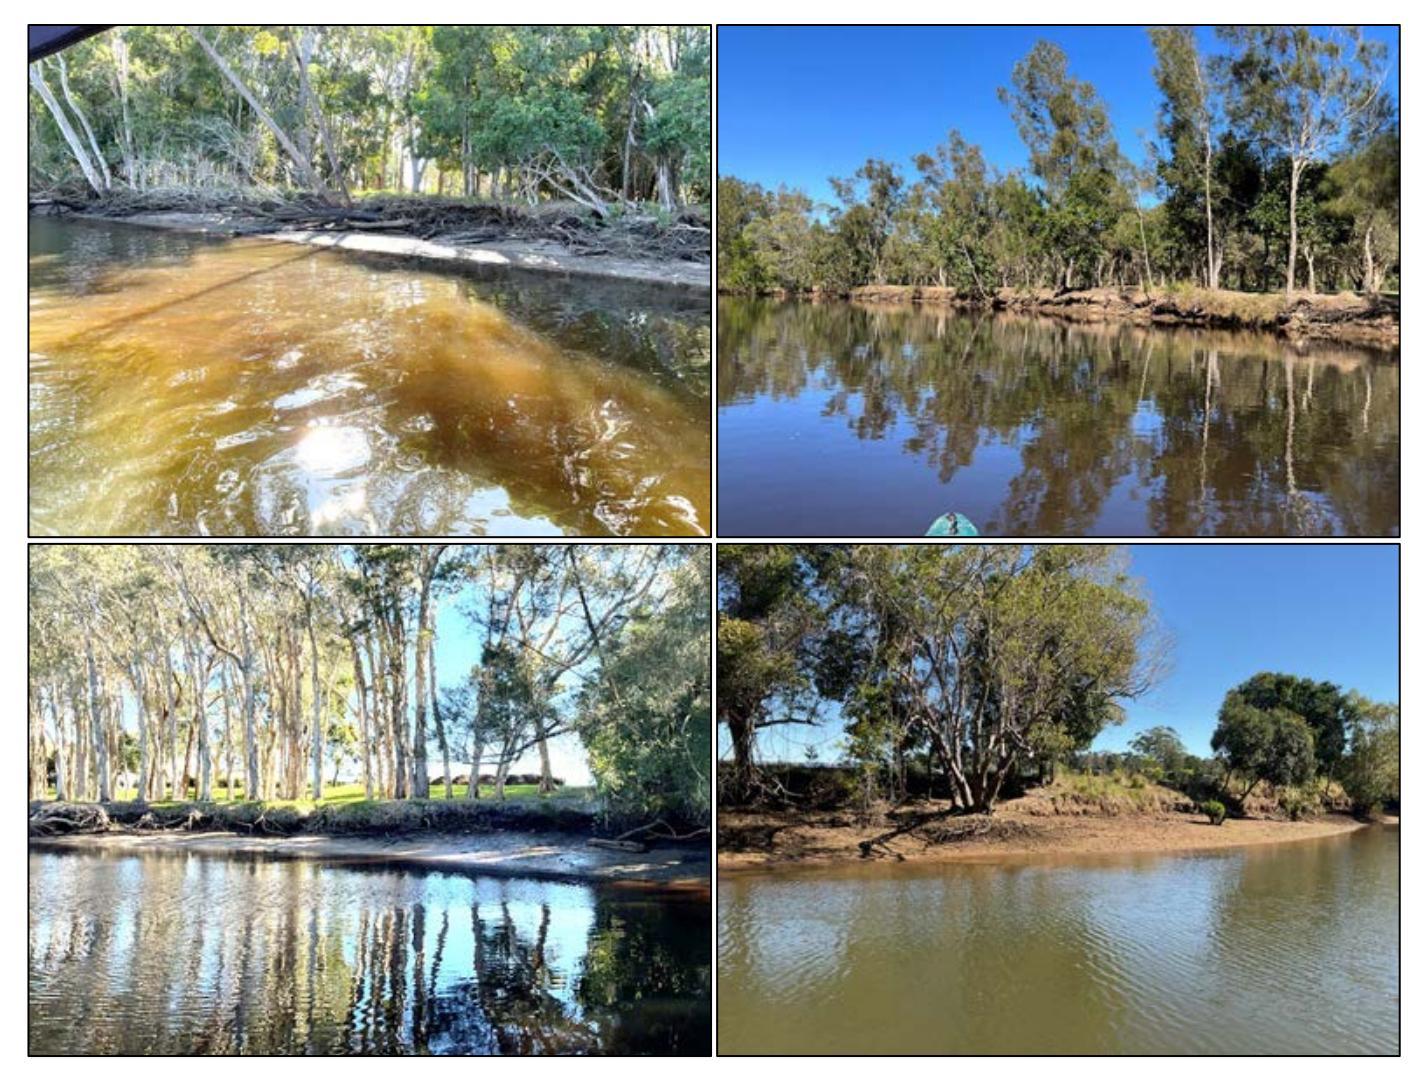
Plate 8Examples of moderate erosion severity: Clockwise from upper left, Brunswick River Reach 229;Marshalls Creek Reach 333; Brunswick River Reach 94; and Simpsons Creek Reach 195.

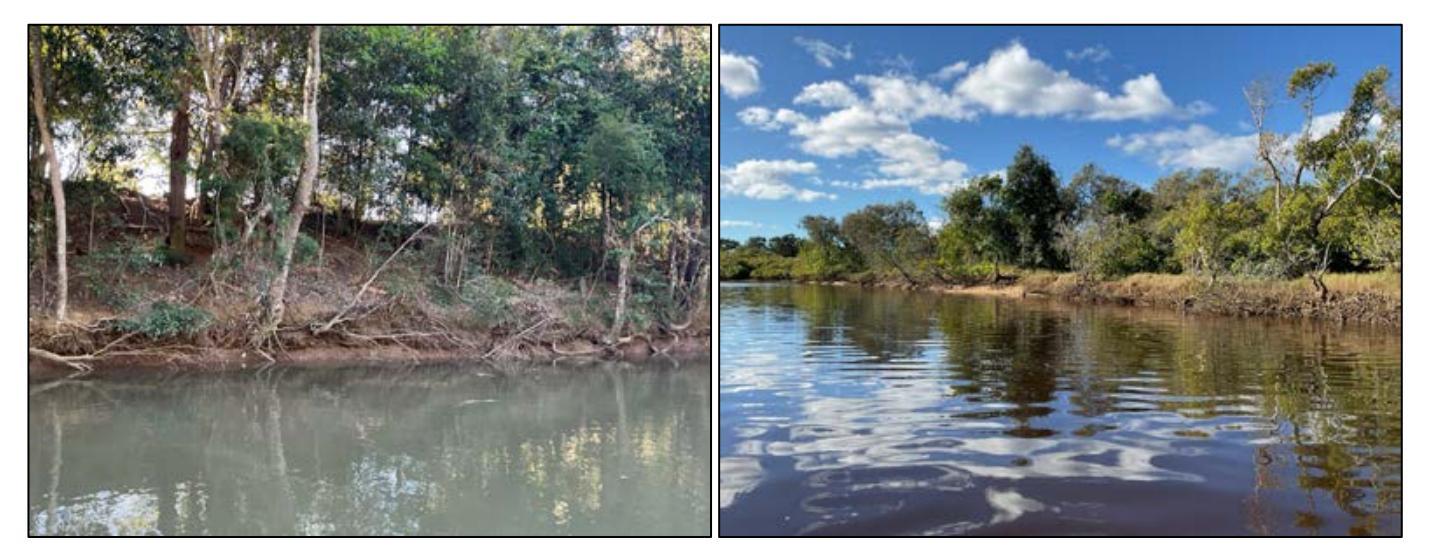
Plate 9 Examples of low erosion severity: Clockwise from left, Brunswick River Reach 229; Marshalls Creek Reach 333.

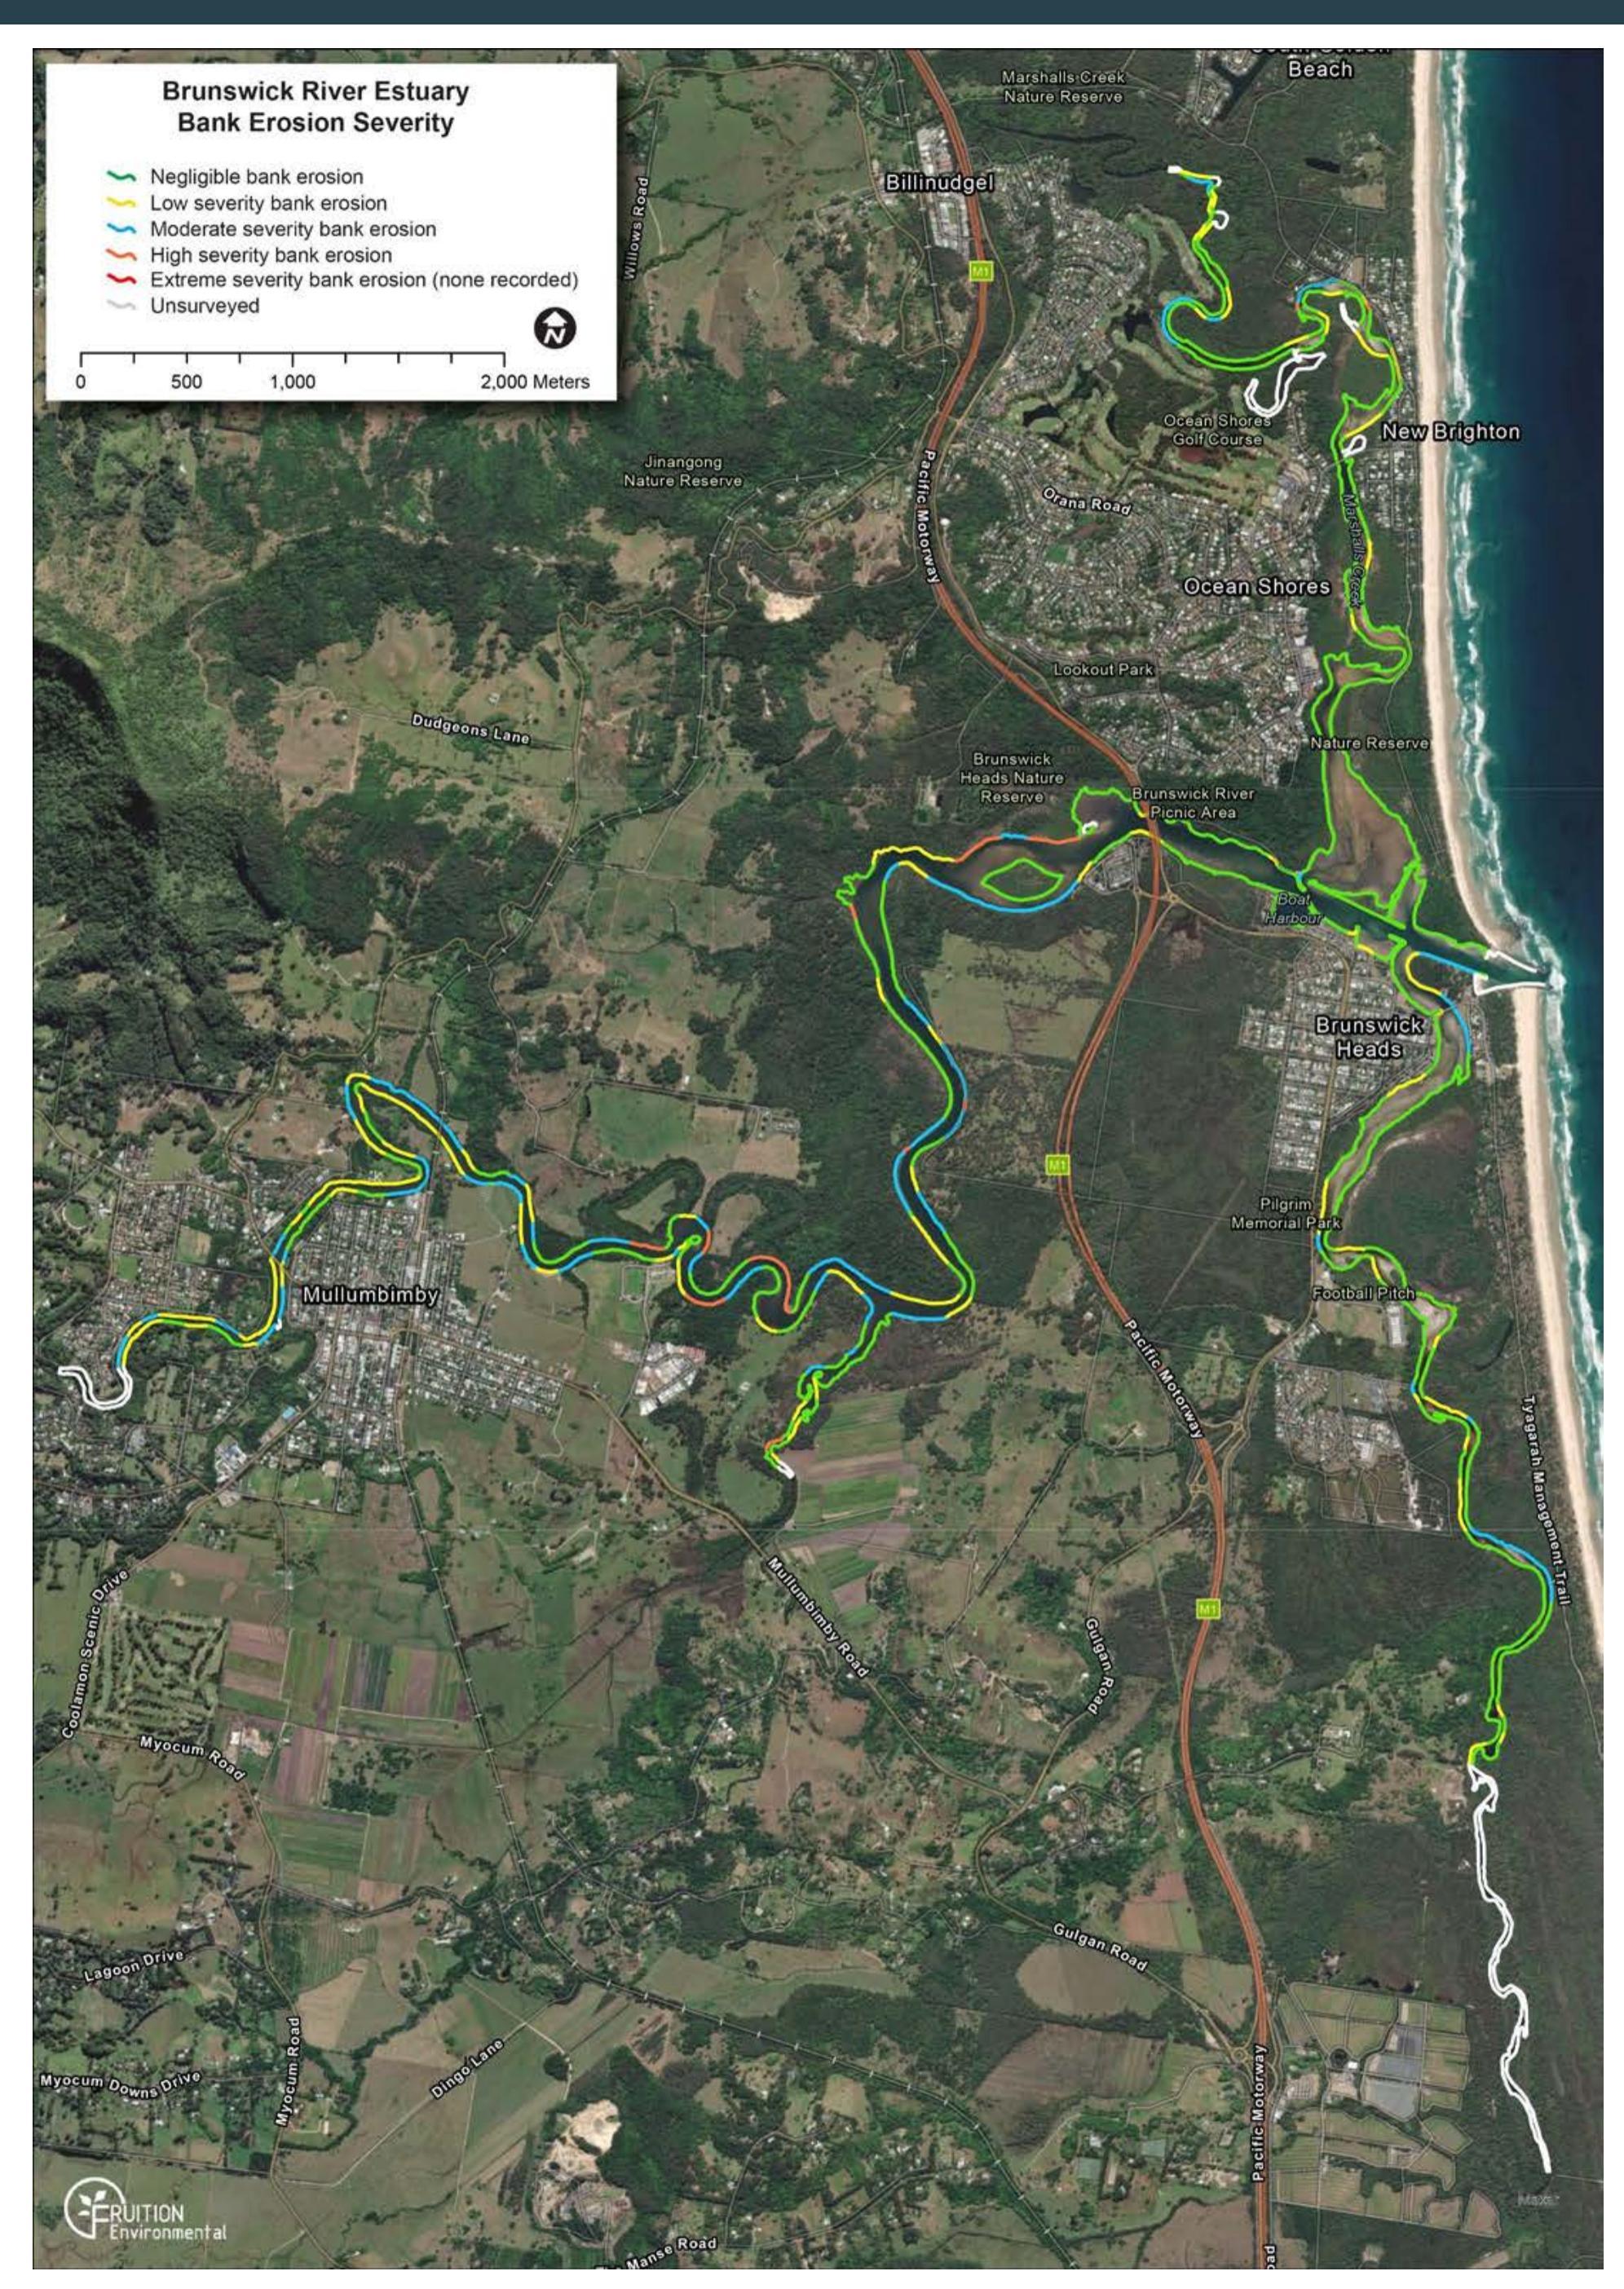
Figure 14 Distribution of mapped bank erosion severity across the Brunswick River Estuary Study Area

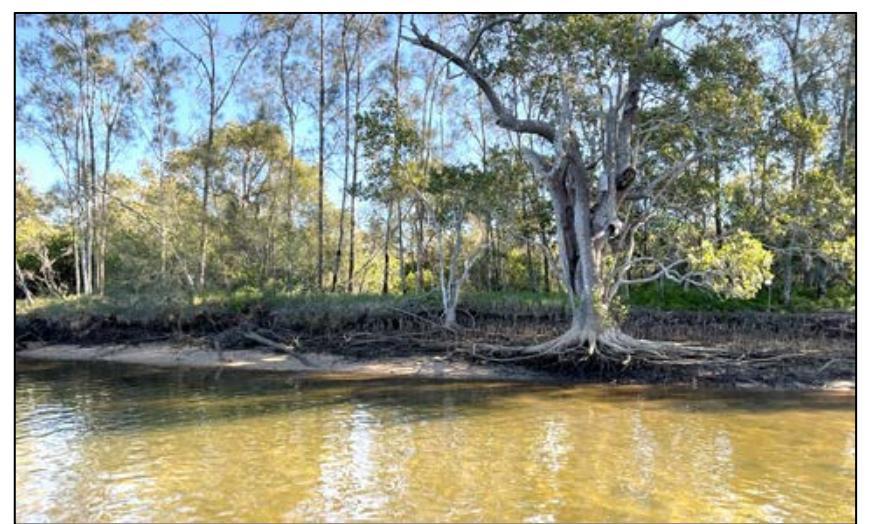
Plate 10 Mangrove stilting

occurs when the drape of peaty/muddy soils overlaying the basal sands are winnowed by persistent wave attack and to a lesser extent tidal or flood flows.

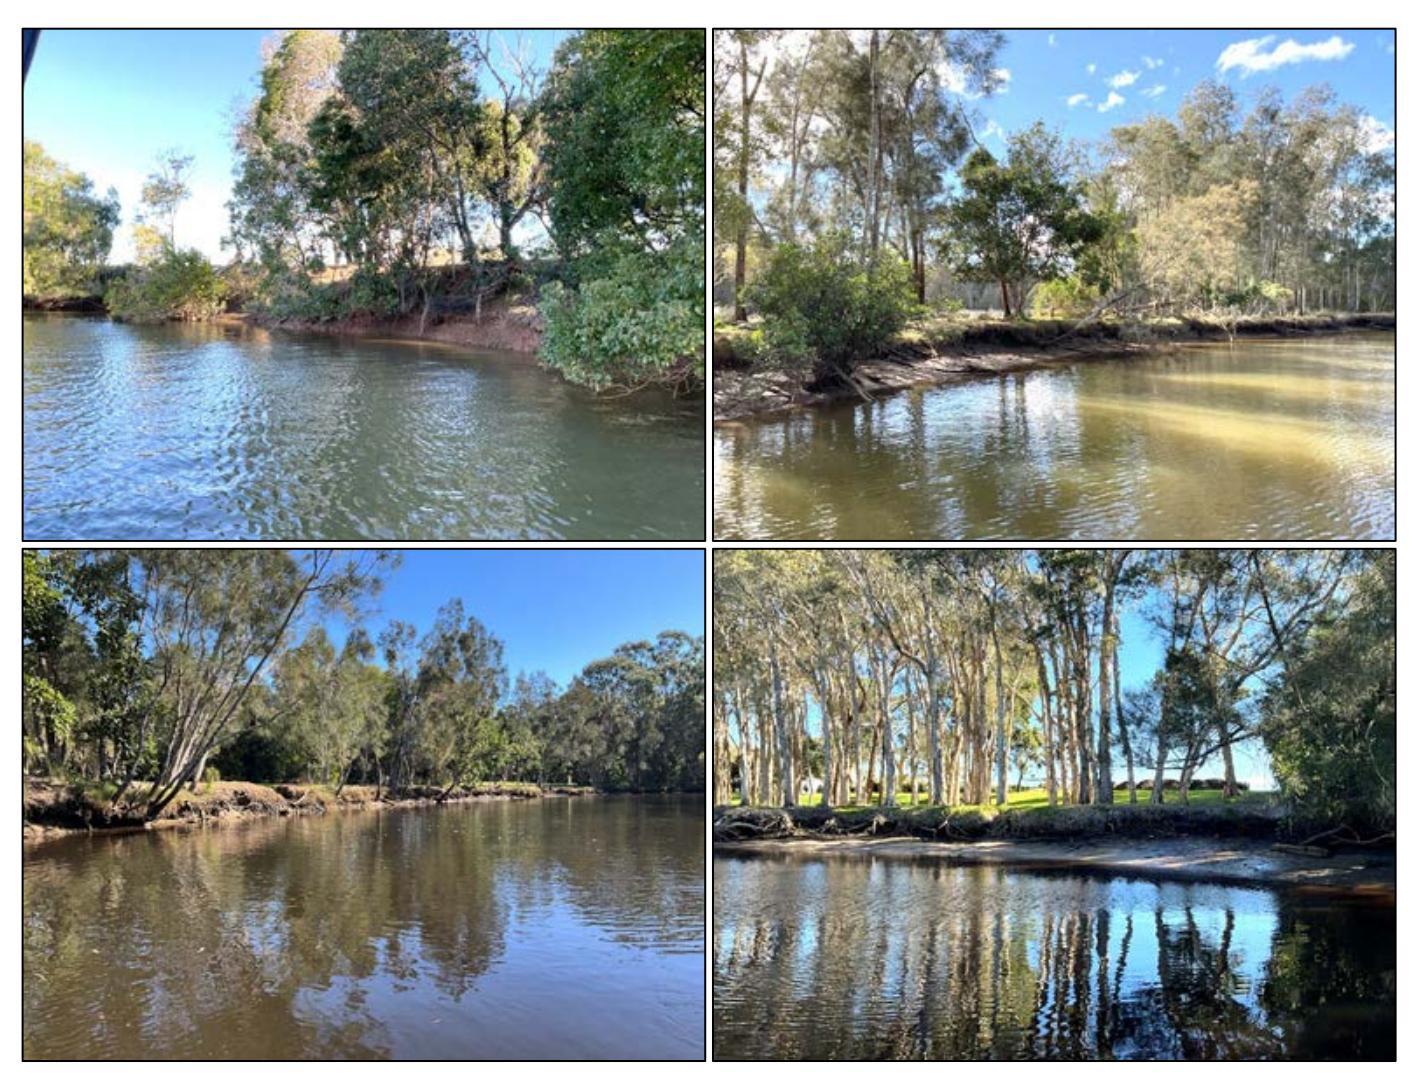
Plate 13Examples of moderate condition riparian vegetation: Clockwise from top left, Brunswick River Reach90; Kings Creek Reach 62; Simpsons Creek Reach 195; and Marshalls Creek Reach 294.

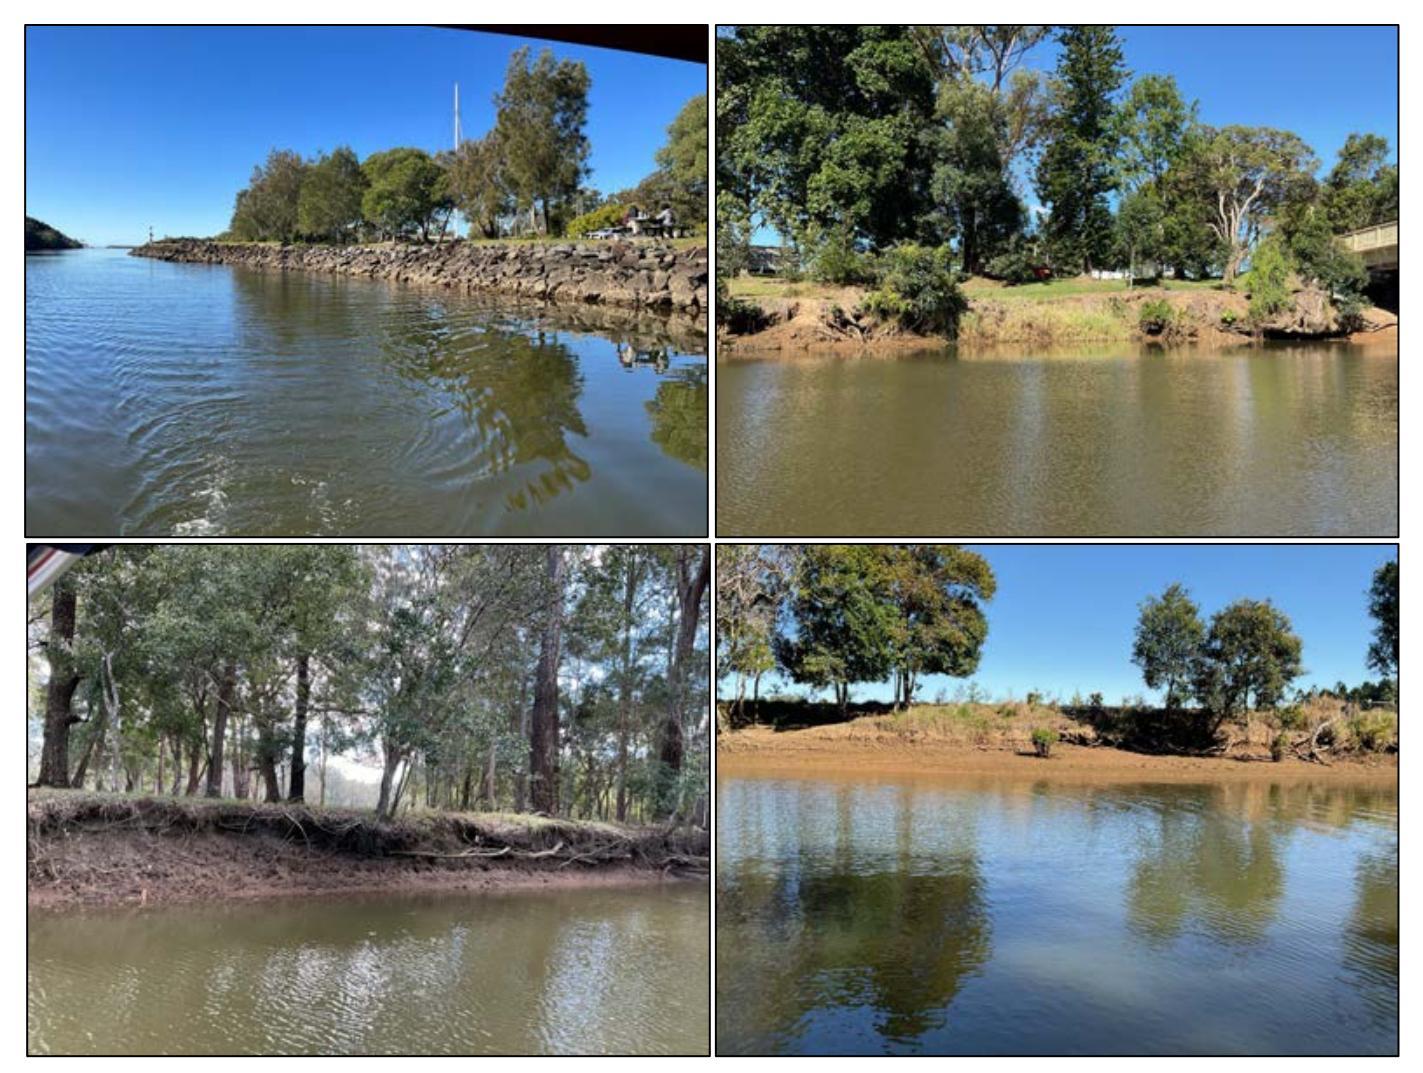
Plate 14Examples of poor condition riparian vegetation: Clockwise from top left, Brunswick River Reach 146,
Brunswick River Reach 191, Brunswick River Reach 94, Kings Creek Reach 56.

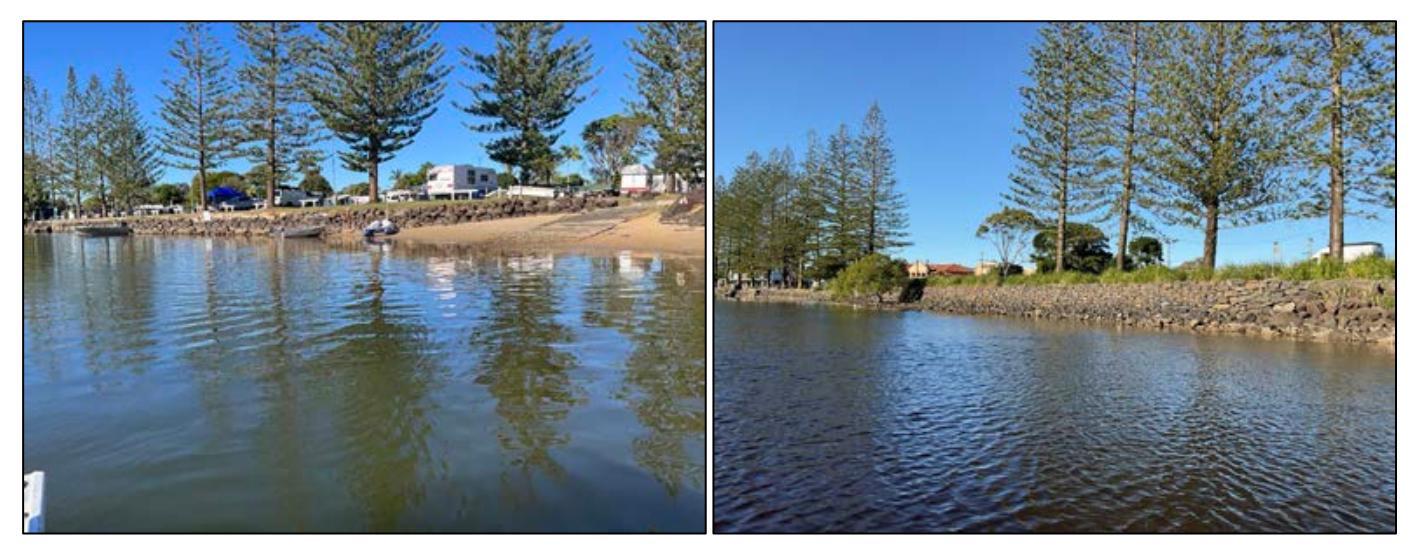
Plate 15 Examples of very poor condition riparian vegetation: Left to right, Brunswick River Reach 145, Simpsons Creek Reach 259.

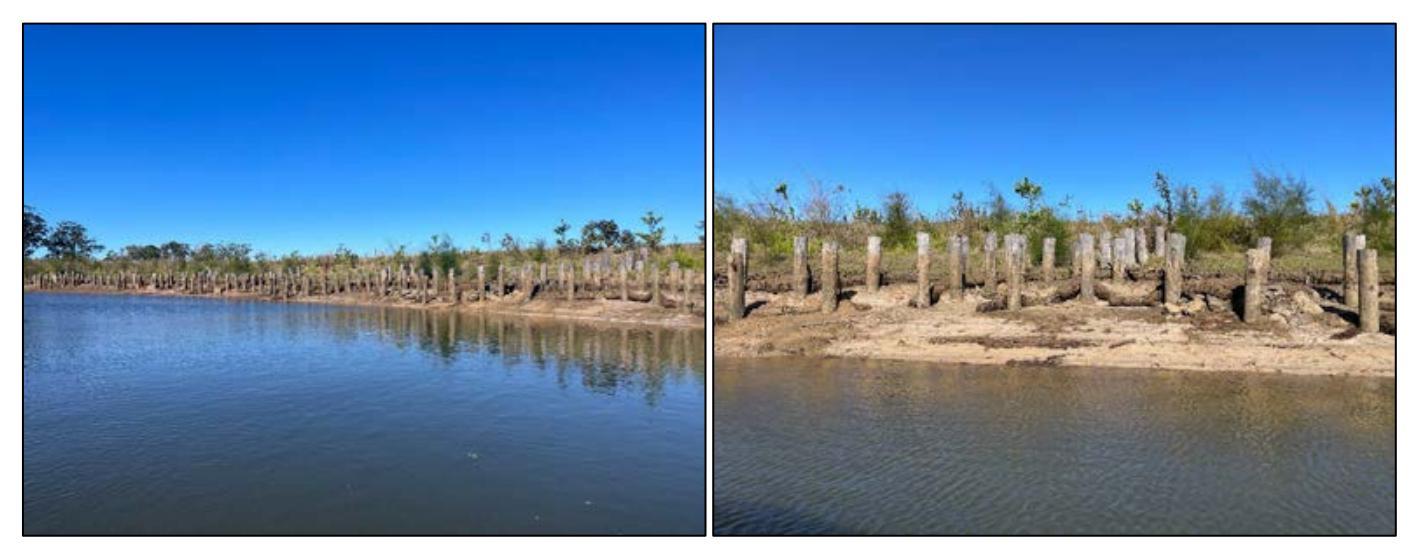
Plate 16 Examples of trial/untested bank protection works in the Brunswick River estuary. These pile field and coir log bank protection works were installed in 2022. Mangroves have recruited in the embayments behind the coir logs but are at risk of undermining as the coir logs have quickly disintegrated below the high tide level. The coir logs were replaced in July/August 2024.

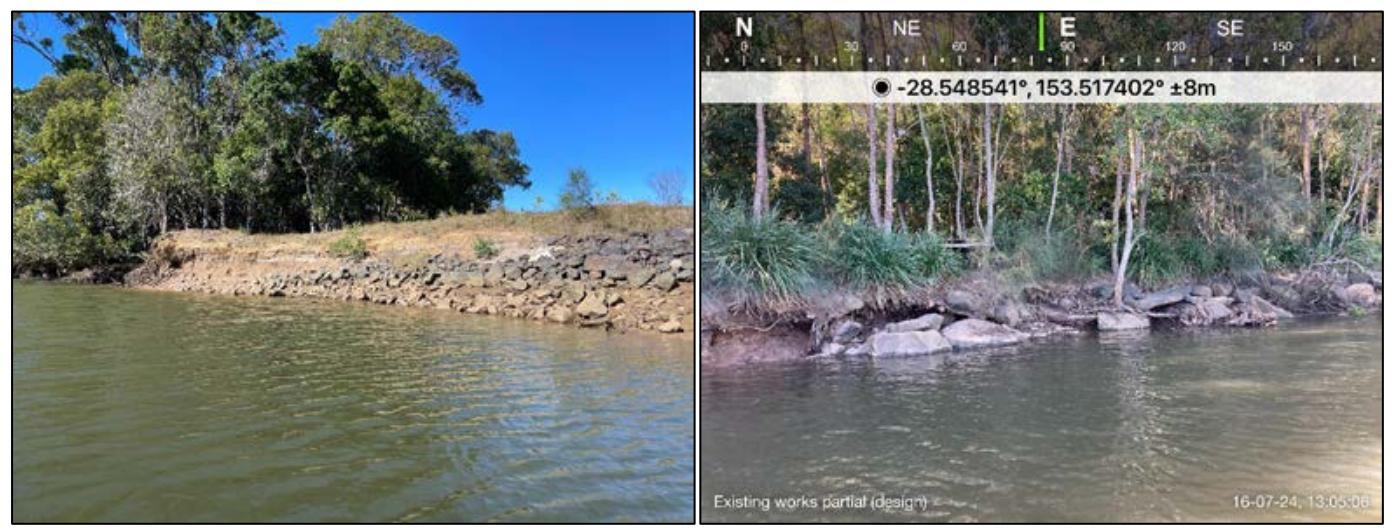
Plate 18Examples of partially effective bank protection (design) in the Brunswick River estuary: From left to
right, insufficient rock blanket thickness and armour toe failure on the Brunswick River Reach 85;
failure of the bank toe and subsequent subsidence on the Brunswick River Reach 71.

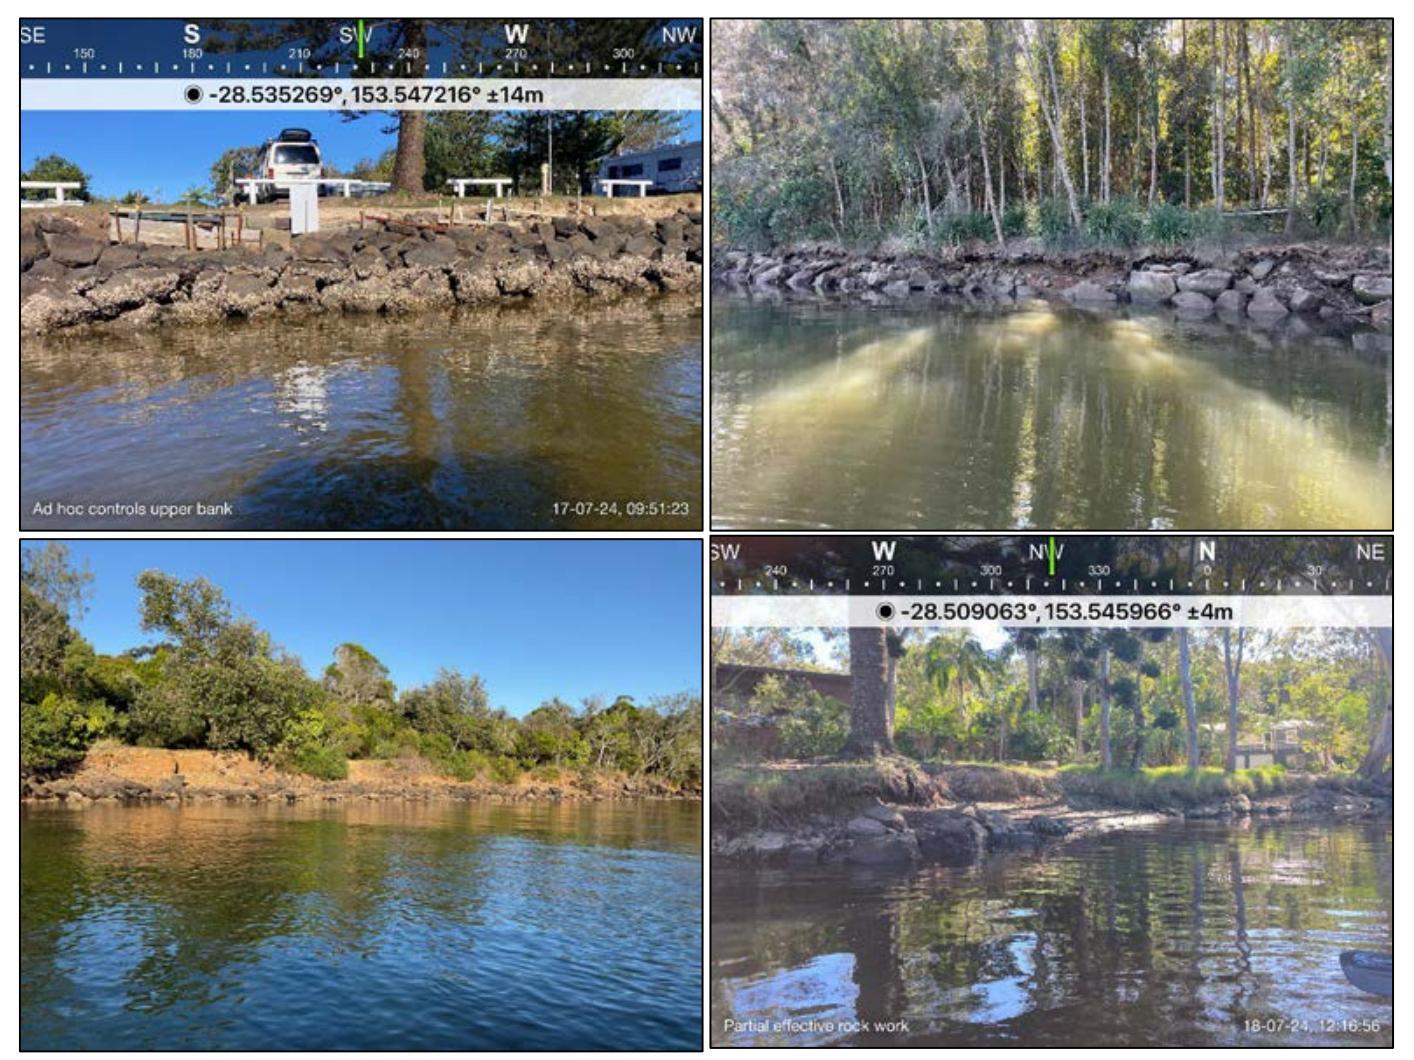
Plate 19 Examples of partially effective bank protection works (condition) in the Brunswick River estuary, From left to right: ad hoc controls above slumped rock revetment in the lower Brunswick estuary Reach 145; subsiding rock works on the Brunswick River exposing upper bank to erosion, Reach 73; partial failure of rock revetment in Marshalls Creek at Reach 311 adjacent to Casons Road, New Brighton; partial failure of rock armouring on the southern entrance wall, Brunswick River Reach 255.

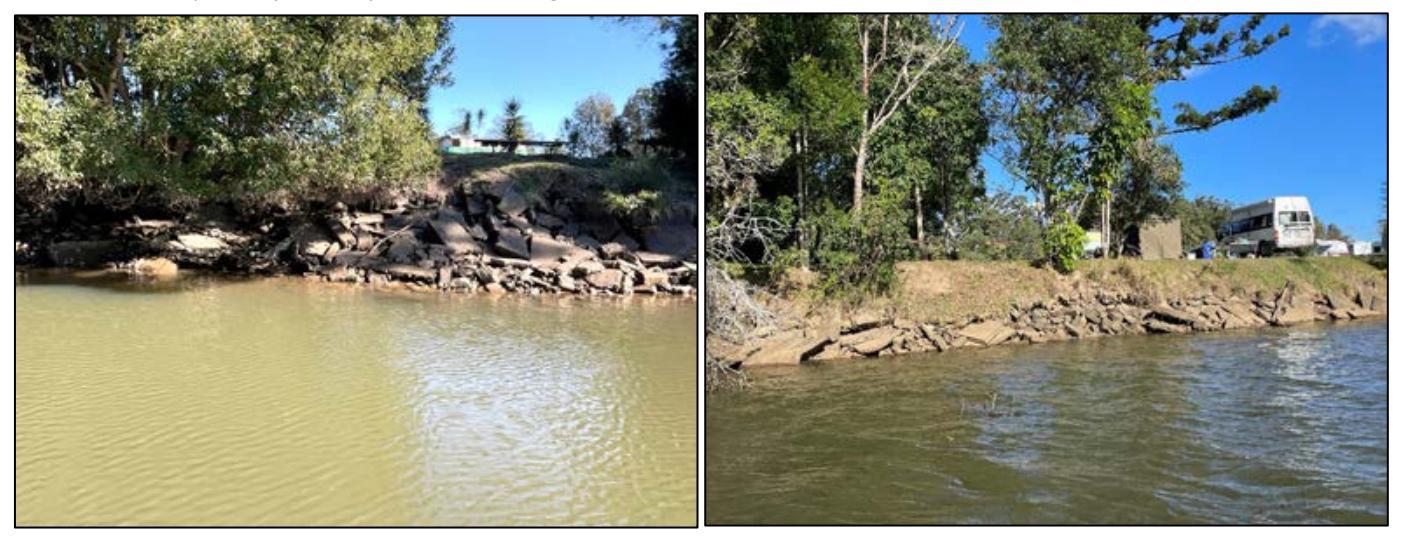
Plate 20 Examples of inappropriate bank protection works in the Brunswick River estuary, from left to right: building rubble dumped over the bank at Reach 61; building rubble as bank protection on the Brunswick River below the rugby club bend, Reach 78.
