LONGWALL HYDRAULIC HAZARDS

WORKSHOP

16 MAY 2007

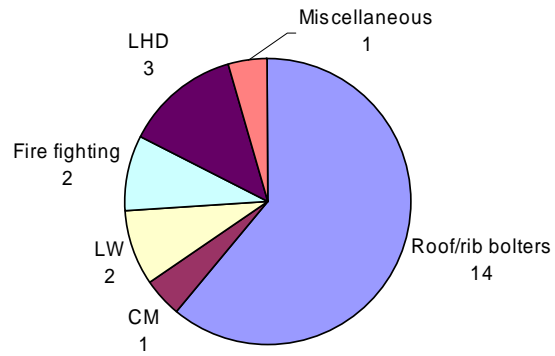
MINE "A"
23 notifications in 15 weeks

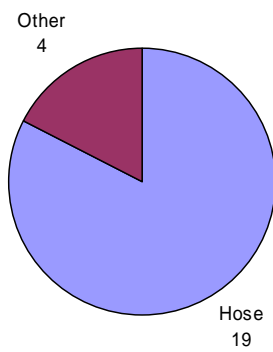
MINE A

TREND: 1.5 notifications per week

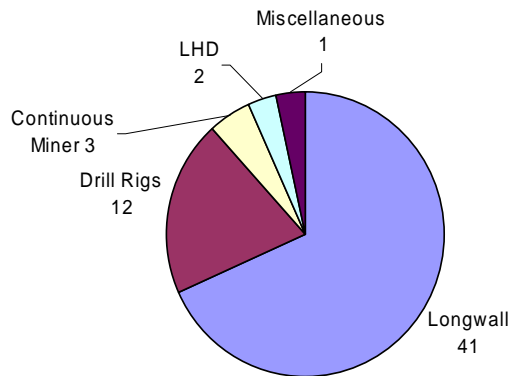
MINE "B"
59 Notifications in 6 weeks

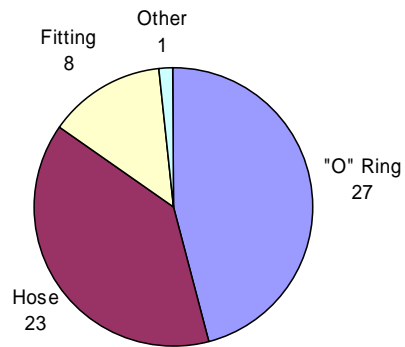
MINE B

TREND: 9.8 notifications per week

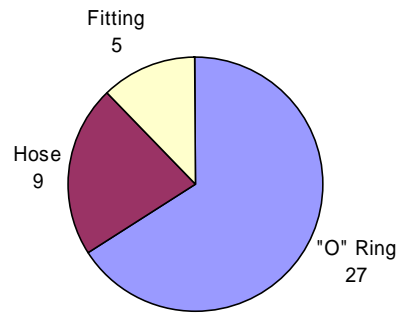
MINE B 41 - LONGWALL

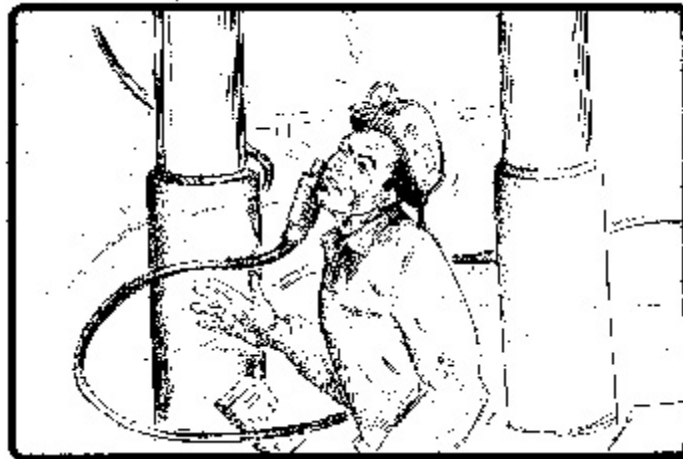
SANBORN CREEK MINE

COAL MINE FATALITY - On Monday, December 4, 2000, a 37 year old longwall tailgate shearer operator, with 13 years mining experience, was fatally injured when he was struck by a broken high pressure hydraulic line. The victim had completed a mining pass and was standing on the toes of the No. 76 shield when a high pressure hydraulic fitting broke in half allowing a fifteen foot length of line to swing wildly in the shield walkway. The line was attached to the underside of the No. 74 shield above the walkway. The 1-1/4 inch, 4500 psi. line, with approximately 15 pounds of couplings attached to the end, struck the victim in the face and head. A second miner in the general area was knocked down and received minor injuries.

- All high pressure hoses should be guarded and/or secured against uncontrolled whipping motion in the event of a failed hose or fitting.
- All high pressure hoses should be located to minimize the risk of exposure to miners from failed fittings and/or rupture.
- Safety chains or suitable locking devices should be used at connection points of high pressure hoses.
- When possible, minimize the amount of connection points on high pressure hoses where miner exposure is the greatest.
