SAFETY ALERT

ELECTRIC SHOCK FROM CIRCUIT BREAKER

Report No: SA 04 10

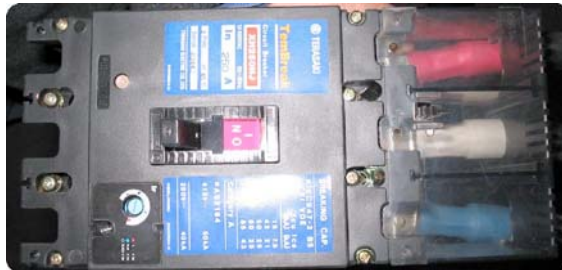
The circuit breaker was indicating that it was in the "OFF" state. The electrician was planning the installation of cables to the circuit breaker when his hand made contact with the exposed load side terminals. These terminals were found to be energised at three phase 415V.

The circuit breaker had previously been dismantled to fit an internal accessory. The circuit breaker appears to have been incorrectly reassembled.

The label showing "OFF" and "ON" had been fitted in reverse. Whenever the circuit breaker was indicating "OFF", it was in fact closed.

1. All operations should have a "Test Before Touch" policy.
2. The policy should ensure that electricity workers prove circuits are de-energised before working in proximity to them by using a fit for purpose multi meter and / or non contact voltage detecting device.
3. All operations should review commissioning procedures for electrical installations to ensure that commissioning tests are conducted for new, modified and repaired installations in accordance with relevant legislation and standards.
