SAFETY ALERT

Lucky Escape from Underwater Truck

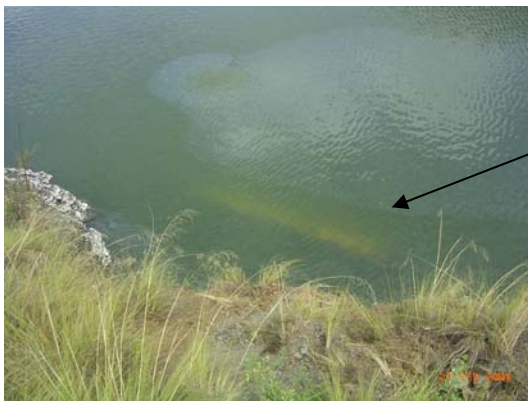
As the truck approached the haulroad descent the operator lost control of the vehicle. Brake application and evasive steering action failed to prevent the truck from rolling over an 8m embankment before coming to rest in approximately 7 metres of water. The operator was able to escape from the cabin and swim to the surface.

Truck submerged approximately 3 metres underwater. (Note: The truck is lying on its side with the cabin extending towards the top of the page).

The incident is currently under investigation by NSW Department of Primary Industries officers. The truck has not been recovered from the water so specific causal factors are still not fully understood.

In light of a number of similar incidents, particularly SA05-10, all mines should immediately review their haulroad operating conditions, as well as previous recommendations, including;

- Fit-for-purpose barriers, such as bunding or windrows, are in place to prevent uncontrolled mobile plant going over embankments.
- Haulroad design and maintenance is consistent with sound industry and engineering practices.

- Haulroads that are redundant or not suitable for use should be barricaded or sign posted to avoid inappropriate access.
- Operators are trained and assessed as competent using a formal, documented system.

- Mobile plant operators are regularly reminded of correct speeds, gear selection and braking procedures.
- Seatbelts are fitted in accordance with MDG 15 *Guidelines for mobile and transportable equipment for use in mines*, and are worn (SA06-07).

- Vehicles are regularly assessed as 'fit for purpose' against MDG 15 requirements.
- Risk assessments and safe work procedures are reviewed to ensure all potential hazards associated with earthmoving activities, particularly haulroads, have been identified and controlled.
