Staple Retention and Outcomes

Longwall Hydraulic Hazards Workshop

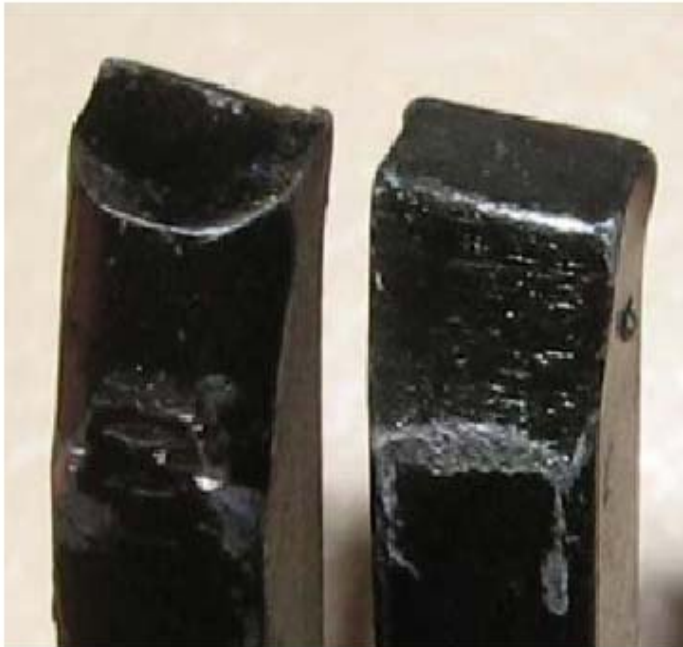
Other Causes

- Geometry of delivered staples varies widely compared to standard
- Stapled finish varies widely (notches etc.)
- Generally considered as a simple consumable

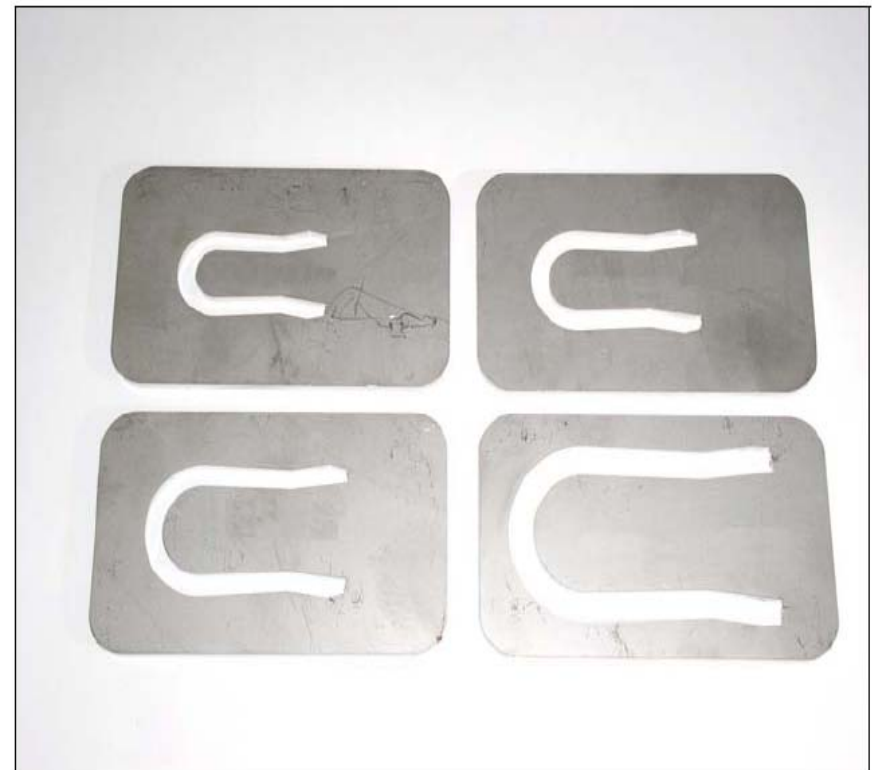
New DBT Stainless Steel Staple

- Determined from Research that a new staple was required that:
 - Had the appropriate hardness.
 - Was corrosion resistant.
 - Had improved geometry for retention.
- Is already in use at some sites (eg: Ashton)
- DBT is currently replacing all stock with the new Stainless Steel staple
- These will be the **ONLY** staples available from DBT
- End users will be notified by Technical Bulletin

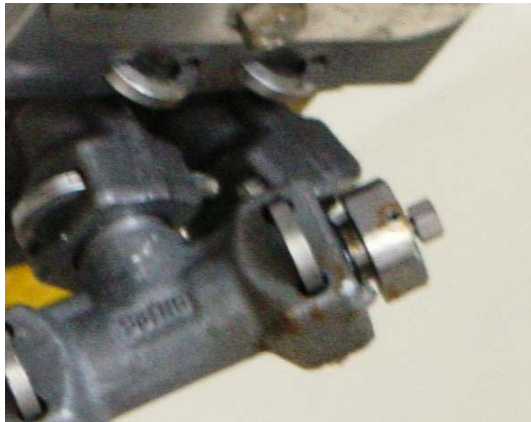
Bleed screws are present on all circuits to dissipate fluids as a final check

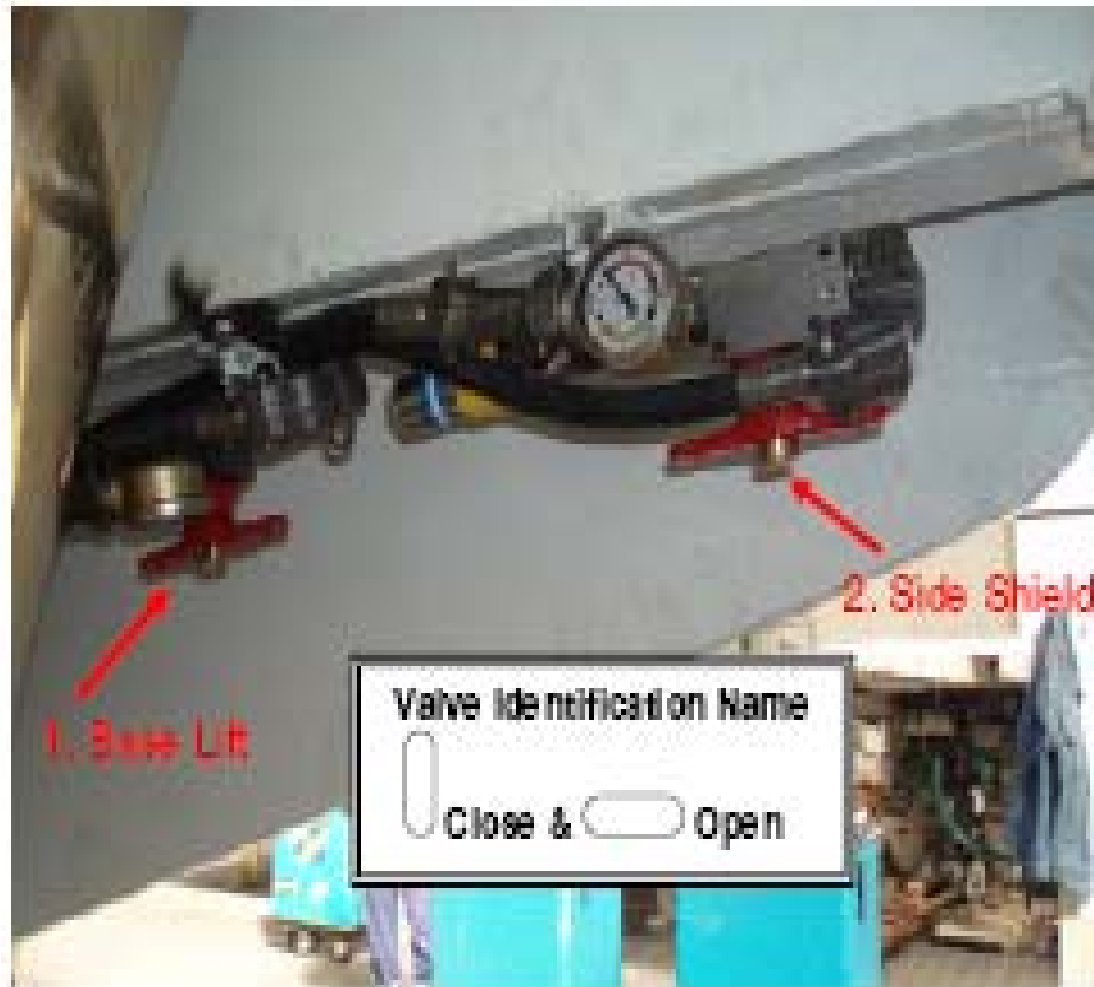
MDG41 – Valve Labelling

- **Some of the evident design variations are**
 - **Addition of hose diffusion sleeve in critical positions**
 - **Addition of hose restraints in critical positions**
 - **Labelled and Lockable isolation valves**
 - **Pressure gauges on each part of the circuit**
 - **Physical barriers between hydraulic components and personnel**
