NSW DEPARTMENT OF
PRIMARY INDUSTRIES

SAFETY BULLETIN

Electrical fuse safety

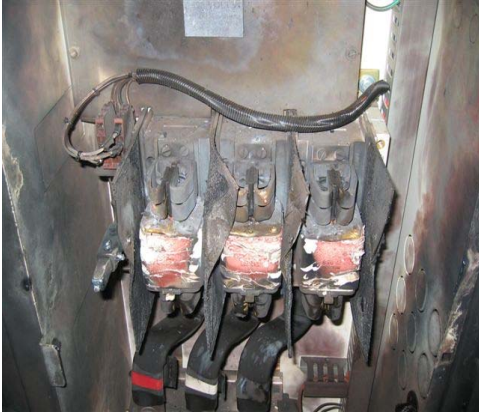
Failure 1: 630 amp 690v fuses
Cat. Bussman Czech 630 NH3G-690

All mines should review all fuses they have in service and all spare fuses at the site. If the above fuses are in use, the mine must contact the fuse supplier for advice, assess the risks and take immediate action to control the risks. Where these fuses are in use, it may be necessary to prevent access to the associated switchgear locations while ever the switchgear is energised, until suitable replacement fuses are installed.

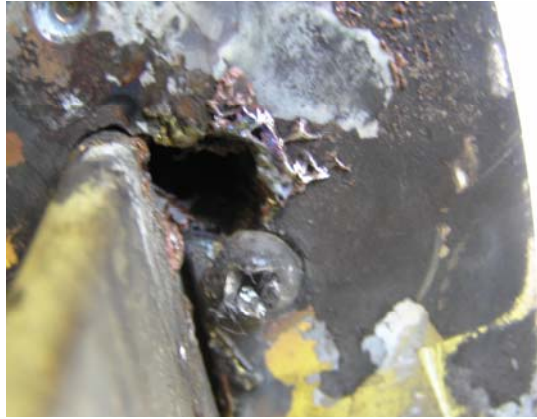
Failure 2: 630 amp 690v fuses
Cat. Bussman Czech 630 NH3G-690

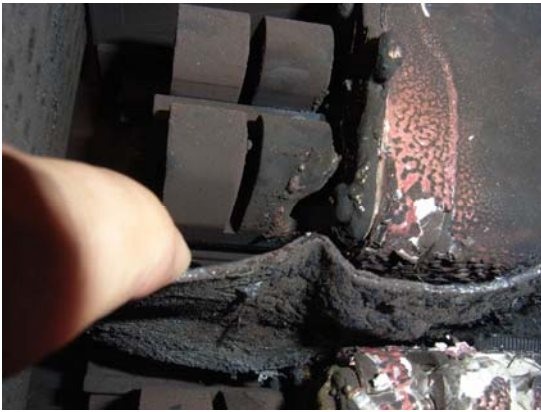
Failure 3: 500 amp 690v fuses
Cat. Bussman OEZ Czeck 500 NH3G-690
