3 Results

3.1 Tomago – Summary of site inspections

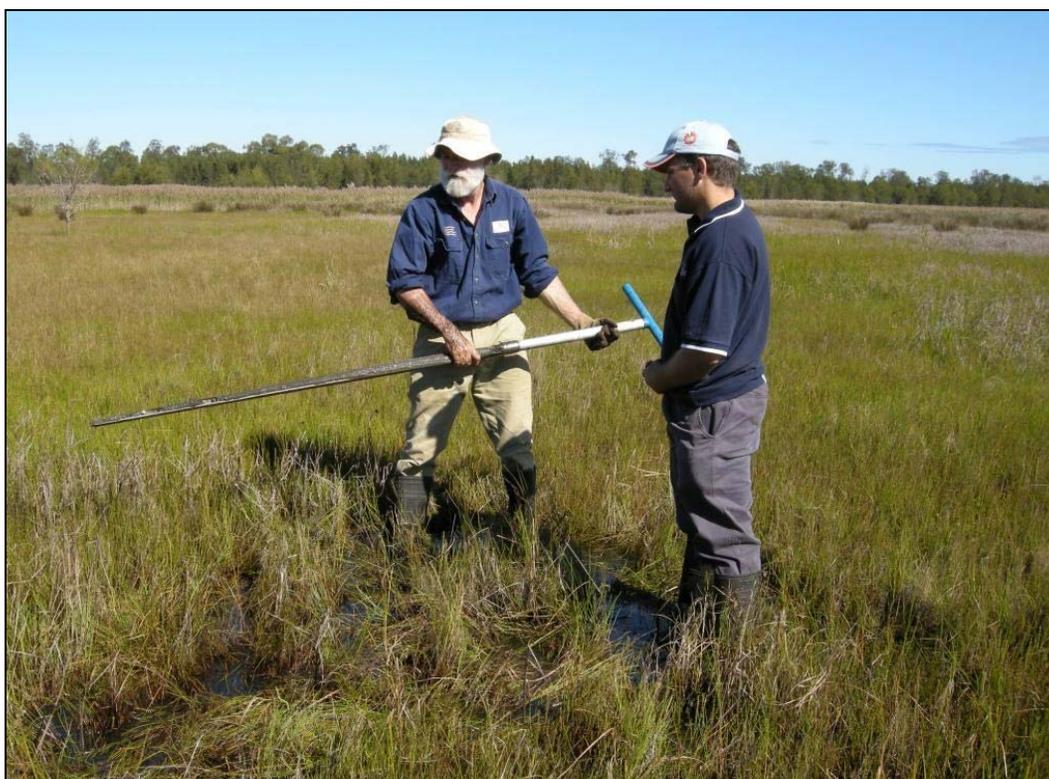
Figure 37: Soil core sampling at Tomago site T6 (photo: J Fredrickson)

It is significant that at site T6 pools of water on the surface contained black rotting vegetation on top of the soil surface, below a layer of orange-stained dead vegetation just under the water surface (which is more aerated than below). When tested in the laboratory water from this shallow pond (10cm deep) was non-acidic (pH 6.3) and severely depleted of sulfate (chloride / sulfate ratio 18.75).

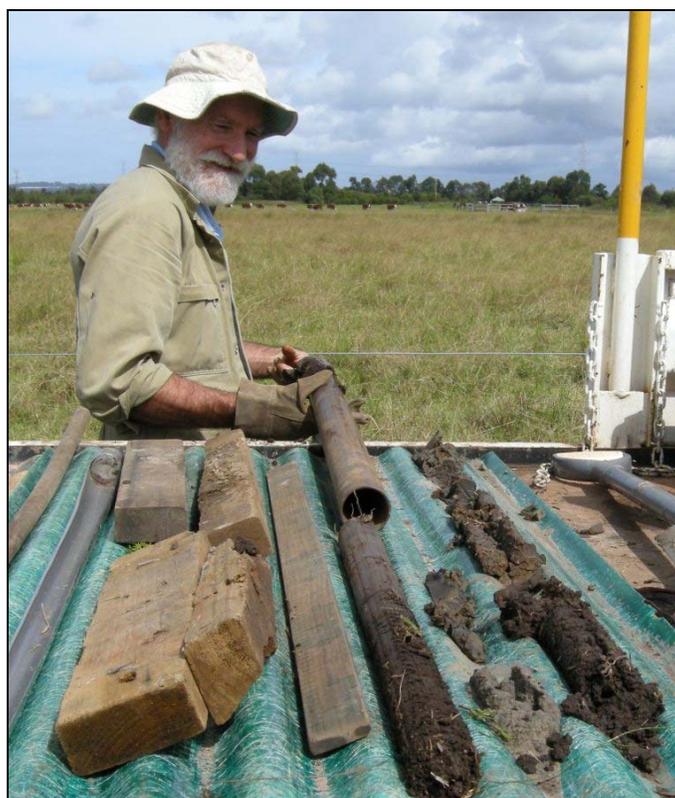
Figure 38: Retrieving a soil core from Kooragang K8 site (Photo: J Fredrickson)

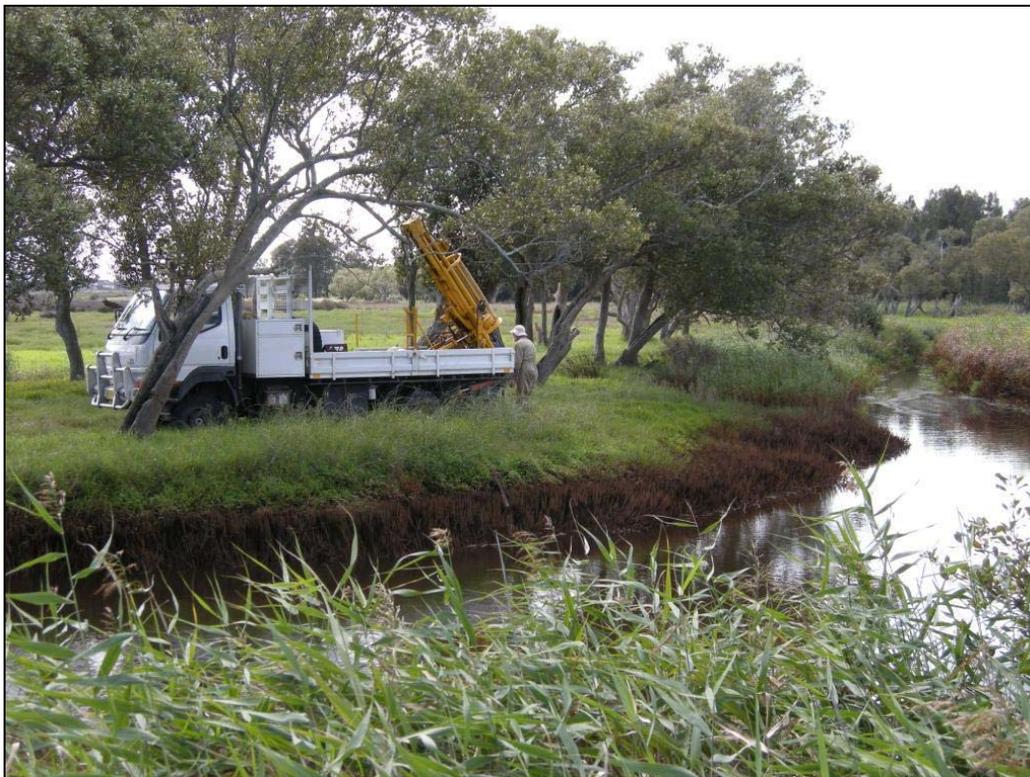
Figure 39: Soil core sampling at Hexham site H1 (photo J Fredrickson)

One remarkable effect on water quality is the effect by the soil on sulfate depletion. At the H1 site both groundwater and water in the nearby drain have depleted sulfate content (the chloride: sulfate ratio is three times higher than in sea water). This is likely to be a result of active iron sulfide formation, due to waterlogging and reducing conditions within the soil profile. This is the reverse of the process of oxidation of sulfides, seen in the high sulfate water at the nearby S2 site.
