Mark Freeman
Investigation Unit
Department of Industry and Investment

Qualitative Observations of OHS Management Systems from Recent Investigations

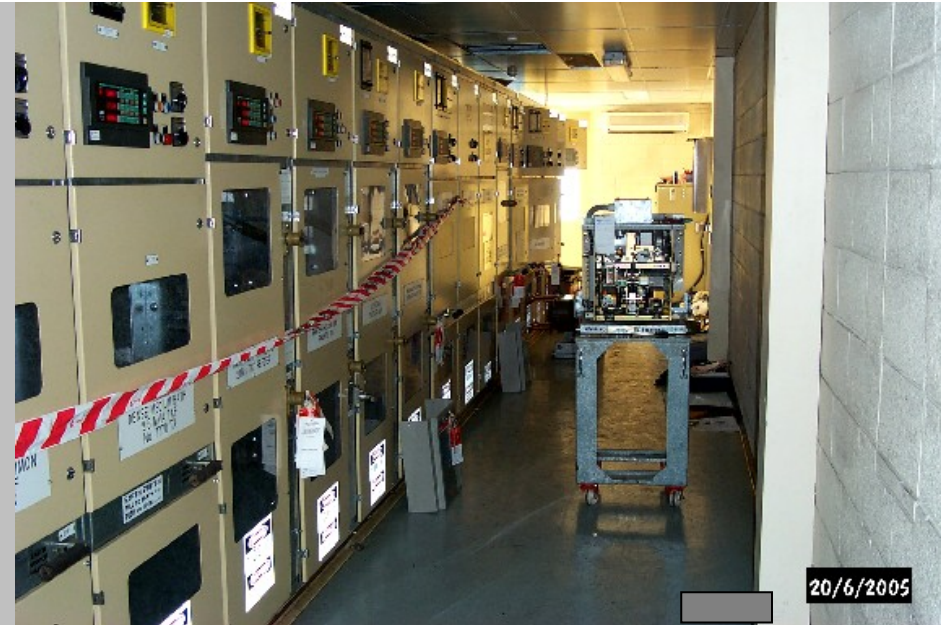
Case study: preparation plant

- Planned mtce in HV switchroom with all power removed
- Last minute, power left on half of the board
- 7 cubicles isolated, and 8 were live
- Contractor contacted live 11 kV bus bars

11kV electric shock,
burns to thumb and
finger

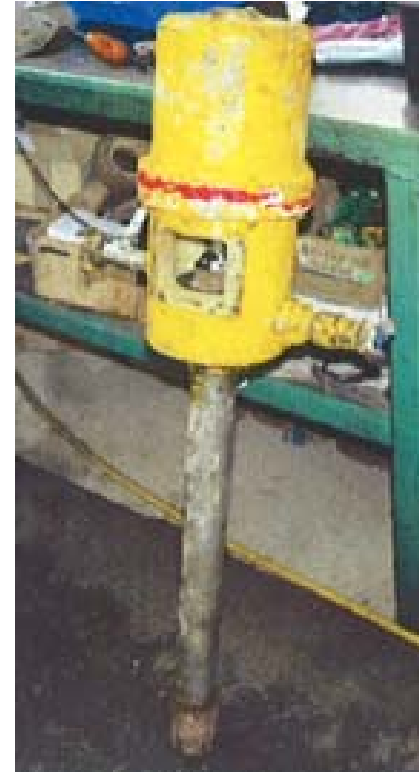
Case study: u/g coal mine

- Grouting roof bolts
- Grout hose blocked up
- Screw driver used to unblock
- Screw driver and grout ejected under pressure
- Grout enters eyes

Serious eye injury

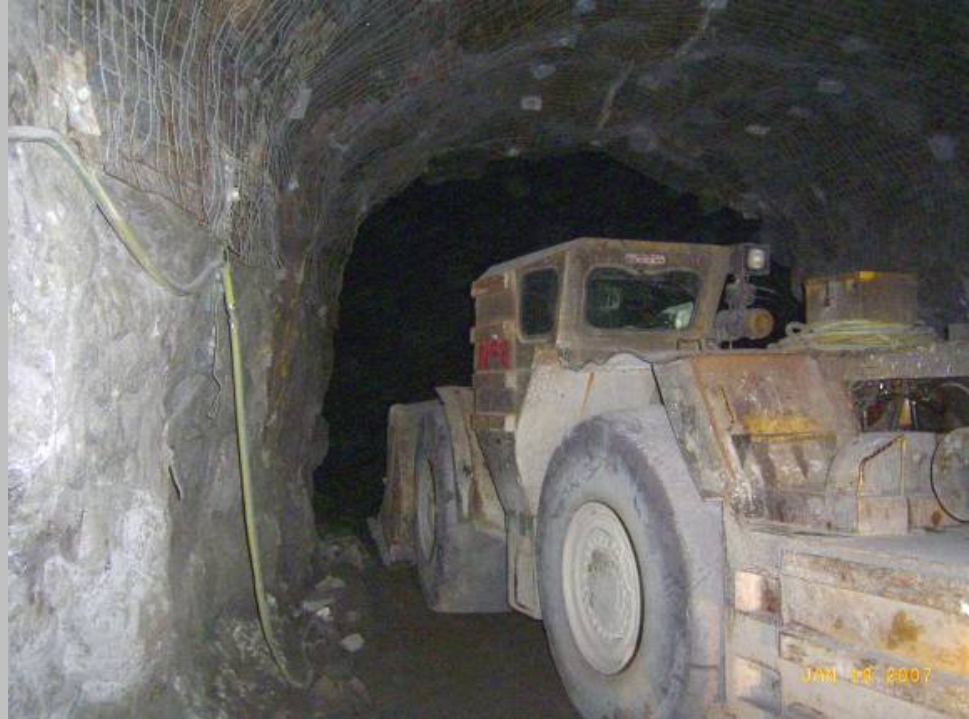
Case study: u/g metal mine

- Operating remote controlled loader to empty a long hole stope
- Attempting to clean around a large boulder in preparation for blasting
- Working alone, found trapped between loader and wall of drive

Fatality

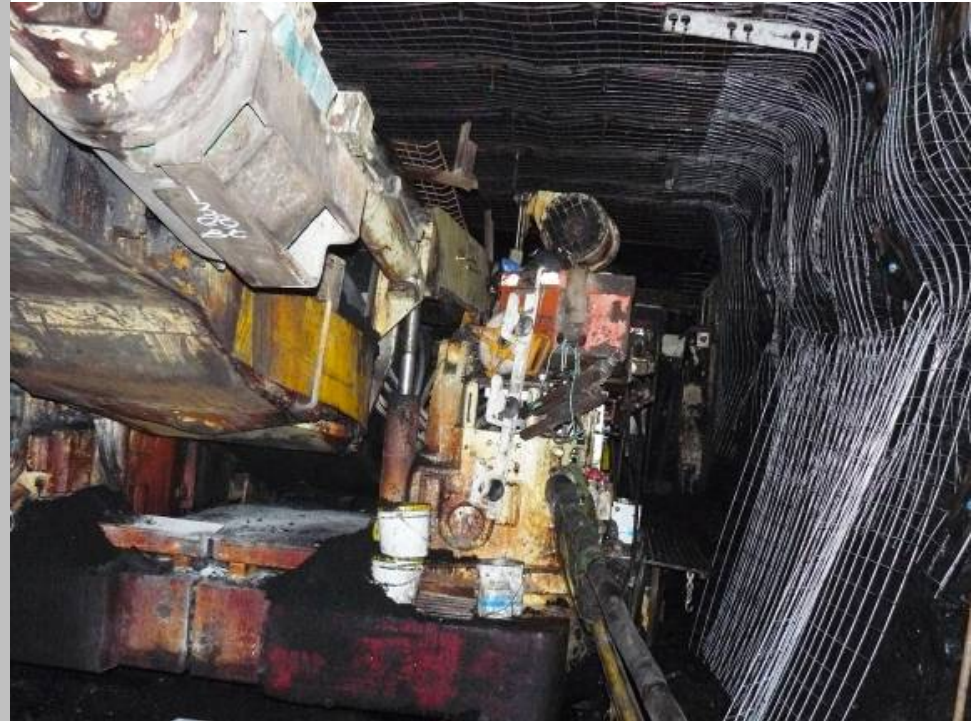
Case study: u/g coal mine

- Operating a continuous miner mounted bolting rig
- Twin wing drill bit caught roof mesh
- Operator's arm became entangled in mesh and wrapped around the rotating drill steel.

Severe trauma to left arm, later amputated
