**REDUCING THE IMPACT OF ROAD CROSSINGS
ON AQUATIC HABITAT IN COASTAL WATERWAYS –
HAWKESBURY-NEPEAN, NSW**

REPORT TO THE NEW SOUTH WALES ENVIRONMENTAL TRUST

**NSW DEPARTMENT OF
PRIMARY INDUSTRIES**

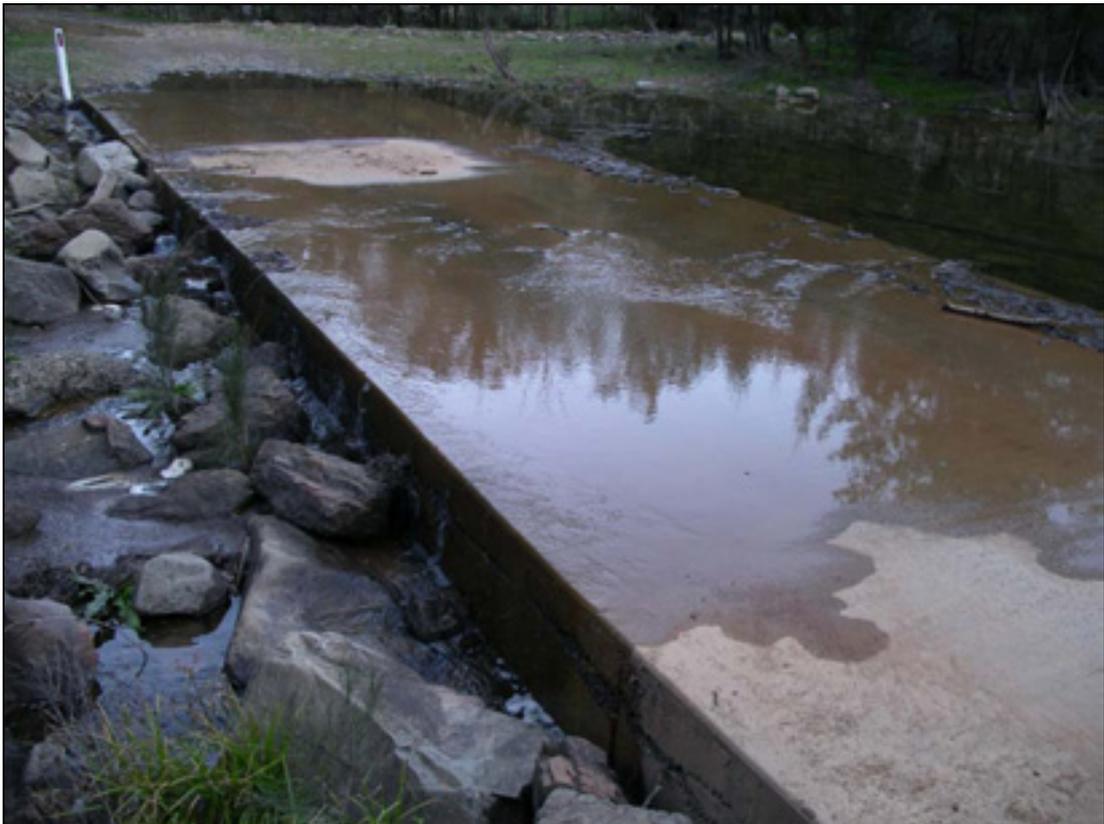
Cover photo: Swallow Tail Pass Fire Trail causeway with excessive headloss over Tarlo River (Upper Hawkesbury-Nepean subregion, Wollondilly River catchment).

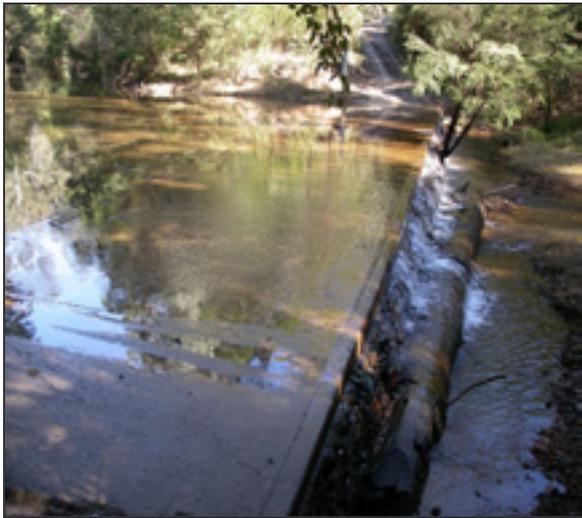
Photo 1. Causeway with high invert (headloss) and shallow water depth (Wheeny Ck, Lower Hawkesbury-Nepean subregion)

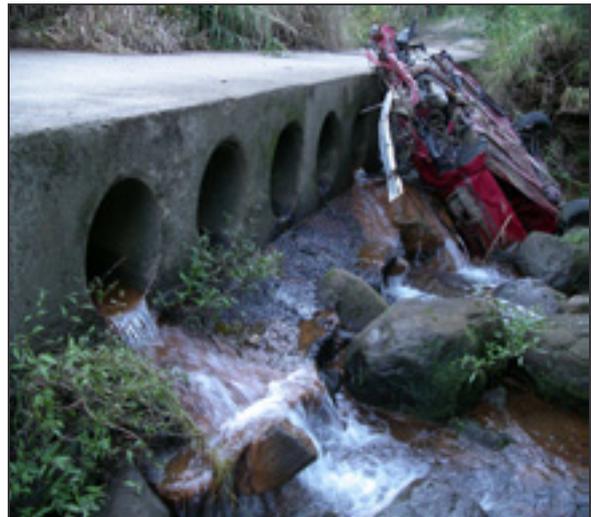
Photo 2. Pipe culvert with high invert (headloss) (Fitzgeralds Ck, Lower Hawkesbury-Nepean subregion)

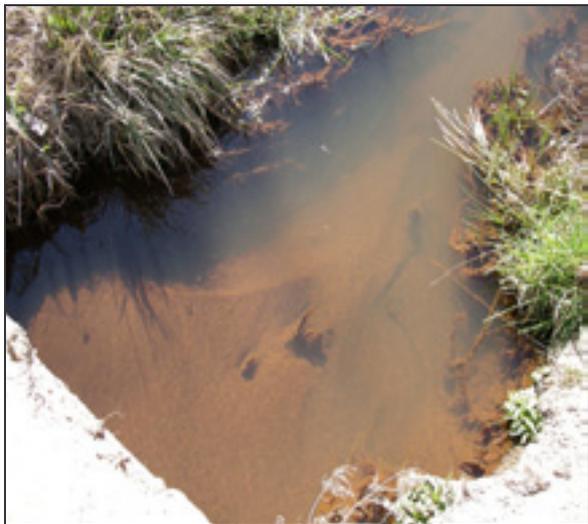
Photo 3. Box culvert on unsealed road producing sediment inputs (Cullenbong Ck, Upper Hawkesbury-Nepean subregion)

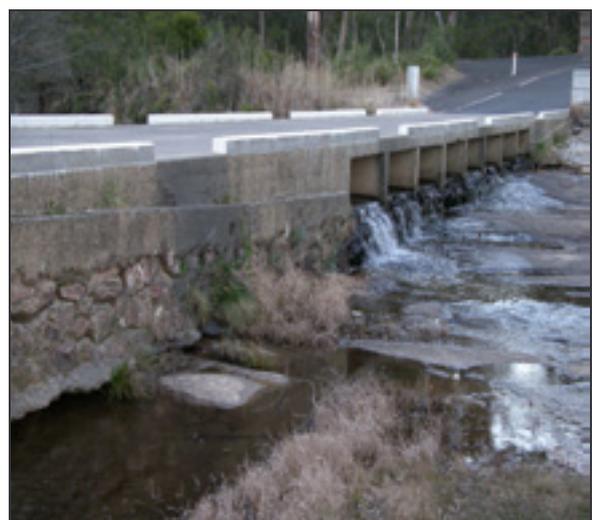
Photo 4. Box culvert with high invert (headloss), and low flow depth (Megalong Ck, Upper Hawkesbury-Nepean subregion)

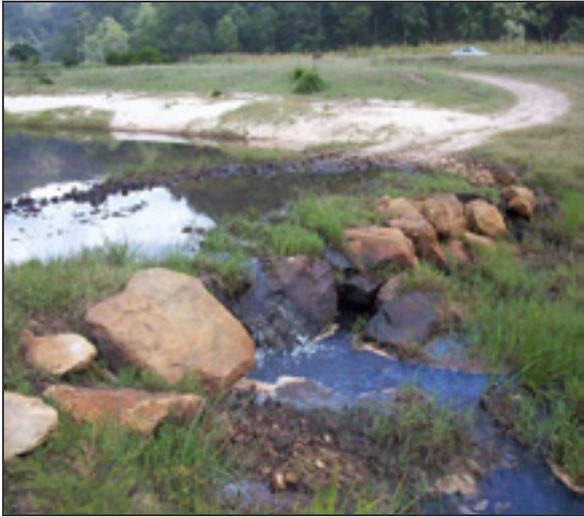
Photo 5. Ford with high invert (headloss)
(Webbs Ck, Lower Hawkesbury-Nepean subregion)

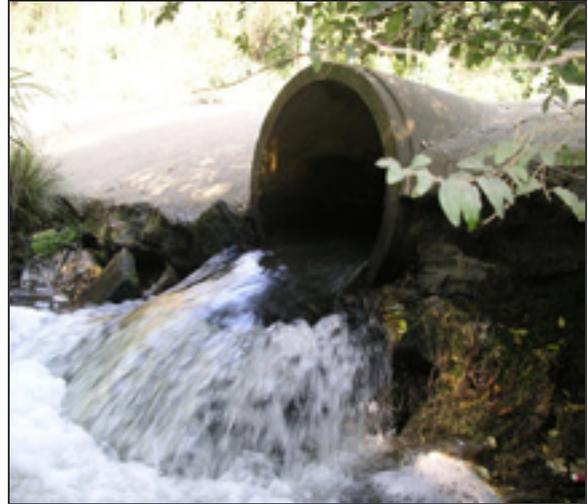
Photo 6. Pipe culvert with high invert (headloss) and
increased water velocities
(Cattai Ck, Lower Hawkesbury-Nepean subregion)

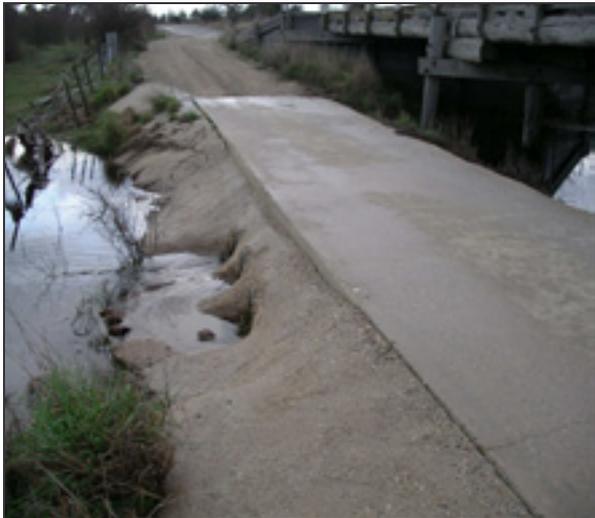
Photo 7. Redundant causeway with inadequate pipes
adjacent working bridge
(Mulwaree R, Upper Hawkesbury-Nepean subregion)

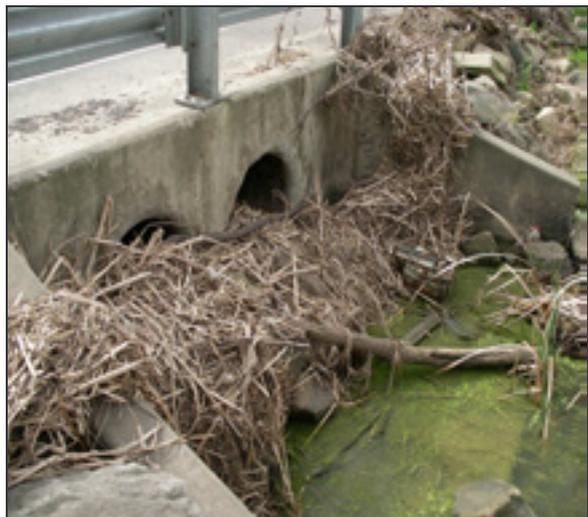
Photo 8. Pipe culvert with excessive debris
(Kemps Ck, Lower Hawkesbury-Nepean subregion)

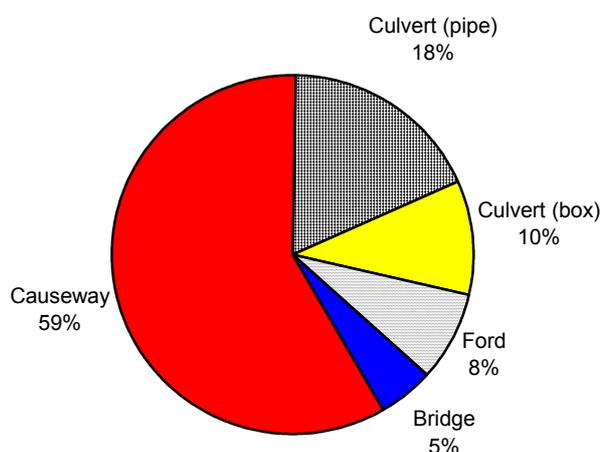
Figure 1. Structure types identified as fish passage barriers in the Hawkesbury-Nepean region.

Several types of road crossings were assessed in the study including causeways, pipe culverts, box culverts, fords and bridges. Several sites identified had combination designs – for example, box culverts placed on top of causeways. Within the Hawkesbury-Nepean region, the most common road crossing barriers identified were causeways (59% of all structures identified), with pipe culverts and box culverts being the next most common barrier types (18% and 10% of all identified barriers respectively – refer Figure 1).

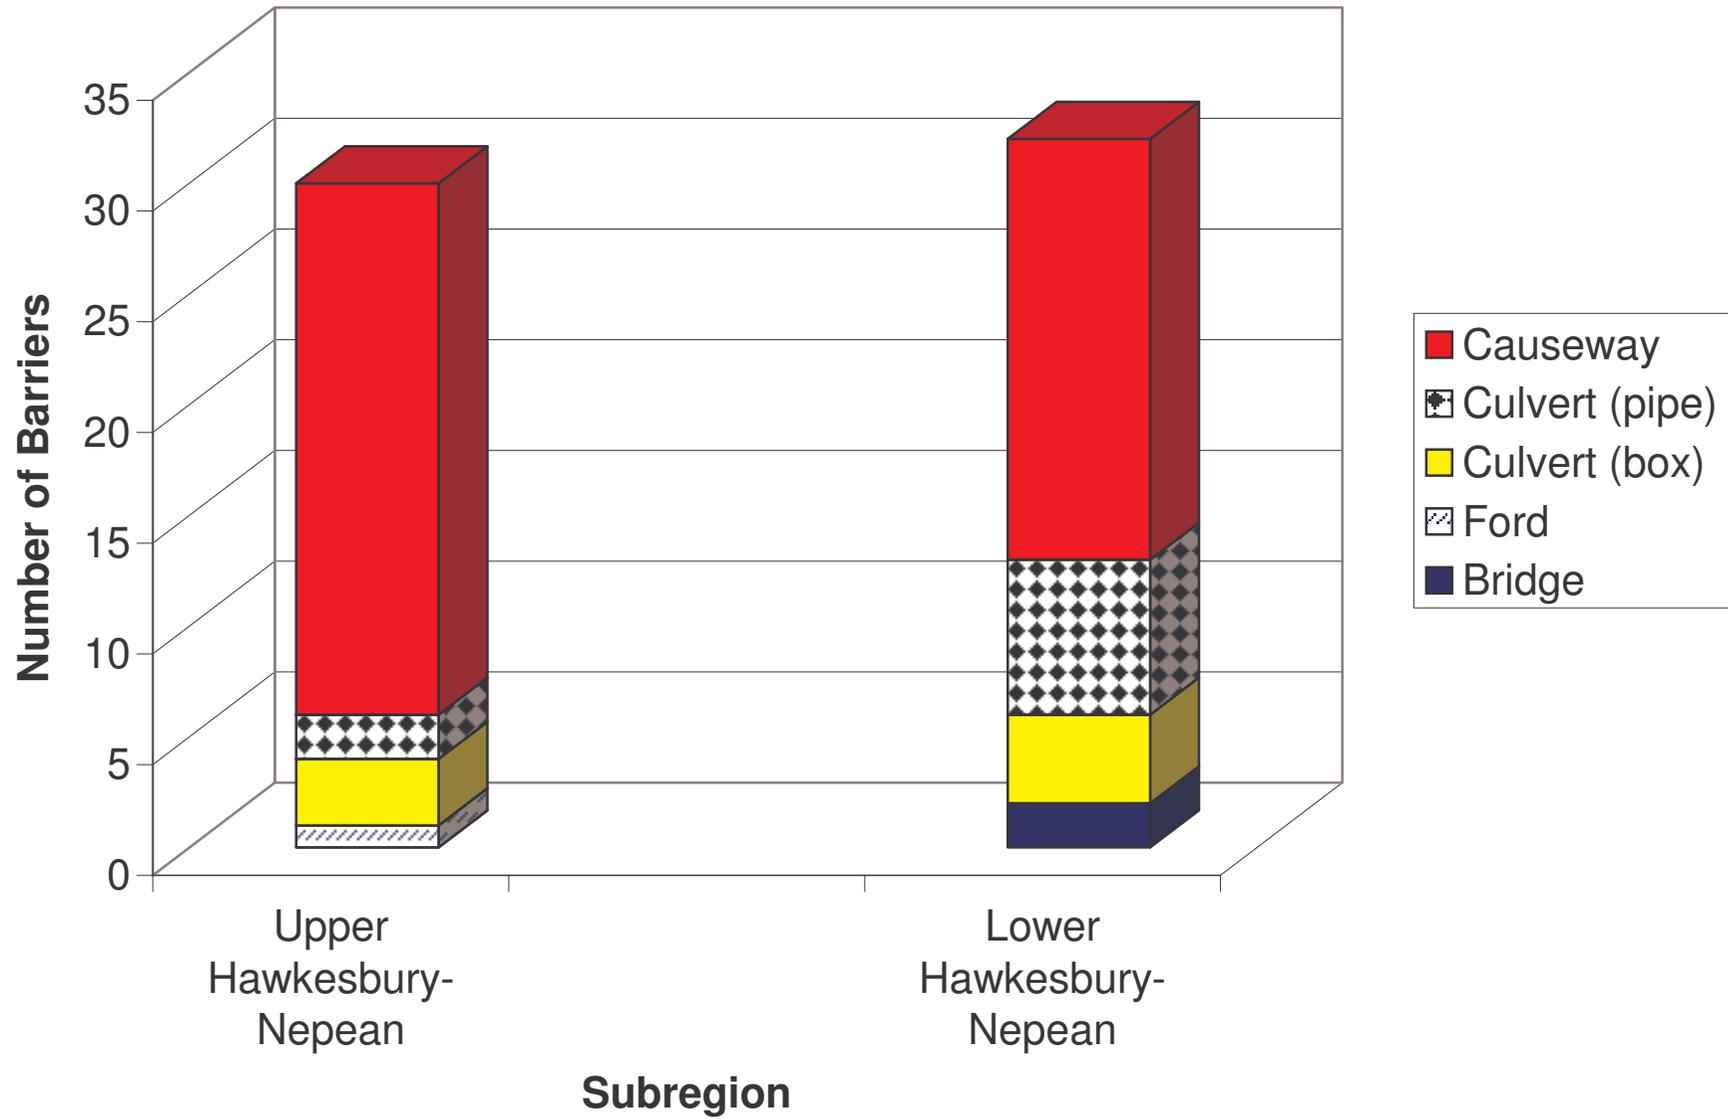
As can be seen in Table 1 and Figure 2, the number of barriers identified and recommended for remediation was relatively even despite the size of the subregion, although the Lower Hawkesbury-Nepean subregion (the larger of the two subregions), possessed marginally greater obstructions both identified and recommended for remedial action.

Figure 2. Fish passage obstructions with recommended remedial actions in Hawkesbury-Nepean CMA subregions.

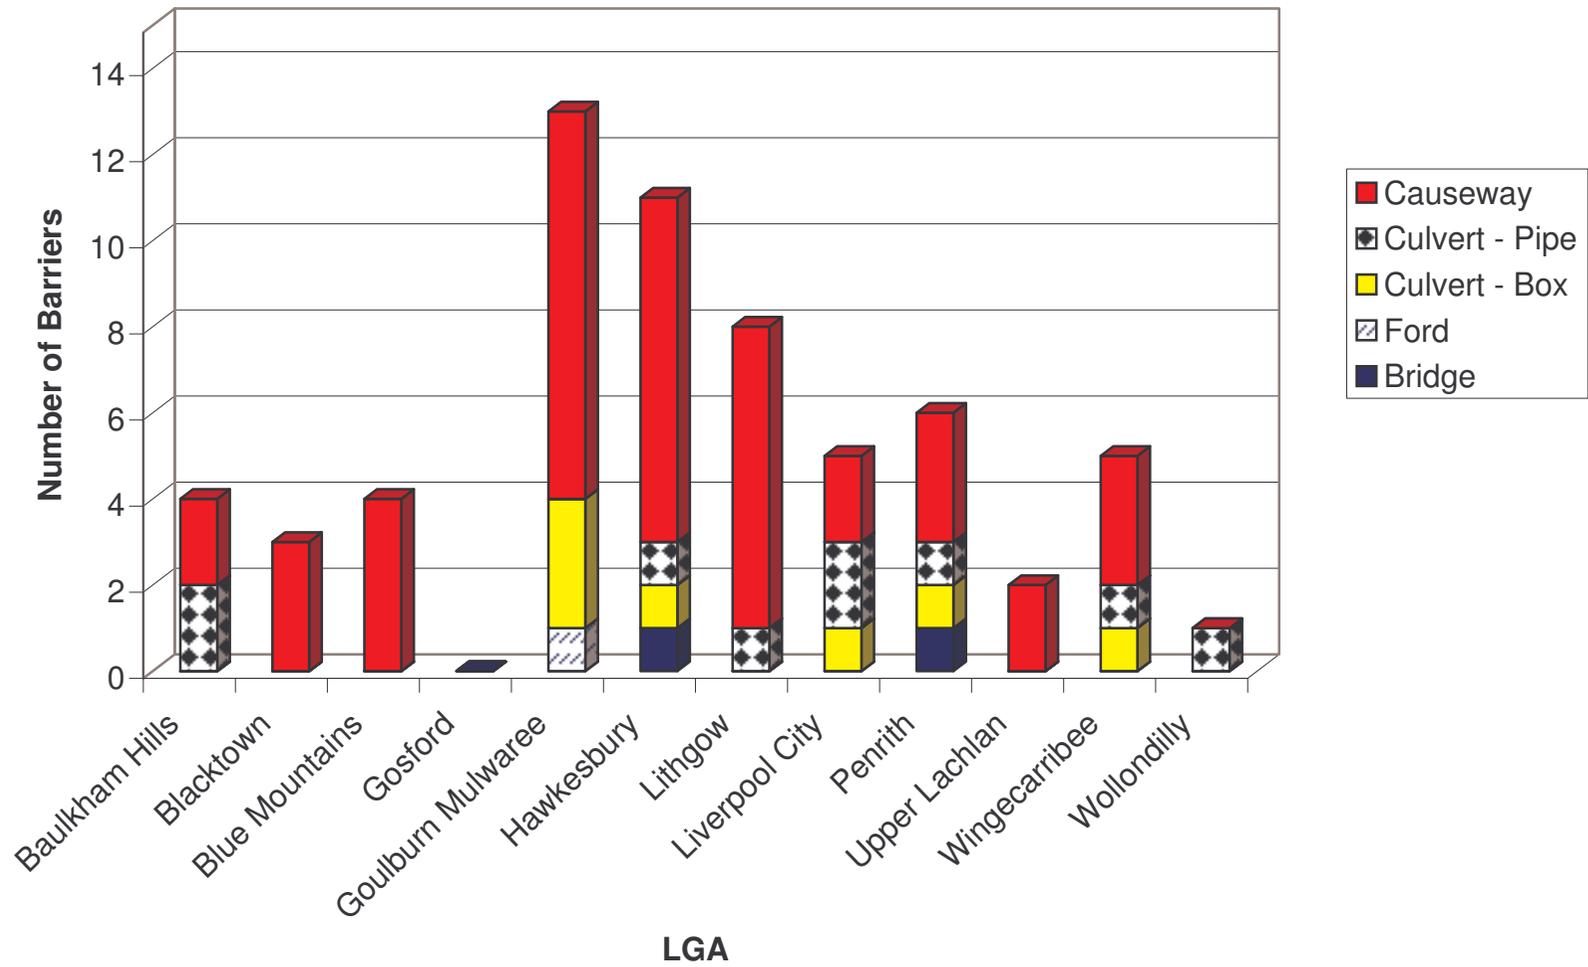
Figure 3. Actioned structure types identified as fish passage barriers in the Hawkesbury-Nepean region by local government authority (LGA).

As shown in Figure 3 and Table 2, the greatest number of sites recommended for remedial action were also within Hawkesbury City (12 sites), City of Lithgow (8 sites), and Goulburn Mulwaree LGAs (8 sites). The vast majority of actioned sites within these three LGAs were located outside of protected areas such as National Parks, State Forests, and Water Supply Special Areas, with many waterways within Goulburn Mulwaree and City of Lithgow LGAs being impacted by rural and semi-urban development, therefore leading to the construction of a greater number of poor crossings. Within the Hawkesbury City LGA approximately half the number of identified sites were recommended for action. This is possibly due to many of the barriers within this LGA being low-level ford crossings and bridges, which are less likely to have a significant impact on fish passage at medium – high flows.

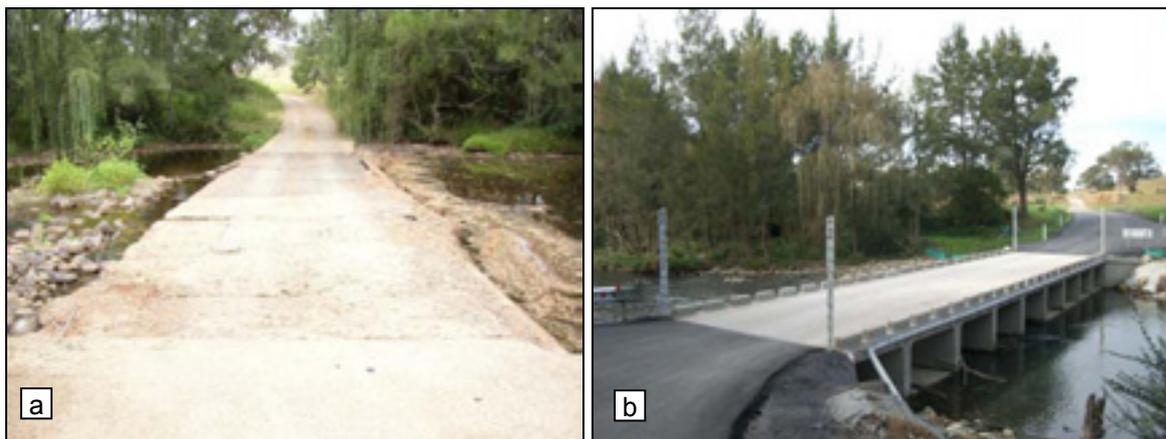
In addition, the provision of low flow cells enable fish to traverse the structure under low flow conditions. A low flow cell is set into the bed of the waterway, so that during low flow conditions this cell is the only one that is inundated. During low flow conditions, water is directed through this cell, with additional cells becoming operable as water levels rise. Surrounding substrate remains in the base of the cell, further minimising the impact of the structure on fish movement by minimising behavioural reluctance to traverse the structure.

Figure 4. Dixons Crossing causeway (Karuah River) prior to (a), and following (b) remediation – note three central low flow cells.

In the Hunter/Central Rivers CMA region, Dixons Crossing on the Karuah River was remediated as part of the demonstration site component of this project in collaboration with the Roads and Transport Authority (RTA), and Great Lakes Council. Dixons Crossing was a low level causeway identified as a fish passage barrier due to excessive headloss and water velocity (through a single pipe culvert) – refer Figure 4a. The structure was remediated through the installation of multiple box culverts with three centrally located low flow cells (Figure 4b). Further information regarding remediation of this site can be found in a companion report (*“Reducing the impact of road crossings on aquatic habitat in coastal waterways – on-ground works component”*).

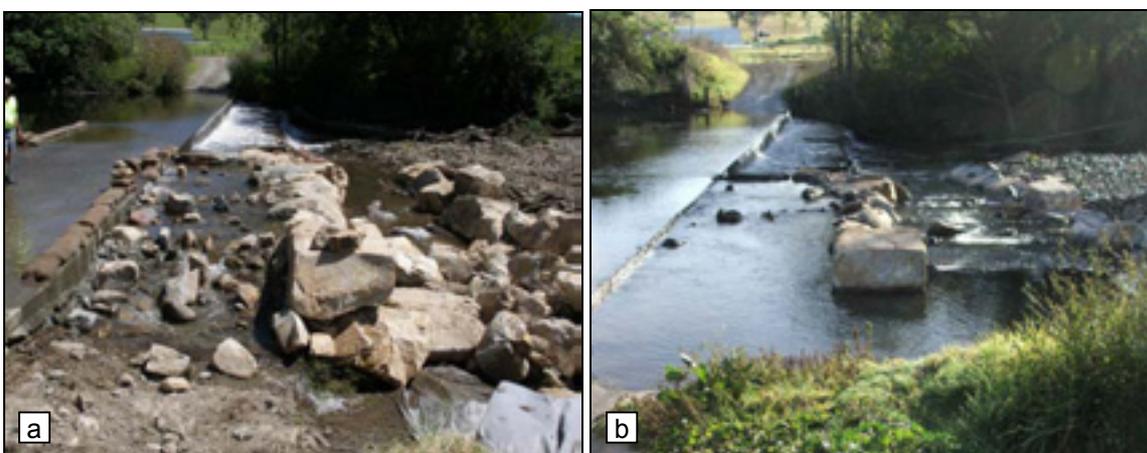
Alternative technologies can also be employed to provide fish passage where traditional methods are unfeasible (e.g. due to funding restrictions). Several causeway crossings on the Gloucester River (Hunter/Central Rivers CMA region) have been remediated by Gloucester Shire Council through the construction of modified partial width rock ramp fishways adjacent the crossings (Figure 5 and Appendix F). These modified fishways run along the downstream edge of the causeway and have their upstream exit at a low flow point on the causeway structure itself (low flow depression in the causeway capping). This means that fish must still negotiate a shallower section of water across the top of the causeway.

Figure 5. Faulkland Road Crossing modified partial width rock ramp fishway (a) during construction, (b) completed work.

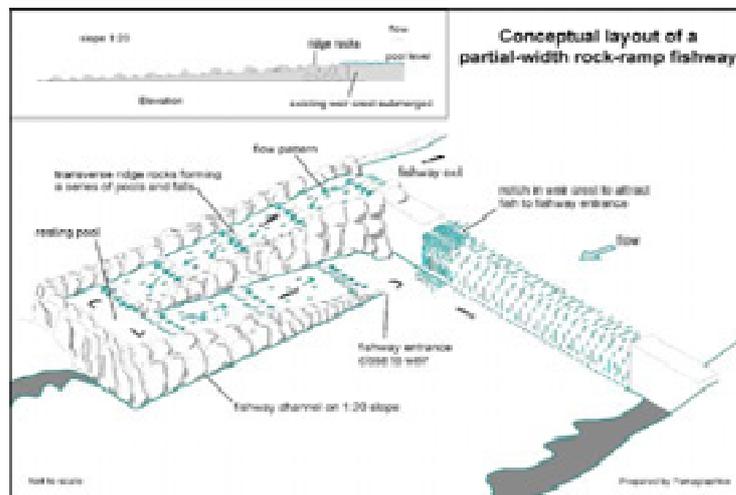
Two variations of this form of fishway are employed in Australia – the partial width rock ramp fishway (below), and the full width rock ramp fishway. As the name implies, the partial width rock ramp fishway only extends part way across the width of a waterway, with water directed down a defined channel; whereas a full width rock ramp fishway extends the entire width of a waterway, with low flows being directed down a defined channel, and moving out from this channel as river flows increase.

In the Gloucester Shire Council LGA (Hunter/Central Rivers CMA), modified versions of the partial width rock ramp fishway have been employed at causeway road crossings, with the upstream exit of the fishway meeting the downstream edge of the road cap at a depression in the road surface. This modified fishway provides a means for fish to reach the road surface, but fish passage remains limited to rising flows when water depth across the road surface is increased.
