REDUCING THE IMPACT OF WEIRS ON AQUATIC HABITAT

NSW DETAILED WEIR REVIEW

SYDNEY METROPOLITAN CMA REGION

NSW DEPARTMENT OF
PRIMARY INDUSTRIES

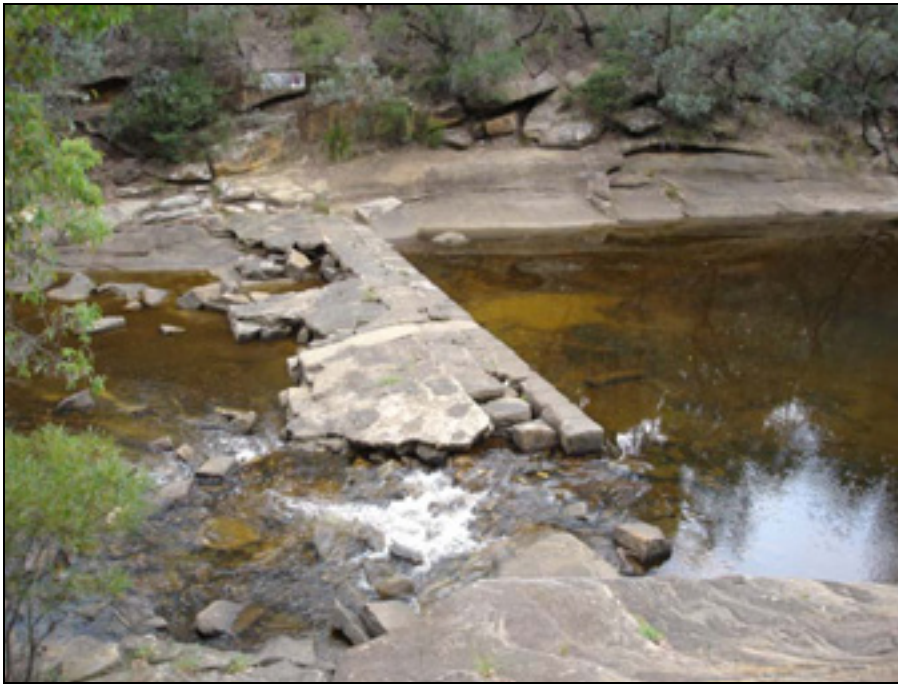
Figure 1. Testers Weir (Ingleburn Weir), Georges River (27/01/2005).

Testers Weir (Ingleburn Weir) is owned by Campbelltown City Council and is located adjacent to the township of Ingleburn in the Georges River catchment, approximately 35km upstream of its mouth at Botany Bay. The structure is a fixed crest weir constructed of sandstone blocks and concrete grout, and is approximately 0.75 metres high and 11 metres across the length of the crest (Figure 1). At present there is a 1-1.5 metre breach adjacent to the left abutment. During low to medium flow conditions the weir restricts fish passage due to excessive slope gradient and minimal flow depth through the breach. During high flows the weir restricts fish passage due to headloss and excessive flow velocity through the breach. This weir resides in Ingleburn Reserve, which is frequently visited by picnickers and bush walkers.

Although Testers Weir is breached and can provide limited fish passage at low and high flows, it is recommended that fish passage remediation activities be investigated to improve the frequency of fish passage past this structure.

The premise behind rock ramp and vertical slot fishways is to create a series of pools separated by small steps, so that an overall slope of 1:20 is created to provide fish passage. A partial width rock ramp fishway could be installed at the breach and utilise local rock (loose sandstone) from the weir breach. The cost of a fishway at this site is somewhat exacerbated however, due to the difficulty of accessing heavy machinery to the river. The fishway design would need to be operable under a wide range of flows, also potentially increasing costs however, if some of the rock rubble could be removed from the breach a smaller, more simplistic partial width rock ramp fishway could be installed below the breach. This would both cheapen costs and significantly improve fish passage at this site.

At present the rock rubble debris forms a barrier to fish passage at low-medium flows due to a steep slope gradient at the breach. By manipulating the rock debris where the gradient is steepest, the gradient could be lowered and fish passage reinstated. Works would not compromise the heritage status of this site, as all material would remain in place (although some would be repositioned). Modification of existing breach rubble is considered the cheapest of all alternatives currently available, despite potential issues with machinery access. This is the recommended option for this site, with further discussions recommended between NSW DPI and Campbelltown Council to determine machinery access issues.

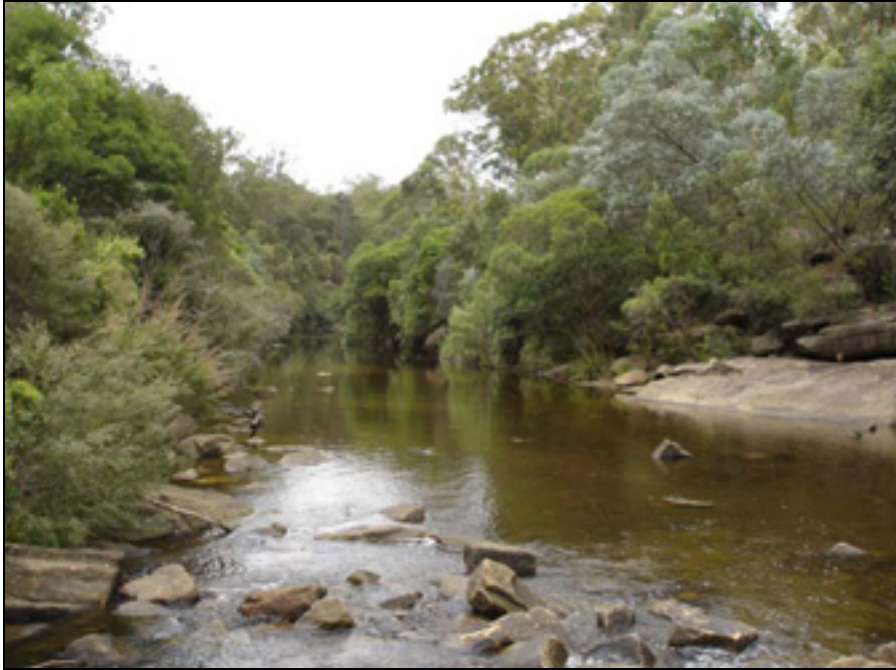
Figure 2. Georges River downstream of Testers Weir (27/01/2005).

The Georges River contains important fish habitat components including riffles, large deep pools and cobble beds (Figures 2 and 3). The site has well vegetated banks with minimal erosion due to a rocky substrate. At the time of inspection aquatic vegetation was not present at this site, whilst riparian vegetation was dominated by banksias, matt rush, and small stands of eucalypts.

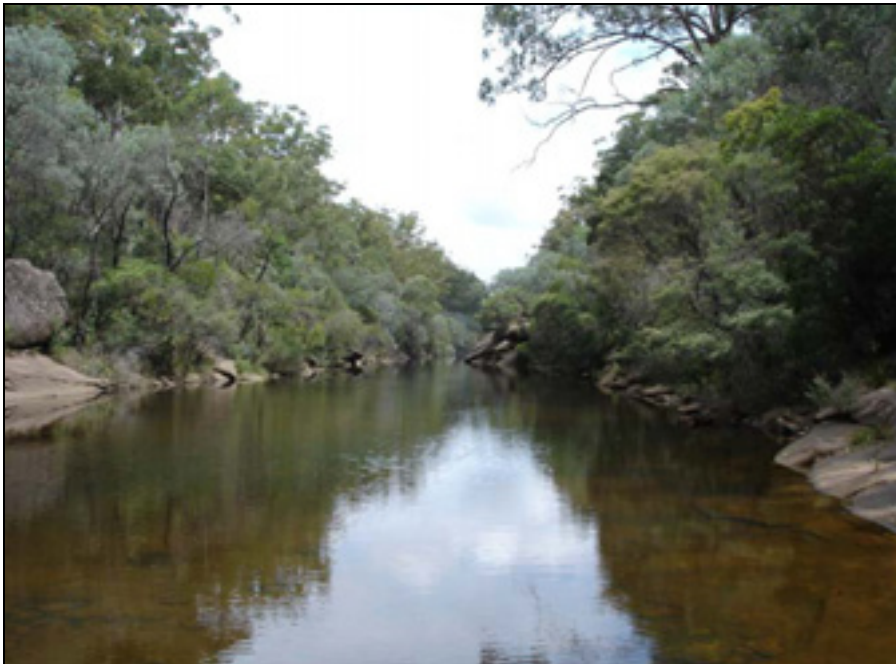
Figure 3. Georges River upstream of Testers Weir (27/01/2005).

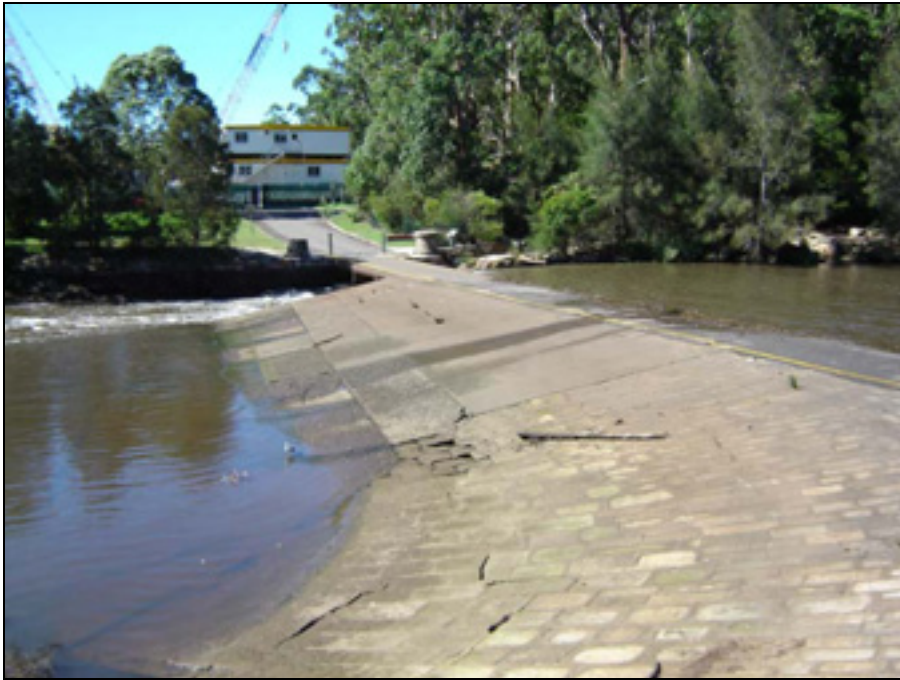
Figure 1. Lane Cove Weir, Lane Cove River at moderate river flow (3/2/05).

At the time of inspection the condition of the weir wall was poor, with large cracks funneling freshwater through the structure on the northern side (opposite side to the fishway). NPWS have advised that, although concerned about the integrity of the structure, it has no plans to repairs on the weir wall unless it is in danger of collapse.

In order to function correctly, it is important to maximise the flow through the fishway. At present several cracks in the weir wall on the northern side of the structure (opposite side to the fishway) enable significant volumes of water to escape, rather than pass through the fishway itself.

To minimise water loss through the structure, it is recommended that these leaks be corrected through the installation of sheet piling in the centre of the structure. Preliminary coring has been undertaken to determine weir composition, and has indicated that the visible sandstone blocks only cap the structure, with the weir generally composed of unconsolidated material. It has therefore been determined that sheet metal piling is possible to a maximum depth of 10 metres due to the unconsolidated fill material, and sand bedding.

An alternative option to fix the leaks is to de-water the weir pool (or part thereof), line the structure with geofabric and sandstone blocks on the upstream side, and allow the weir pool to refill.

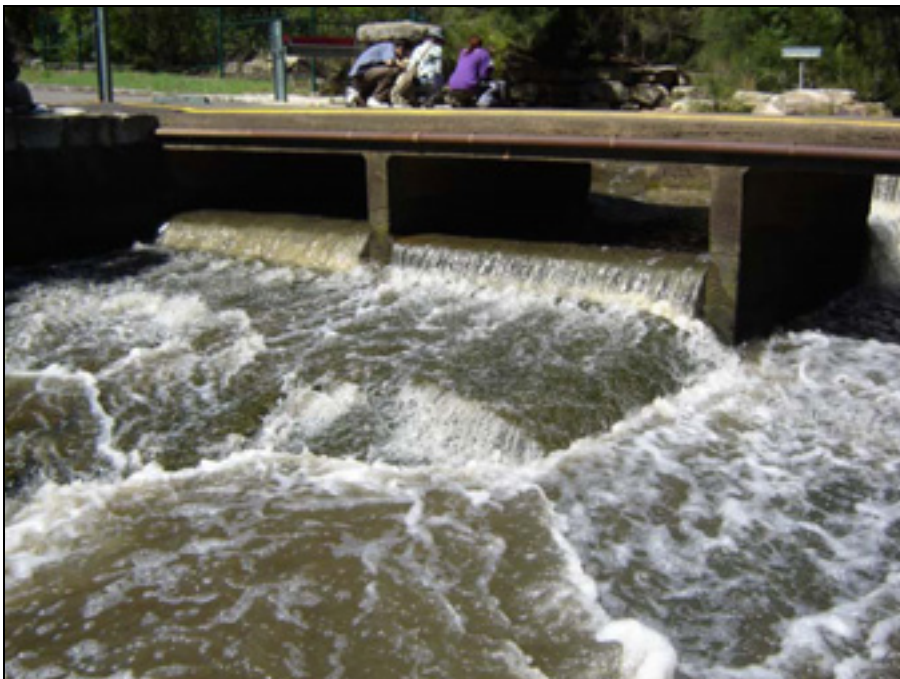
Figure 2. Entrance to fishway at moderate river flow showing headloss, flow depth and slope gradient at low tide (3/2/2005).

During construction of the fishway the space between boulders forming the longitudinal rock ridges in the fishway (tombstone rocks) were filled in with grout, which now acts to impede flow and fish passage during low flow conditions.

Wherever possible the grout between the longitudinal rock ridges along the fishway base should be removed to minimise headloss between resting pools and improve fish passage at lower flows. In addition, one of the resting pools is thought to be too small to act in the manner it is required, it is therefore recommended that the ridge rock defining this pool (approximately half way along the fishway) be removed to create a larger pool by combining with the pool adjacent.

The longitudinal fishway wall that delineates the fishway from the river has some leaks near the downstream end of the fishway. These leaks act to attract fish, causing accumulations at this site, and decreasing movement up the fishway. It is recommended that any holes or gaps in the fishway wall should be identified and filled in conjunction with the removal of grout between longitudinal rock ridges.

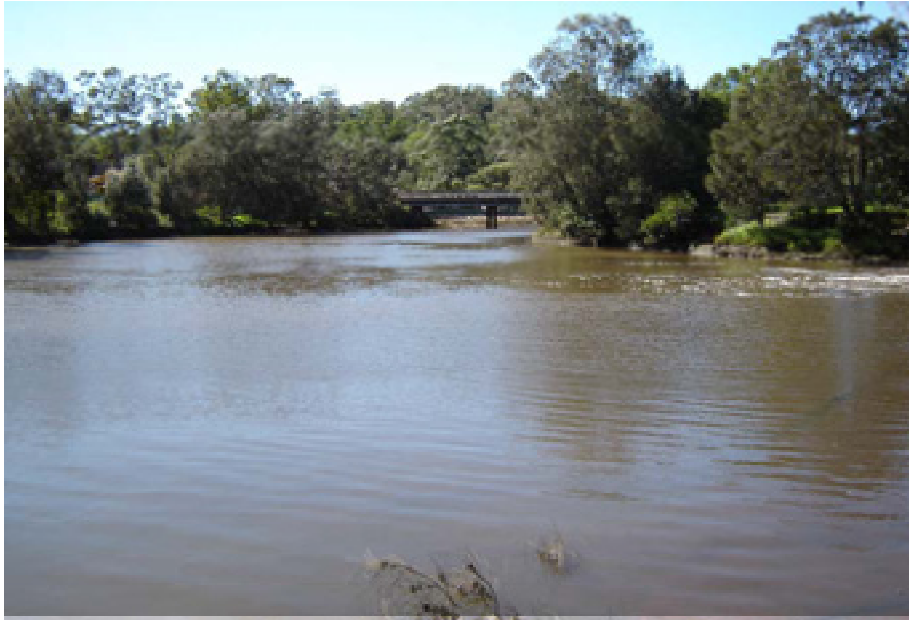
Figure 3. Lane Cove River downstream of Lane Cove Weir and Fishway (3/2/2005).

Lane Cove River contains important fish habitat components including large deep pools, large woody debris and cobble beds. The site has well vegetated banks with erosion at fixed points frequented by canoe users upstream of the structure. At the time of inspection the aquatic vegetation was primarily introduced species such as *Sagittaria* spp. and *Elodea* spp. Riparian vegetation was dominated by eucalypts, casuarinas, and *Ficus* spp (Figures 3 and 4).

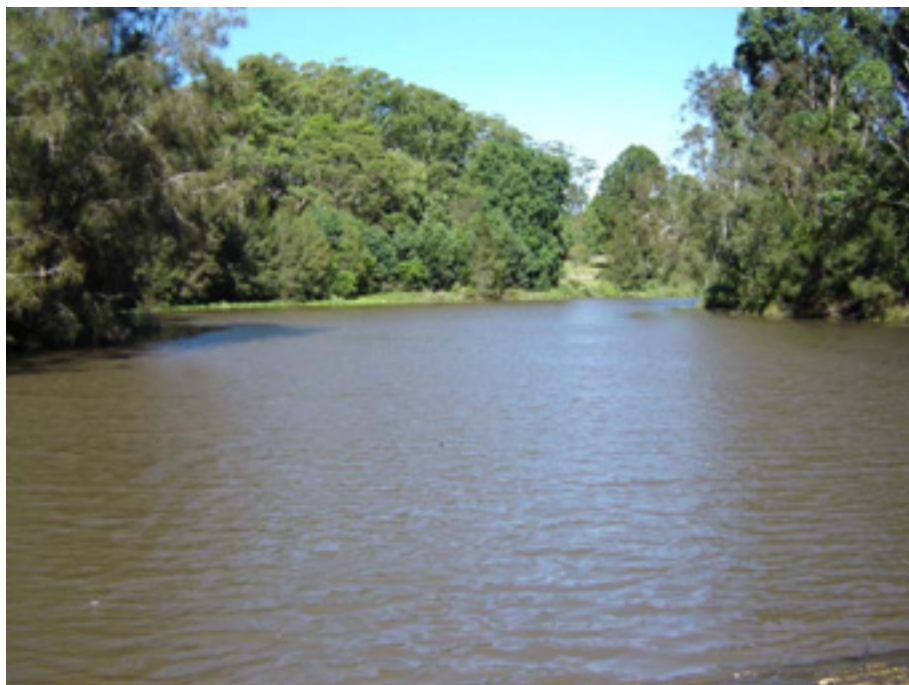
Figure 4. Lane Cove River upstream of Lane Cove Weir.

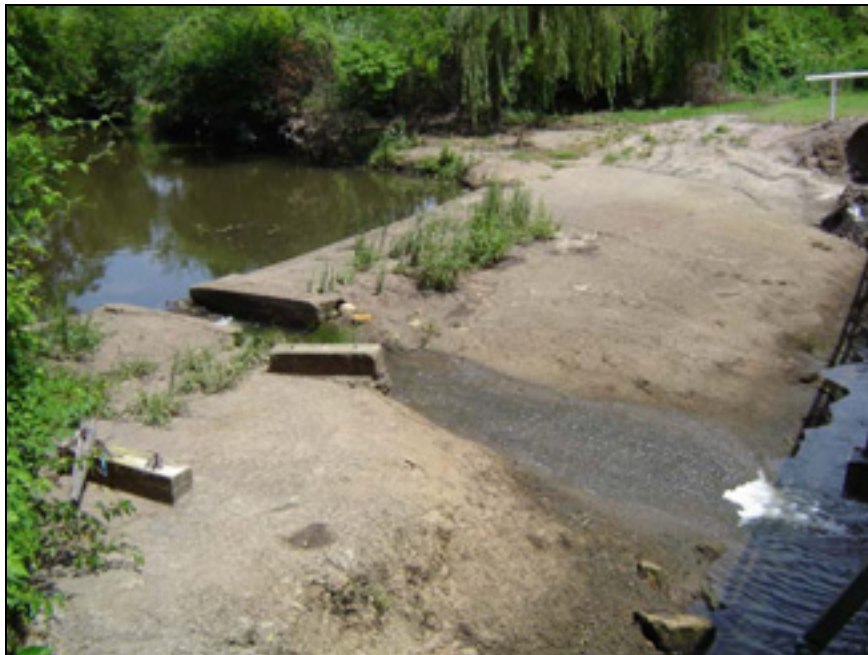
Figure 1. Wolli Creek Weir, Wolli Creek (9/2/05).

Wolli Creek Weir (Turella Weir) is located on Wolli Creek adjacent the suburb of Turella in the Cooks River catchment (Figure 1). Wolli Creek is a tributary of Cooks River, the confluence of which is approximately 2km downstream. The structure is a concrete fixed crest weir, approximately 2 metres high and 13 metres across. During low to medium flow conditions, the weir restricts fish passage due to excessive head loss (750mm), minimal flow depth and an excessive slope gradient.

Currently no licensed water extractors draw from the weir pool. At the time of inspection the weir was in working condition, although some cracks were evident allowing water to seep through.

The complete removal of this structure would provide the greatest benefit to the health of Wolli Creek and provide improvements in the availability of aquatic and riparian habitat. Removal of the structure would reinstate estuarine conditions upstream of the present weir structure however, which would lead to changes in riparian and aquatic vegetation types present. It is for this reason there is currently a lack of support for this initiative. In addition, it is also likely that important infrastructure now resides within the weir wall and may prevent the complete removal of this structure.

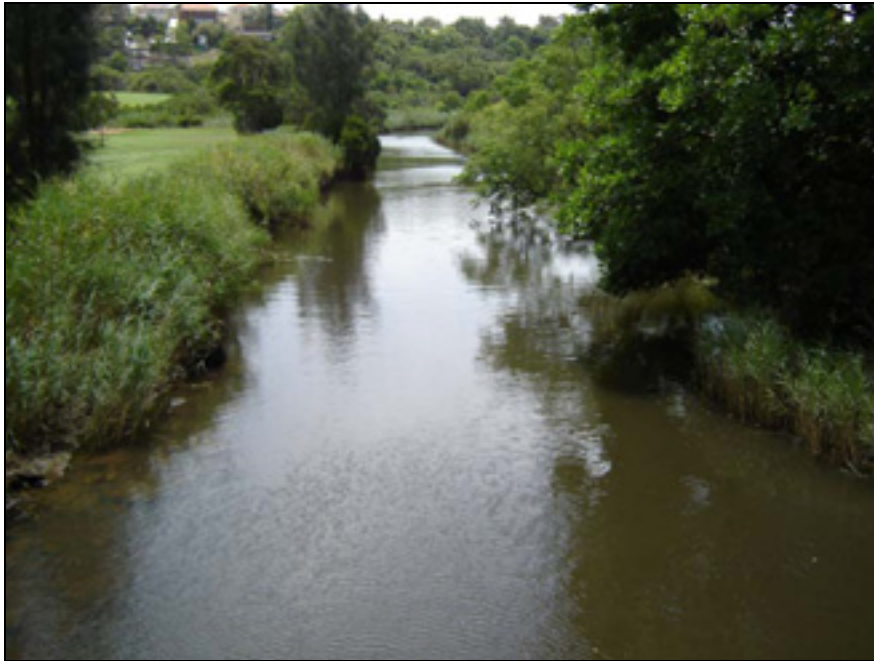
Figure 2. Wolli Creek downstream of Wolli Creek Weir (9/2/2005).

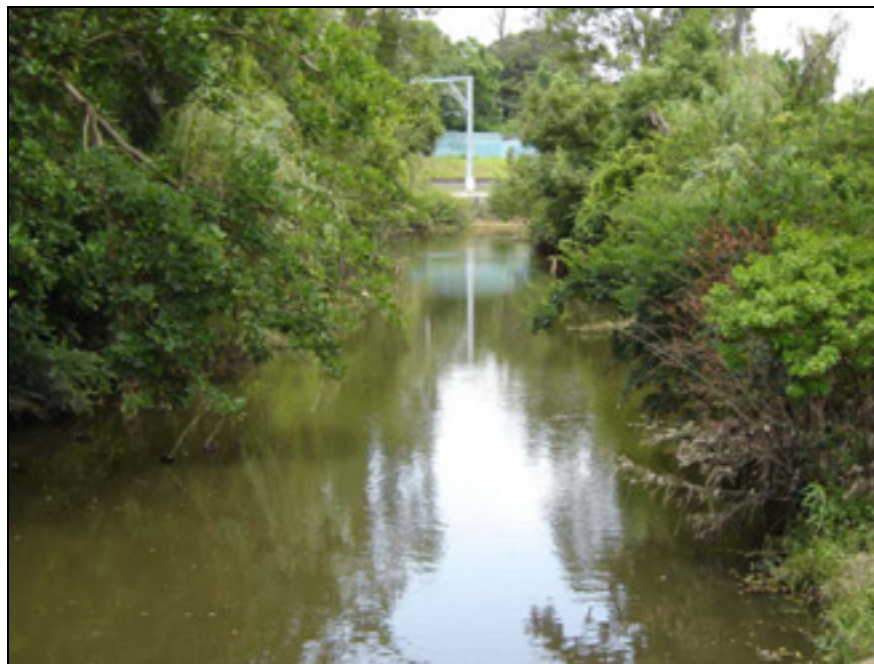
Although the upstream riparian and instream vegetation includes a range of exotic species, Wolli Creek is recognised as possessing a diverse and unique range of native plant species. Riparian vegetation adjacent the weir pool comprises introduced coral and willow trees, in addition to the introduced morning glory creeper (Figure 2). Casuarinas, common reed, and mangroves dominate the downstream riparian zone that borders the estuarine section of the creek (Figure 3).

Figure 3. Wolli Creek upstream of Wolli Creek Weir (9/2/2005).

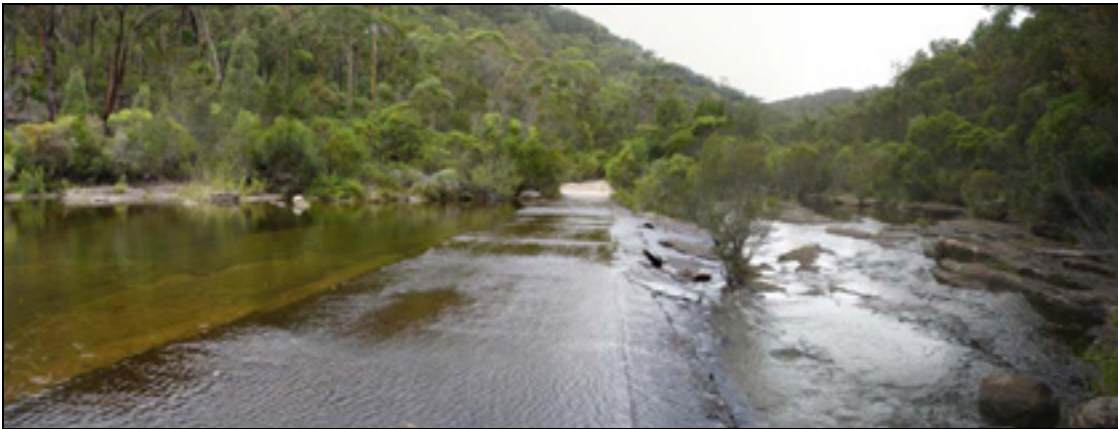
Figure 1. Pass of Sabugal Weir, Woronora River (17/1/05, 6ML/day).

A stone weir wall originally spanned the river on the upstream edge of the structure, but over time large flows have removed most of this part of the structure, with only some of the foundations and iron reinforcement still being evident. At the time of inspection the condition of the weir was considered poor with small to medium sized cracks evident.

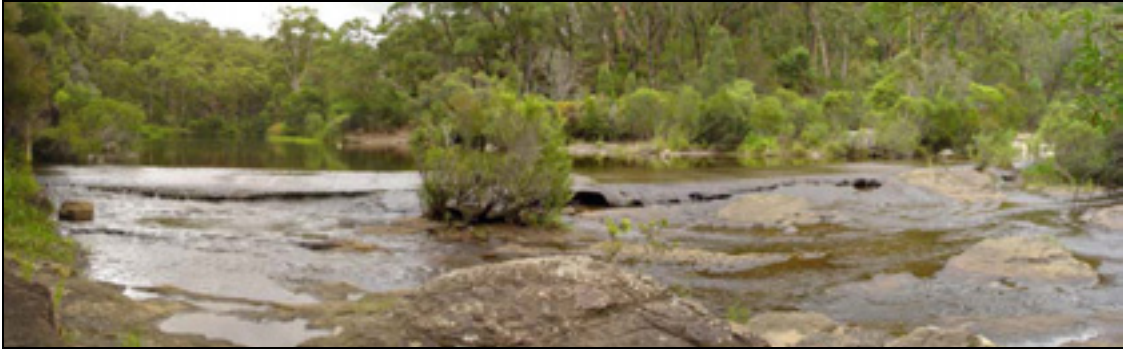
Figure 2. Woronora River looking upstream from below Pass of Sabugal Weir (17/1/2005, 6ML/day).

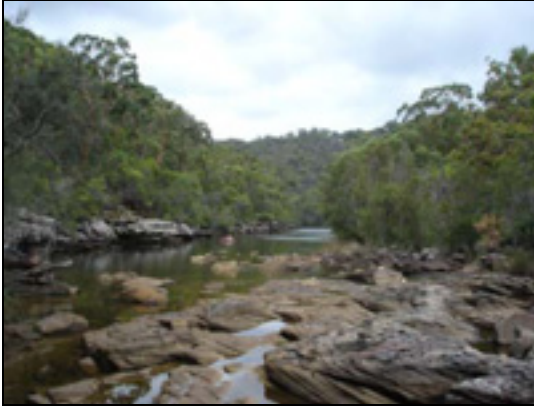
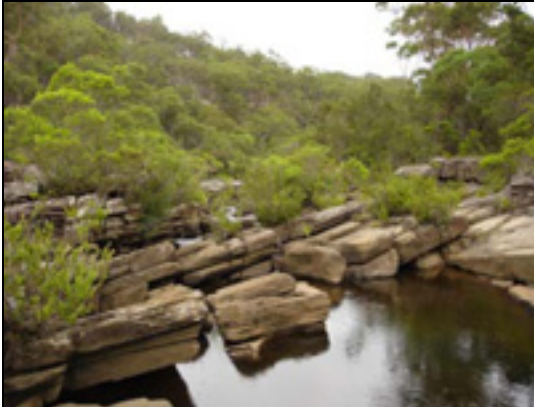
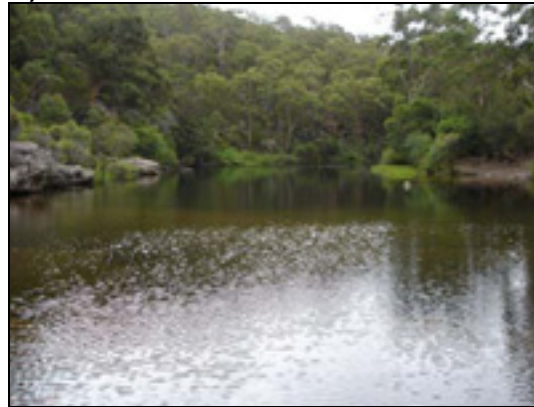
Figure 3. Woronora River habitat surrounding Pass of Sabugal Weir (17/1/2005, 6ML/day). A) looking downstream of “The Needles” and Pass of Sabugal Weir, B) looking upstream, 150 metres downstream of the weir, C) looking upstream at “The Needles”, 75 metres downstream of the weir, D) directly upstream of the weir.

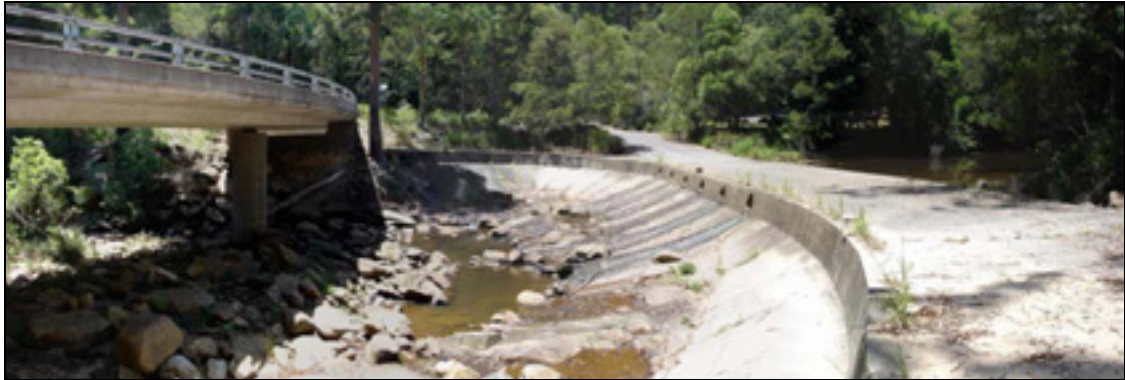
Figure 1. McKell Avenue Weir, Hacking River (14/1/05).

No hydrological flow data has been recorded for Hacking River. Drown out of McKell Avenue Weir has been predicted to occur only during extremely heavy flows, which are very rare in this section of the basin, although it is assumed that some fish passage is possible at these times. It should be noted that flows within the Hacking River are overall quite low, with periods of no flow causing the weir pool to dry out completely.

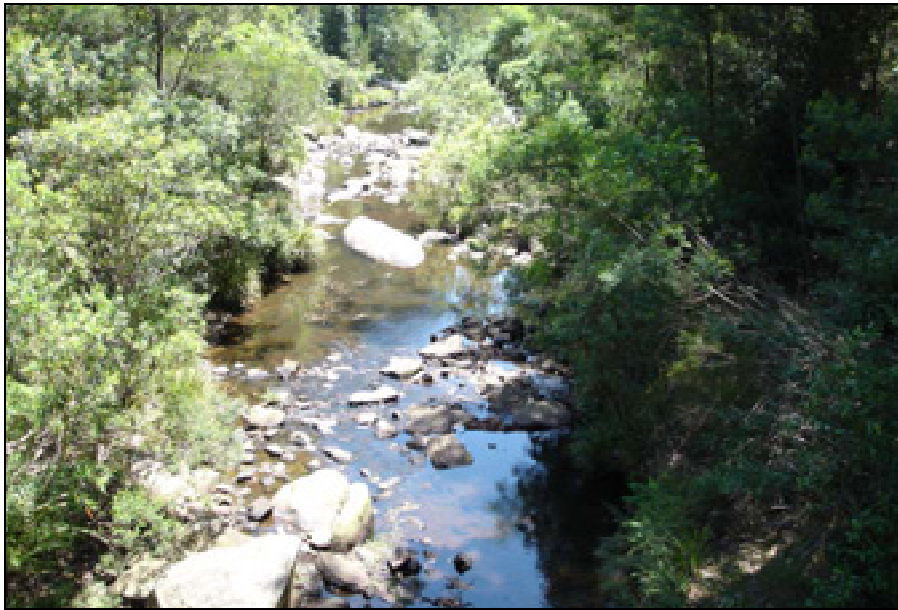
Figure 2. Hacking River downstream of McKell Avenue Weir (14/1/2005).

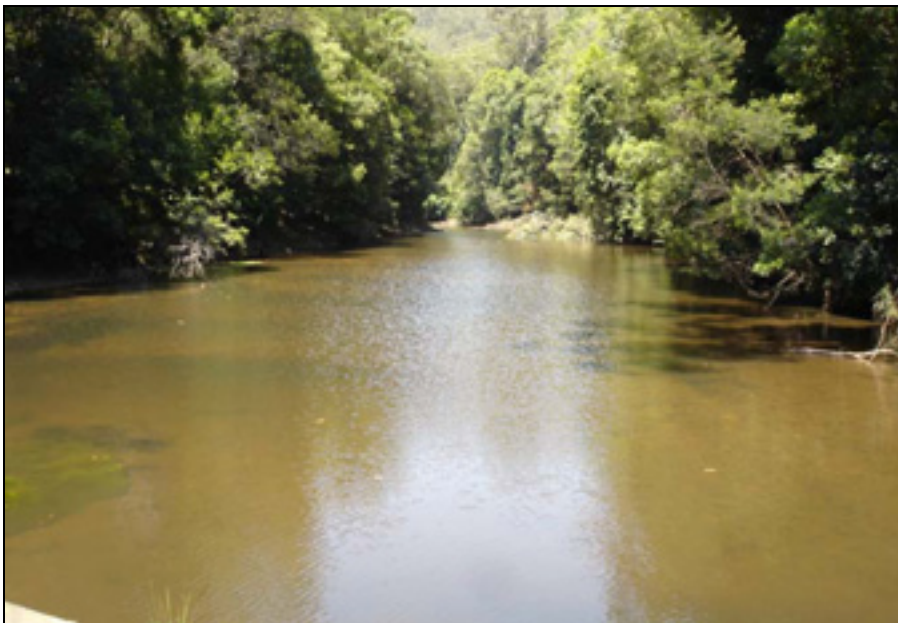
Figure 3. Hacking River upstream of McKell Avenue Weir (14/1/2005).

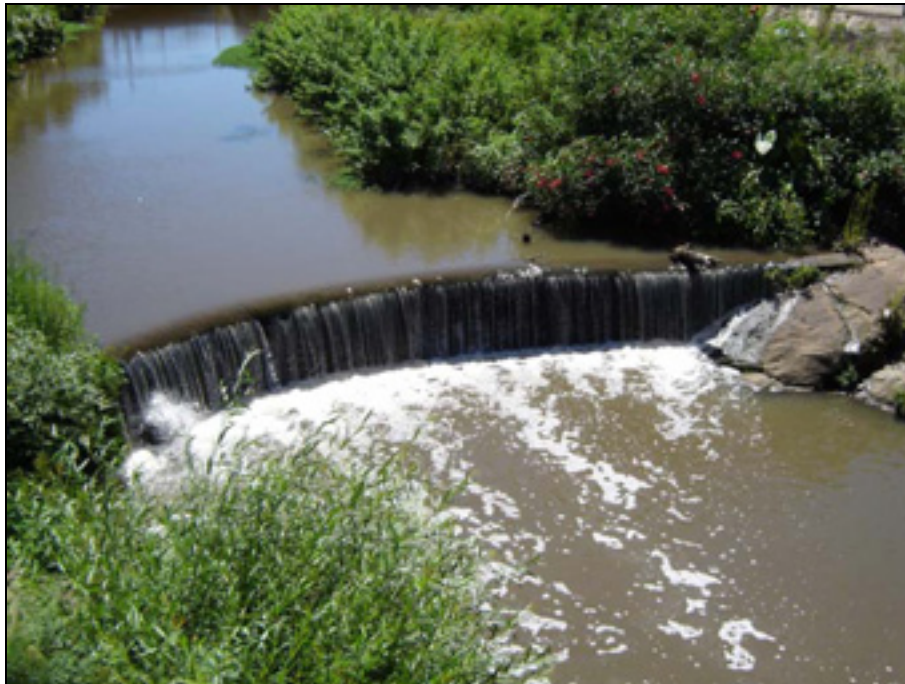
Figure 1. Woollen Mill Weir, Darling Mills Creek (3/2/05, 2.6ML/day).

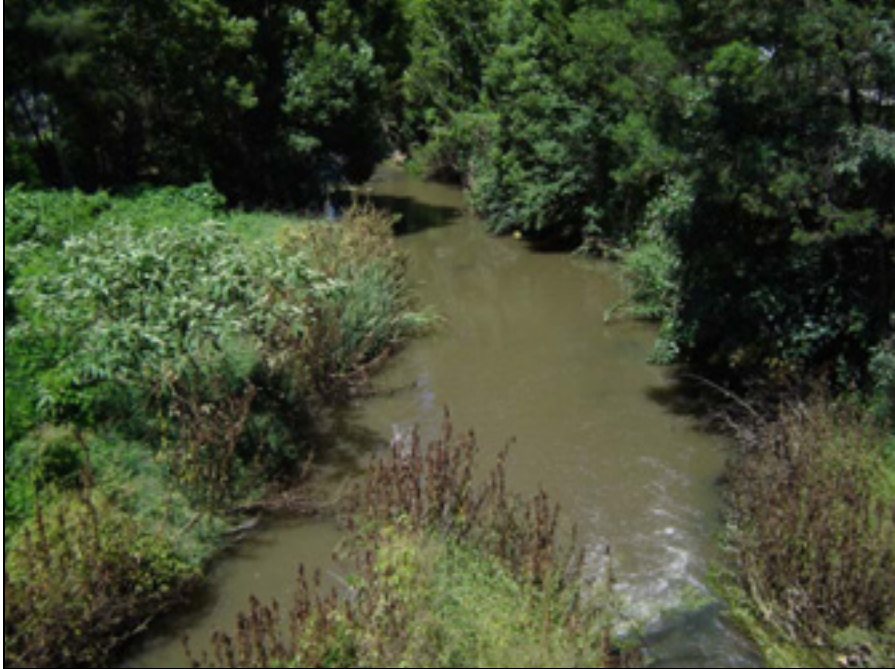
Darling Mills Creek contains important fish habitat components including deep pools and overhanging branches. This site has well vegetated banks dominated by exotic species such as lantana and willows, with small stands of native *Ficus* spp. also present.

Figure 2. Darling Mills Creek downstream of Woollen Mill Weir (3/2/05, 2.6ML/day).

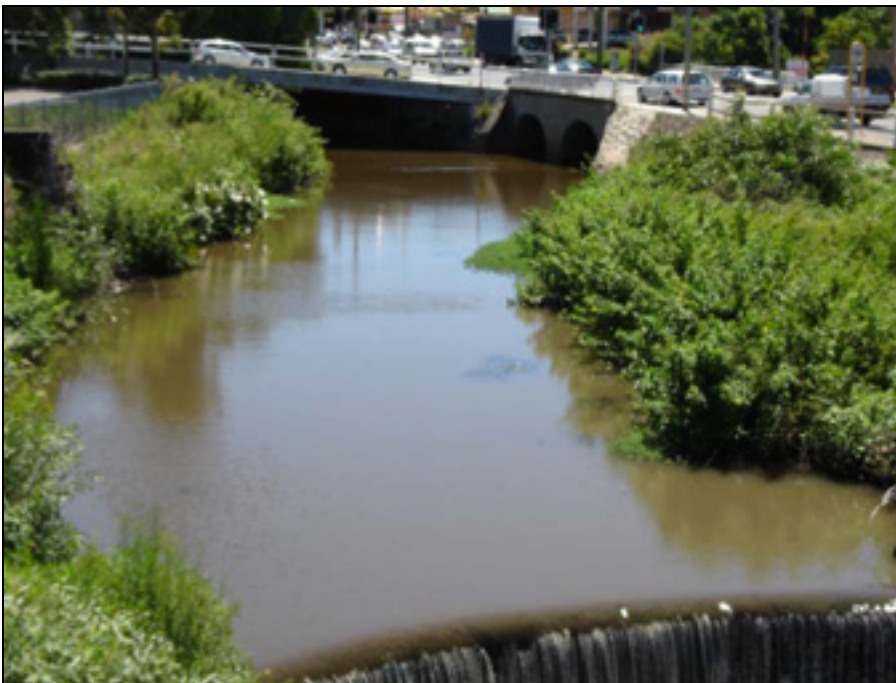
Figure 3. Darling Mills Creek upstream of Woollen Mill Weir (3/2/05, 2.6ML/day).

Erosion is present at fixed points, and is significant approximately 125 metres upstream, where undercutting of the left hand bank should be addressed as a matter of priority. At the time of inspection, some aquatic vegetation was present at the site, and was dominated by parrots feather (*Myriophyllum* spp.). It is recommended that in order to improve fish habitat at this site, native riparian zone plantings and bank stabilisation works should be undertaken either side of the weir.

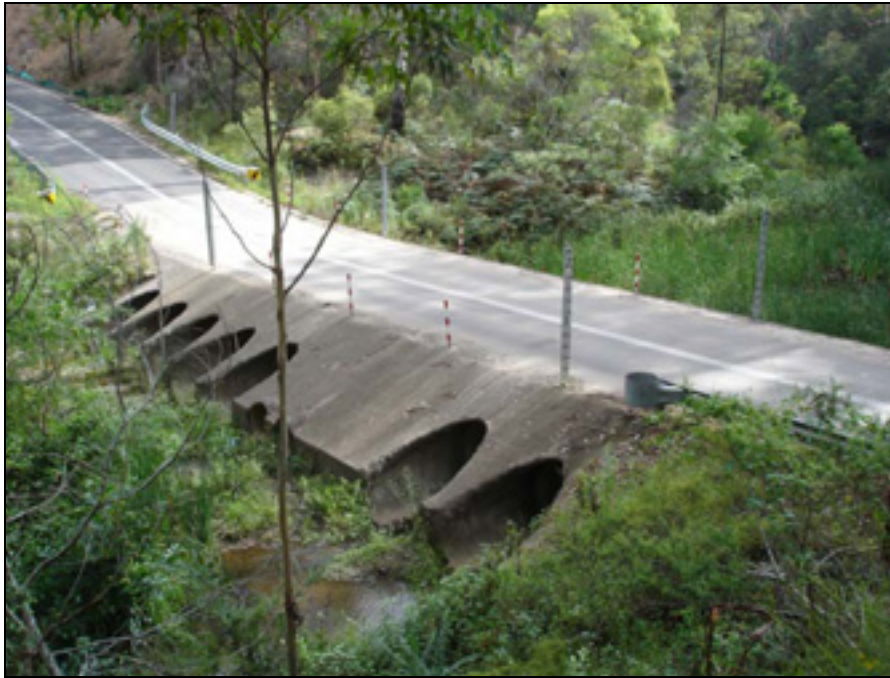
Figure 1. Wedderburn Weir, Georges River (27/01/2005).

- **Option 2** – Remove and replacement with a bridge

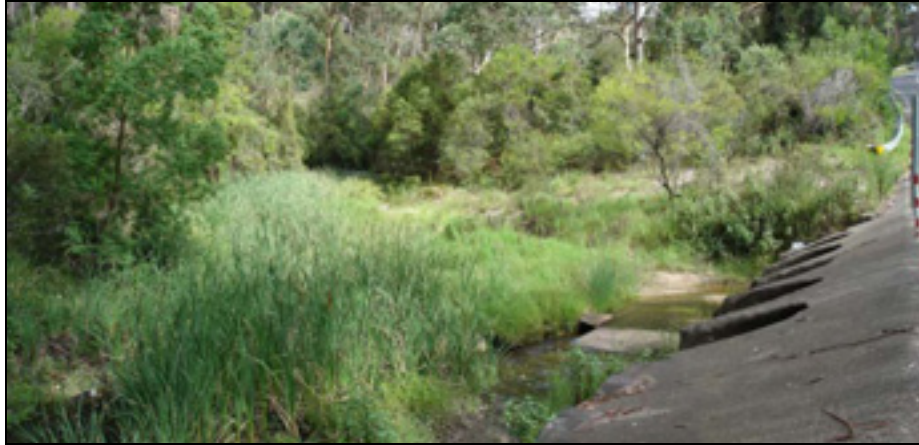
At the time of inspection, aquatic vegetation at this site was dominated by cumbungi with some introduced water hyacinth present in the upstream weir pool. Eucalypts, banksias, and exotic weeds dominated riparian vegetation.

Figure 2. Habitat directly downstream of Wedderburn Weir showing dense stands of cumbungi blocking channel (27/01/2005).

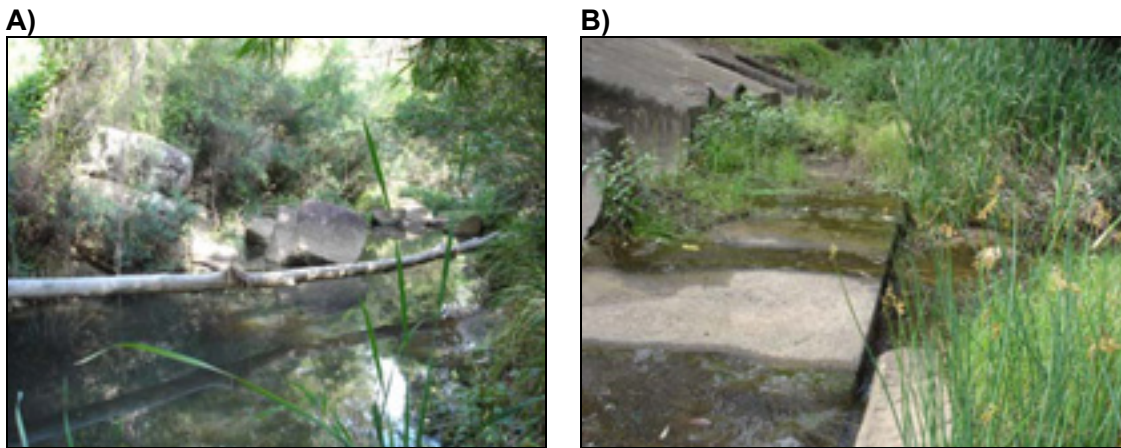
Figure 3. Wedderburn Weir, Georges River (27/01/2005) showing A) habitat downstream of structure, B) apron with 200mm headloss and minimal flow depth (downstream side).

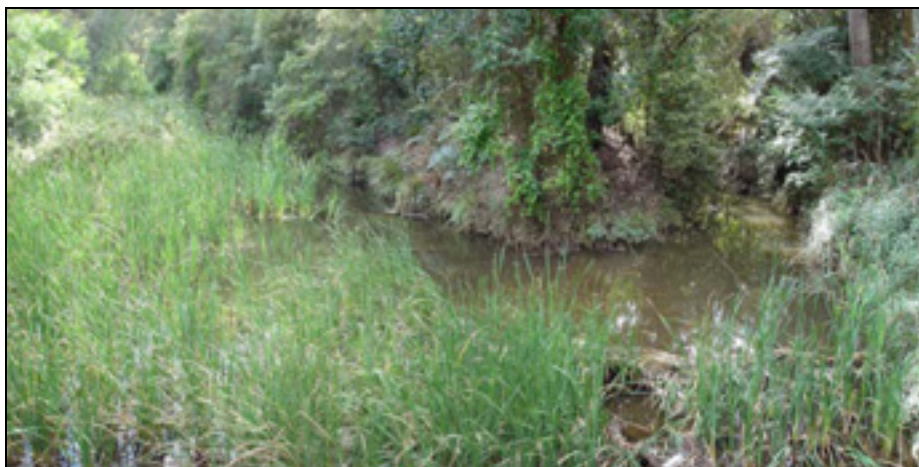
The Georges River contains important fish habitat components including riffles, large deep pools and cobble beds. Although the site has moderate to well-vegetated banks upstream and downstream of the site (Figures 2, 3A, and 4), extensive erosion is evident in and around the downstream weir pool. This eroded sediment has gradually filled in the downstream channel, allowing a dense stand of cumbungi (bulrush) to develop and severely reduce the available aquatic habitat (Figure 4).

Figure 4. Georges River upstream of Wedderburn Weir (27/01/2005).
