SAFETY ALERT

INJURY TO EXCAVATOR OPERATOR

Report No: SA05-04
File No: 05/1521
Comet ID: 317519933001
Prepared by: Angus Mc Douall
Date Created: 05 April 2005

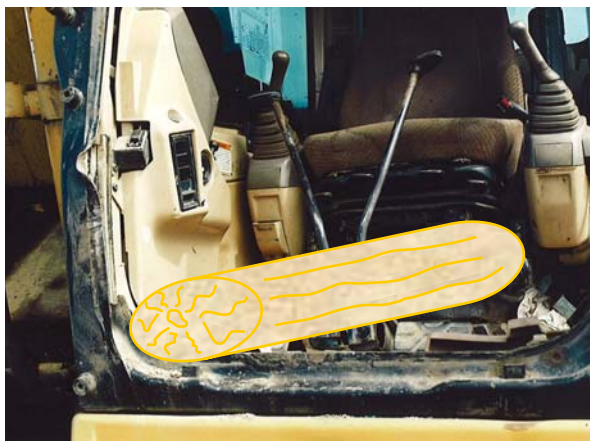
As the excavator slewed towards the truck, both poles dislodged. One pole fell to the ground, while the other speared into the operator's cabin.

Direction of the pole

Review risk assessments and safe work procedures to ensure that all-potential hazards associated with earthmoving have been identified and controlled.

Ensure that fit for purpose equipment is available on site and is used when activities differ from core earthmoving work.

Review the adequacy of windscreen protective devices where materials are handled that have the potential to be propelled towards the cabin.

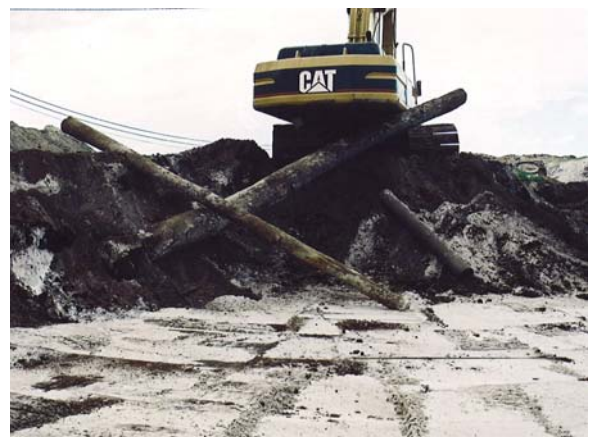
Poles final resting place

The pole lodged against the track controls, driving the machine forward. This resulted in the pole jamming across the operator's leg and into the access door. It was not able to be determined whether evasive action by the operator knocked the slew control or whether the end of the pole came into contact with the lever. Fortunately the cabin rotated to the left and the pole was released.
