SAFETY ALERT

STORED ENERGY

Report No: SA 05 - 13
Comet ID 317524292001
Date: 14/9/2005
Prepared by: Paul Drain
&David Nichols
Phone (02 49 31 6626)

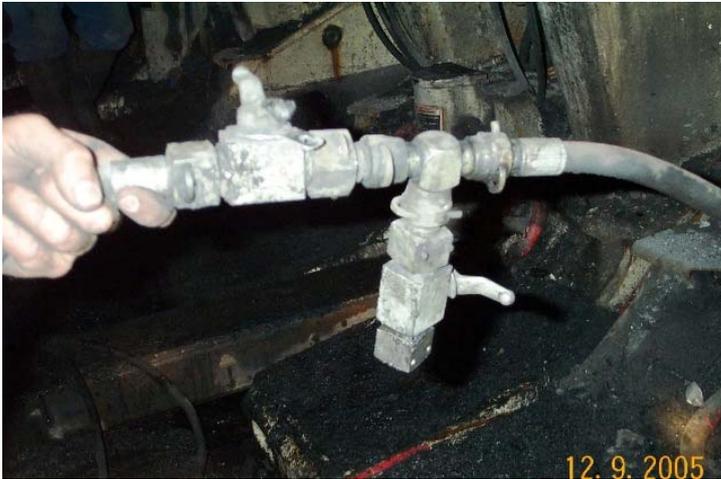
The incidents occurred while setting up longwall chocks on an installation face using whip hoses connected to an adjacent chock Power Take Off (PTO) outlets. The employee isolated the hydraulic power in the whip hoses and released the pressure in the lines by opening the bleed line (Refer Photo No 1 & 2). The employee's hand was over the bleed outlet. The hydraulic fluid released and hit the employee's hand causing injury (near miss fluid injection).

Normal isolation valve and bleed valve arrangement for the Whip Hoses

1. Mines consult with the OEMs for the recommended procedure and equipment to install and remove the roof supports.
2. Review the equipment and components of the installation and recovery hoses for fit for purpose application.
3. The isolation valves should be the positive lockable type and the bleed valve (lockable type) should be capable of releasing the hydraulic pressure in a controlled state.
4. All procedures should include positive isolation instructions i.e. use lockable hydraulic isolation valves, with bleed valves that release the hydraulic pressure in a controlled manner away from all employees,(use a diffuser refer photo 3)

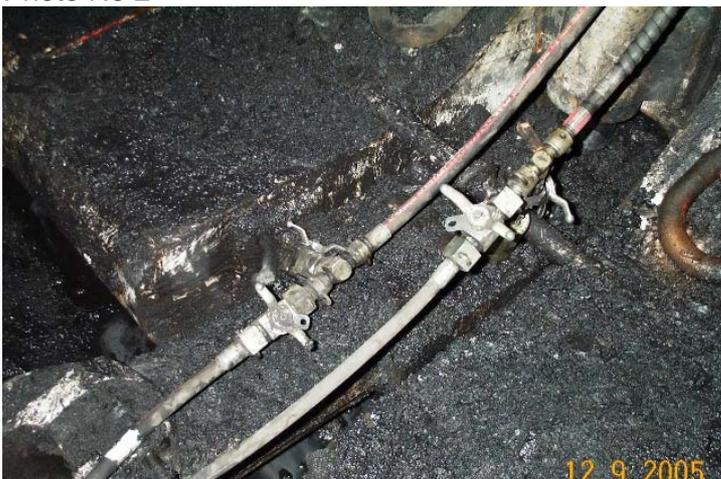
Photo No 2

Whip hoses isolation and bleed valve lying on the ground

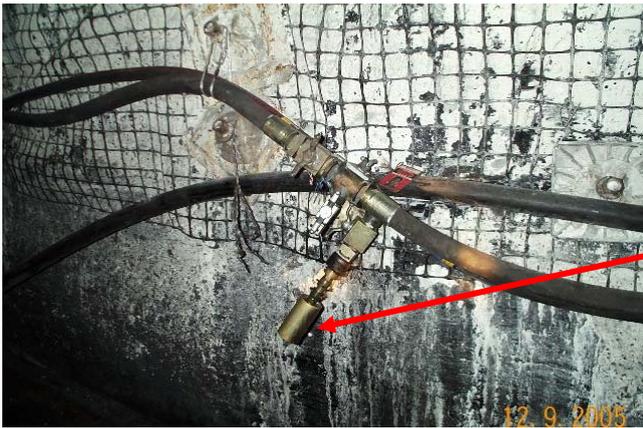
Photo No 3

Diffuser outlet

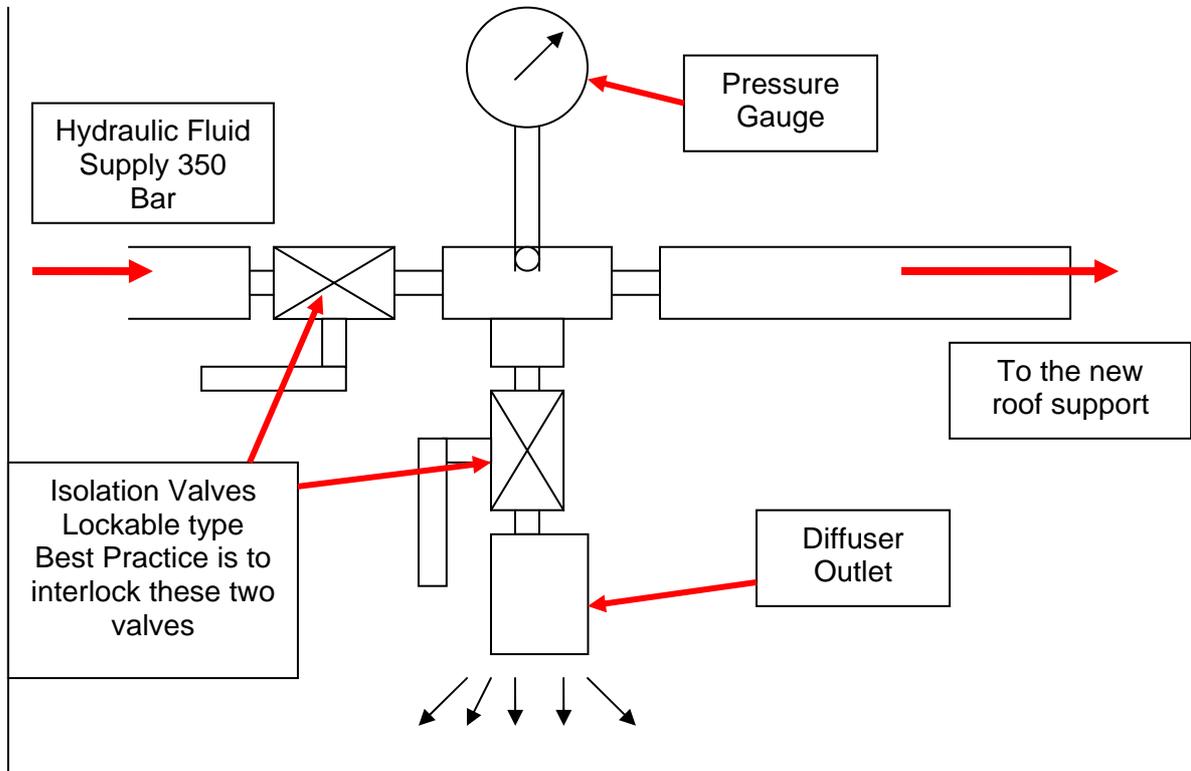
Drawing 1

The following equipment could be mounted on a board (e.g. Perspex) to have a hard barrier between the diffused hydraulic pressure flow and the employees.

and the depressurisation must be proven eg with a pressure gauge (Refer Drawing 1).

5. The pressure line must be connected to the relative ports, and return line must be connected back to tank at all times.
6. The hydraulic system must have pressure relief in the event of over pressurisation.
7. If possible reduce the installation pump pressure (eg from 350 Bar to say 150 Bar) to activate the roof supports. (Usually reduced pressure is used on the installation face not the recovery face)
8. Review SA05-01 Change Work Practices, Employer Obligations.
9. Review the OH&S Regulations 2001 Chapter 5
10. The pressure and return lines for PTO should be different sizes (eg DN10 & DN13).
11. Best practice is to interlock the isolation valve and the bleed valve so both valves cannot be open at the same time (Refer to Drawing 1).
