# STAPLES

# Known Staple limitations

# 35 MPa Staple standard

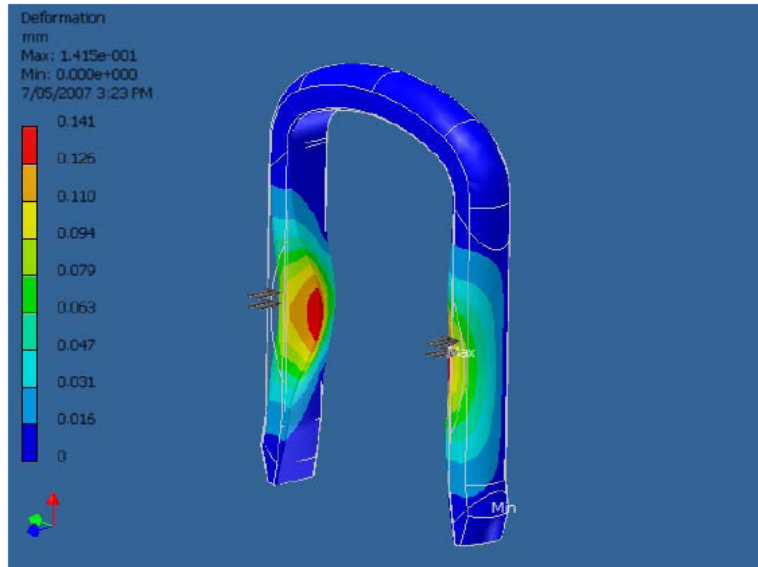
FEA & FMEA

Deformation

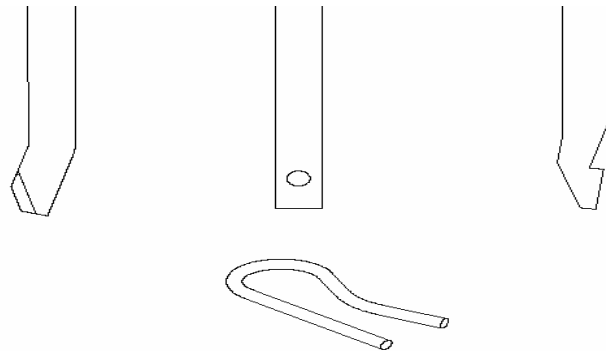
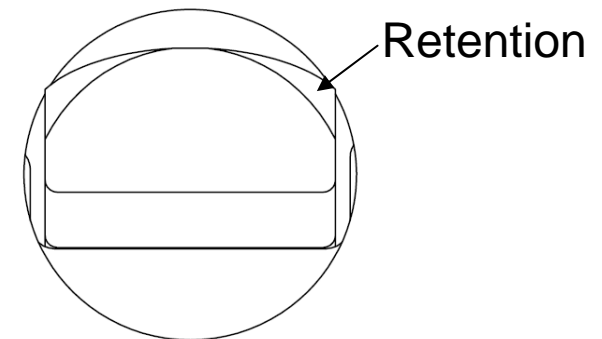
## Staple End view

# Staple retention (Walk-out)

Recognized as major problem (particularly when mixing 4 known staple lock standards, SAE, DIN, BS & NCB )

Staple walk-out also prevalent with mixed source Super staple lock, as there are no standards.

(Retention methods being used: Kinked leg, 'R' clips, Wire ties, Ratchet leg, Bands, Clamps etc)

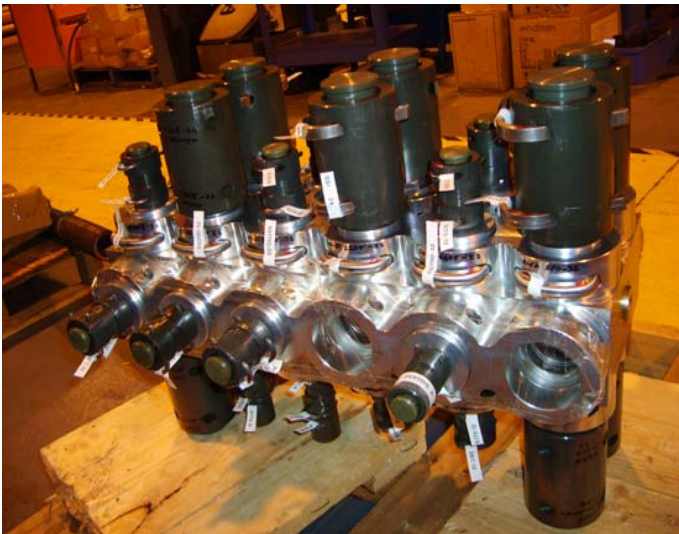
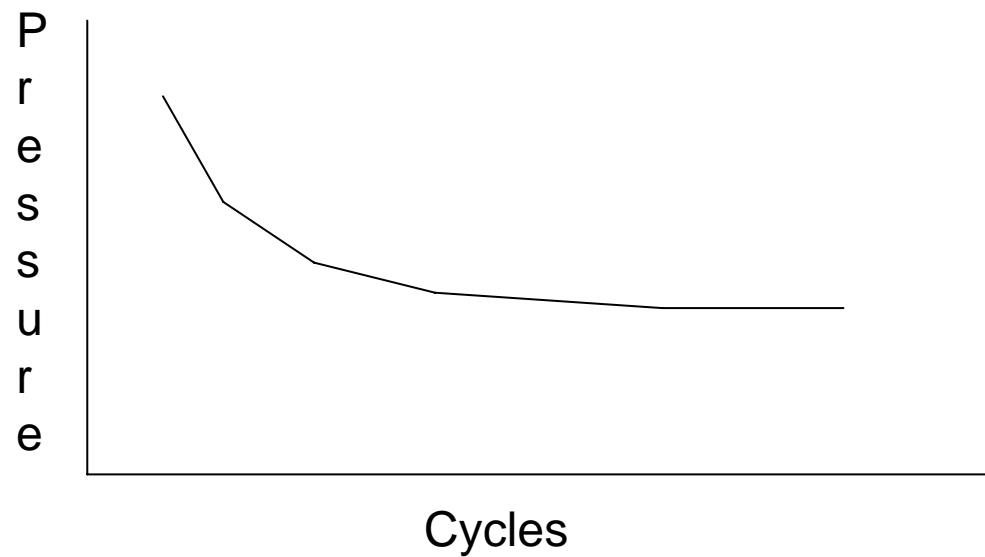
# Cyclical testing

- Objective to create Sn curve

(Pressure vs cycles to  $10^6$ )

Common Impulse test

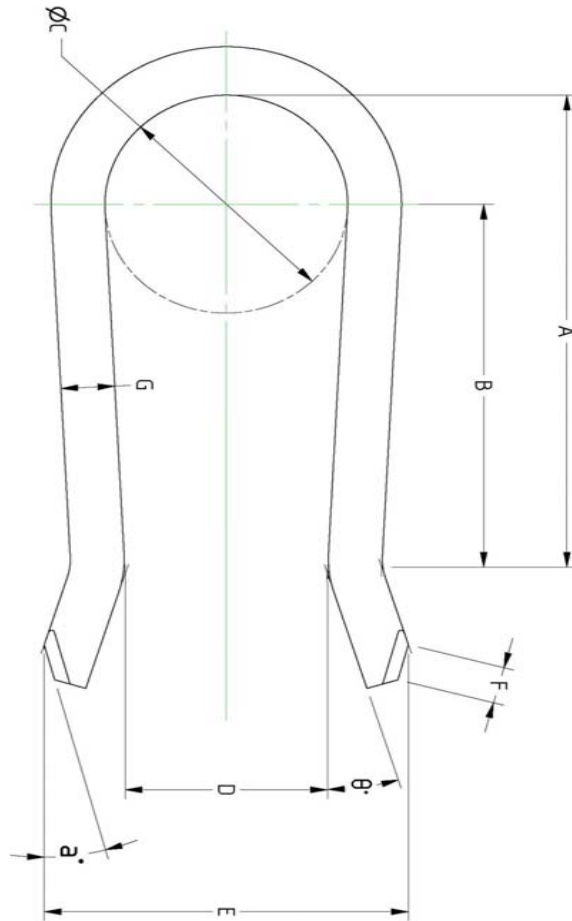
# Do's + Don'ts for Staples

Based on metallurgical evaluation

## Do's

- Understand cyclical demand
- Use staples once ONLY
- Obtain a Certificate of Conformance

## Don'ts

- Mix & match standards
- Hardness >48 HRC
- Electroplated (Hydrogen embrittlement)
- 304 Stainless (sulphur resistance)
- Barbed legs (broaching female)
- Stamp legs

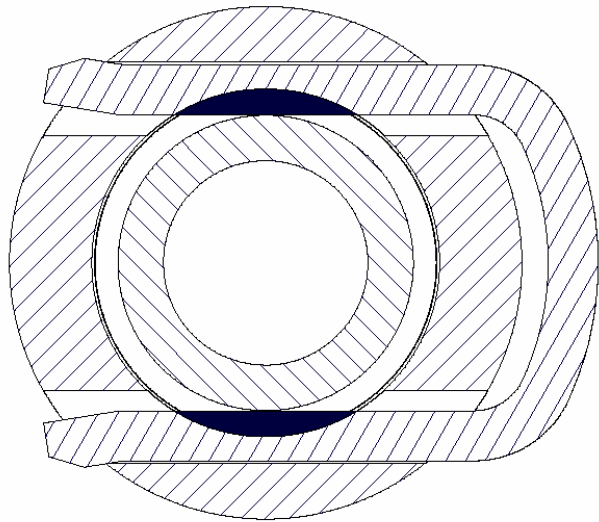
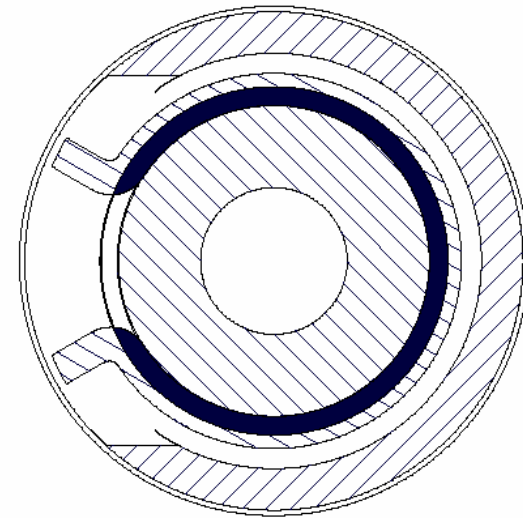
# Alternatives

**Clip-lok**  
Patented

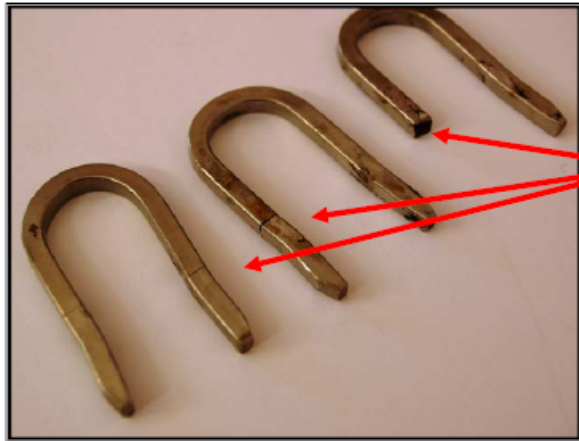
Staple legs  
broken and  
cracked

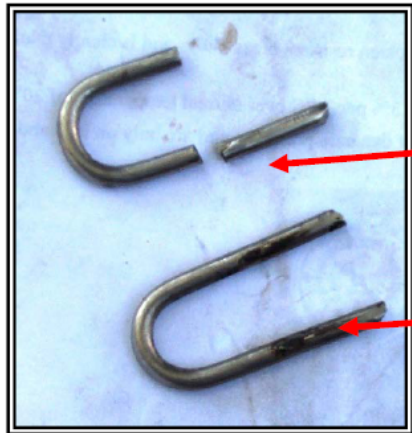
Broken  
Staple Legs

Wear Marks

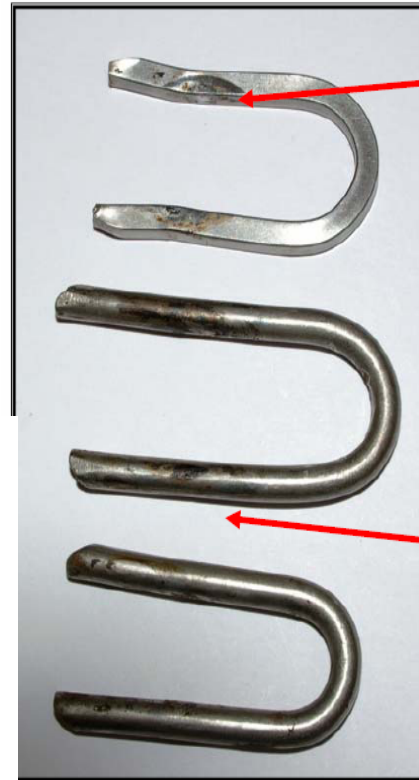
Staples worn and  
starting to wear where  
the hose is contacted

Wear marks

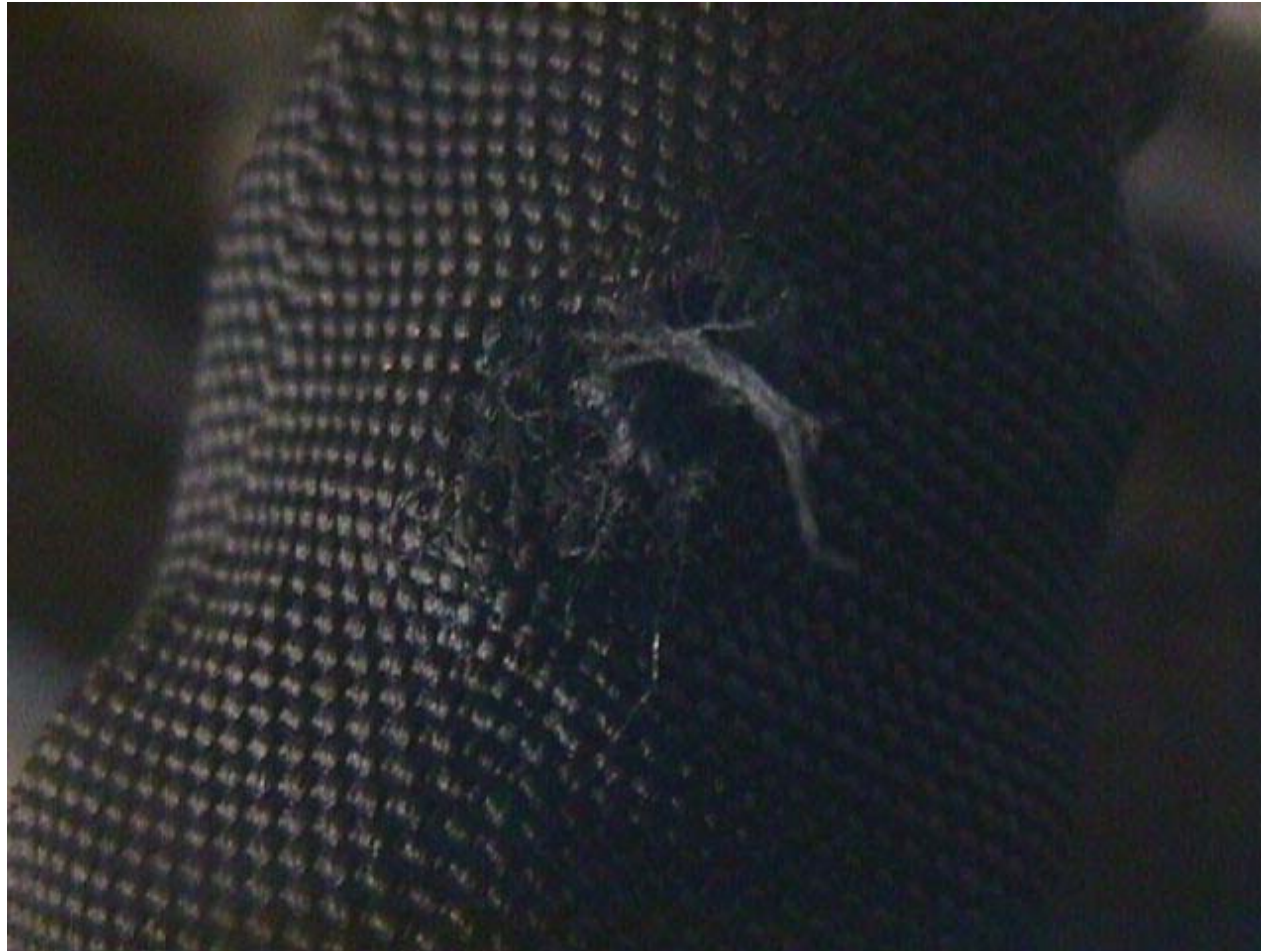
# Hose Sleeve

Close-up view on the Hose Sleeve  
Ø0.8 mm pin hole damage
