## MINE SAFETY

# INVESTIGATION UNIT

Electric shock injury involving 3.3kV electrical  
equipment at coal mine preparation plant

15 November 2007

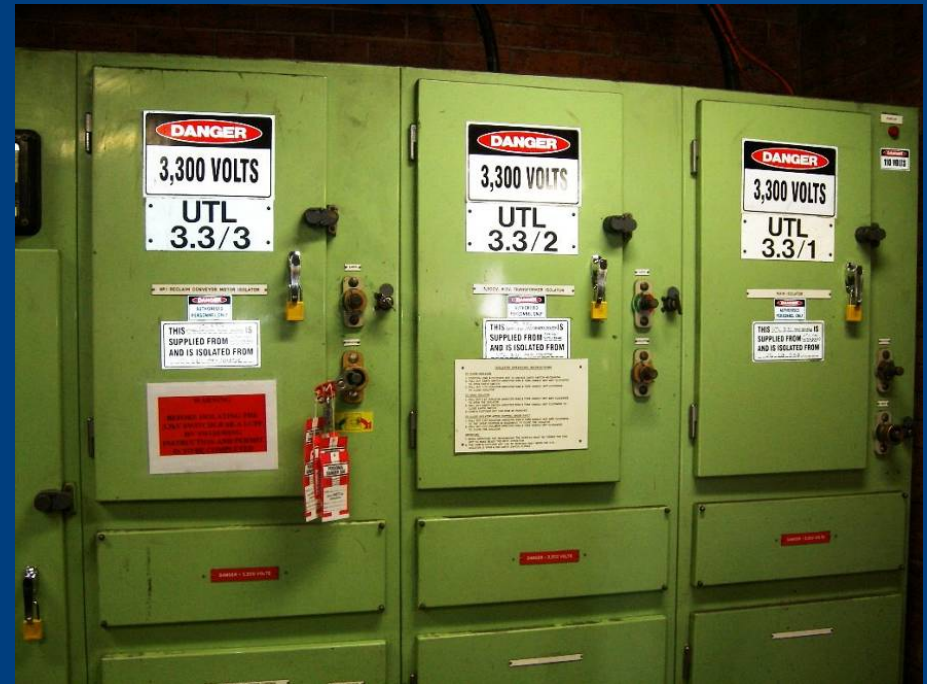
# 3.3kV switchboard

- Locks fitted after the incident
- Castell key and earth switch
- Main incomer and the correct isolation point for access to UTL 3.3/3 cabinet
- Conveyor motor starter panel supplied from UTL 3/3.3

- Absence of engineered controls to prevent the access to live conductors in 3.3kV electrical installations
- Inadequate documented procedures for high voltage work
- No formal training in high voltage work
- Absence of high voltage testing equipment in switch room.
