# SAFETY ALERT

## SERIOUS ELECTRIC SHOCK INCIDENT

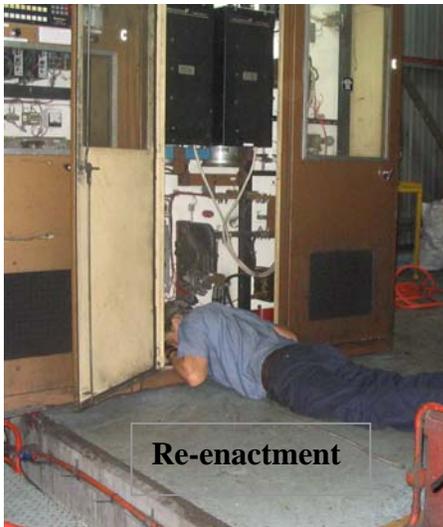
#### **Picture 1.**

While working alone the electrical service engineer opened an enclosure containing energised circuits in order to draw the cables into the enclosure. He made contact with a direct current source of 460 volts.

*The photograph at left is a re-enactment of the position where the victim was prior to and after receiving multiple electric shocks. A DC contactor and bus bars are in the immediate vicinity of the victim's head and right hand.*

1. Mines should review work practices and ensure work is not undertaken in close proximity to exposed energised electrical conductors.
2. Mines should review contractor management and ensure that documented scopes of work and appropriate supervision are provided.
3. Mines should ensure electrical enclosures are properly secured against unauthorised access. Note only competent electrical trades people or engineers should be authorised to open electrical enclosures.
4. Mines should apply the Guidelines for the Safe Use of Electricity in NSW Mines, MDG 2004 to enhance electrical engineering safety. This document provides guidance for prevention of electric shock and burns. Additional reference material is contained in Workcover Industry Code of Practice “Low Voltage Electrical Work”.
