SAFETY ALERT

Diesel Engine System Running on Atomised Hydraulic Oil

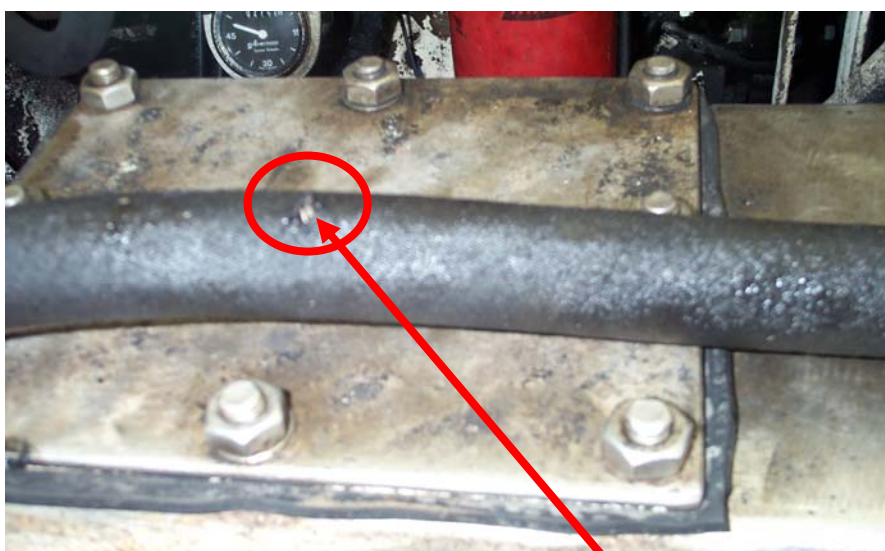
The LHD was inspected and it was found that the steering pump output hose failed by developing a hole approx 5mm wide. This hole atomised the hydraulic oil creating a pressurised oil spray (mist) in the engine compartment and torque converter area.

Hydraulic oil covered the engine and centre drive shaft compartment. The air filter and intake flame trap were saturated with hydraulic oil.

Pin Hole in the hydraulic hose

1. All mines should check the integrity of pressurised hydraulic or fuel lines in the vicinity of the engine compartment on a periodic basis.
2. Where appropriate fuel and hydraulic lines should be shielded or routed away from hot surfaces or engine air intakes, refer MDG 15.
3. Fuel and hydraulic hoses or pipes that are damaged, worn or fatigued should be replaced immediately if they are located near the engine compartment
