SAFETY ALERT

Unplanned movement of elevating work platform

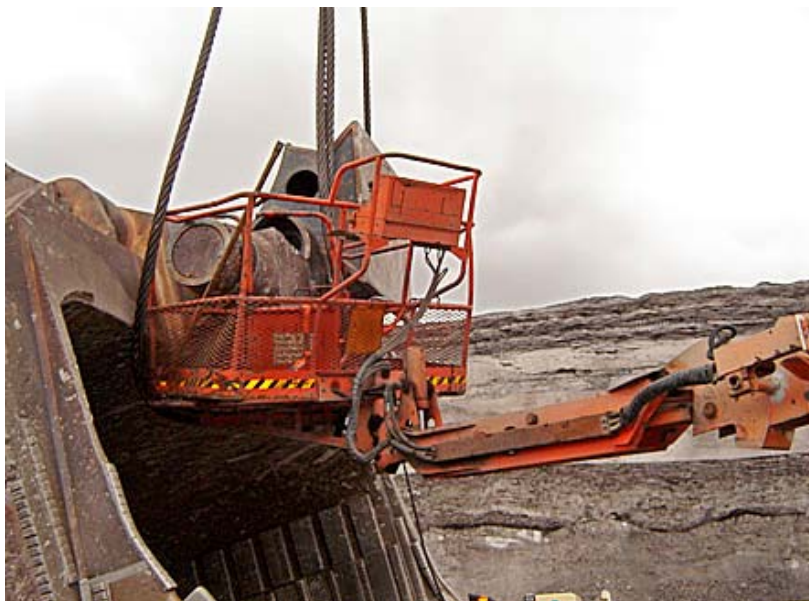
An elevated work platform (EWP) operator and his assistant were injured and trapped in an elevating work platform basket when the machine suddenly moved forward causing the basket to crash into the bucket of a P&H 4100 shovel.

The operator put his foot on the “dead man” and was reaching for the boom-up control when the EWP propelled forward into the bucket.

The elevating work platform after being propelled into the bucket of the P&H 4100

- The safety locking mechanism of the forward / reverse control lever jams in the unlocked position.
- The safety locking mechanism of the swing control lever jams in the unlocked position.

- Ensure all pieces of hired equipment have a thorough mechanical and electrical inspection prior to work, to assess fitness for work.
- Ensure thorough pre-work inspections are carried out by competent people.
- Ensure that hired equipment is maintained in accordance with:
 - The original equipment manufacturer's maintenance manual.
 - Relevant Australian Standards – AS 1418.10 and AS 2550.10
 - Regard to its duty and work environment.
- Ensure that the hirer has thorough and detailed maintenance records and defect management systems for the equipment.
- Ensure the machine is set up in accordance with the operator's manual.
- Ensure operators are competent with the various types of EWP's they are required to operate.
- Ensure risk assessments are carried out thoroughly and emergency rescue procedures are in place.
