# SAFETY BULLETIN

## Portable power tools

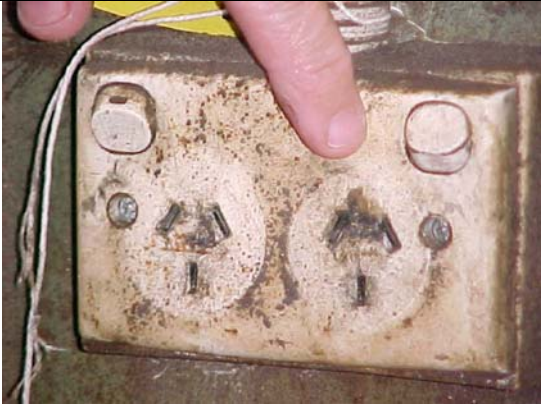
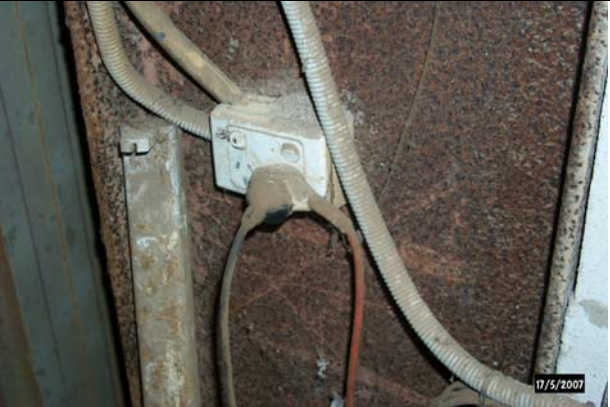
<p>Power outlet unsuitable for the environment</p>	<p>Socket outlet not rated for the location, poor wiring standards to the socket outlet and the inappropriate use of piggy-back plug / sockets</p>

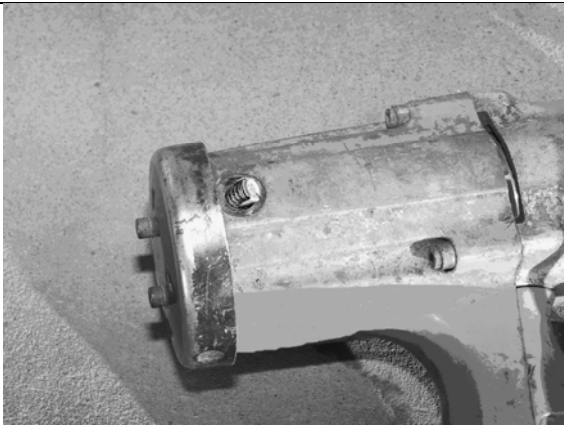
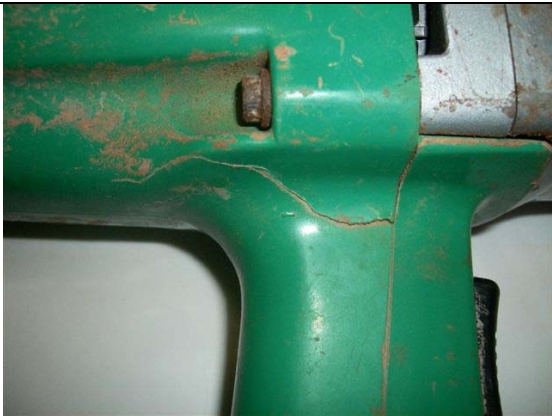
<p>Impact wrench – brush holder damaged</p>	<p>Impact wrench – cracked casing</p>

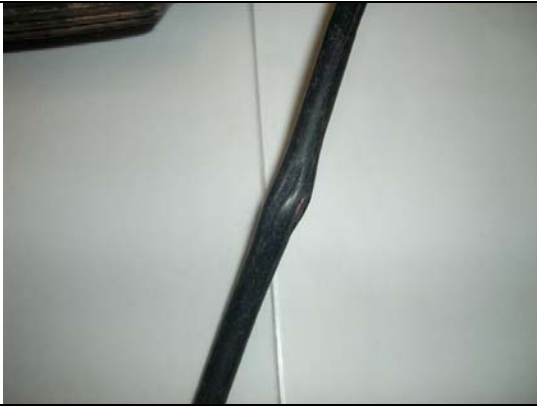
Damaged impact wrench lead

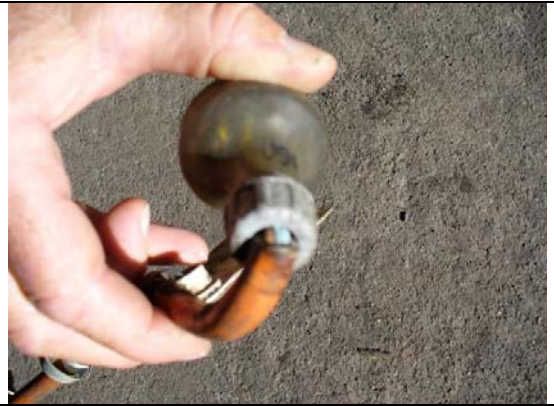
Defective cable connection to the plug

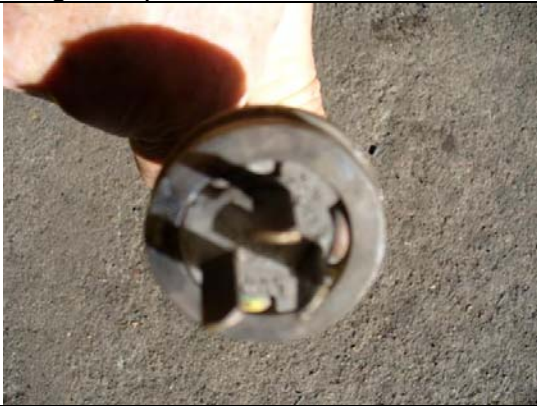
Plug inadequately IP-rated

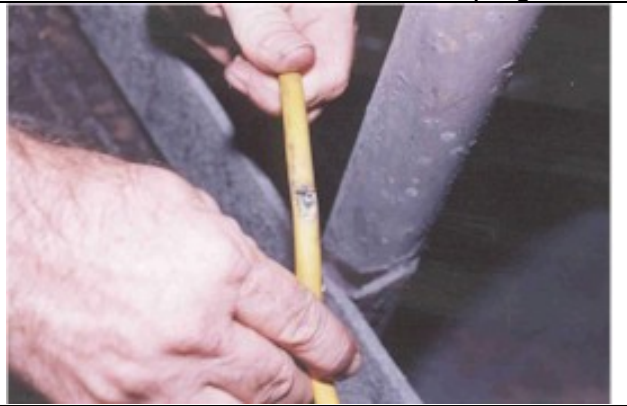
Damaged extension lead due to poor installation practices.

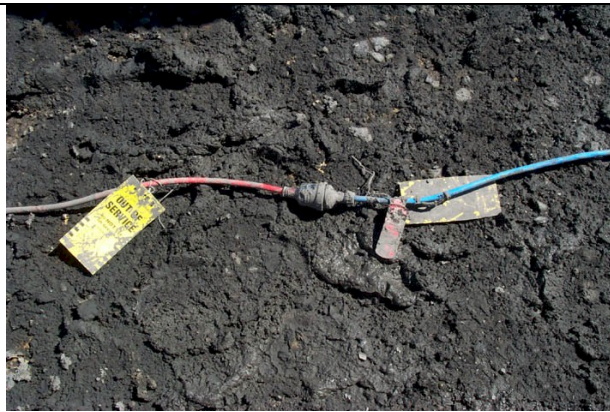
Leads not suitable for the environment and poorly installed

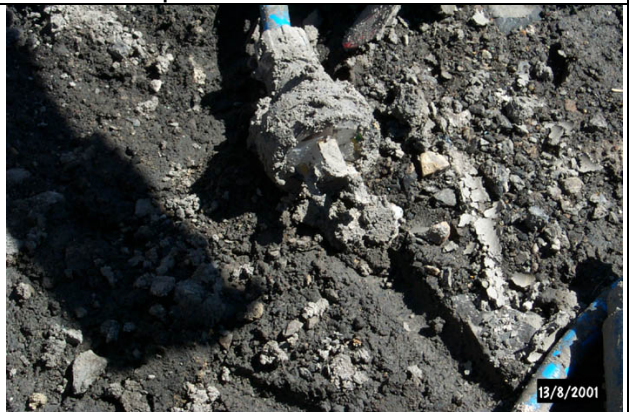
Plug not suitable for the environment, poorly installed and poorly maintained

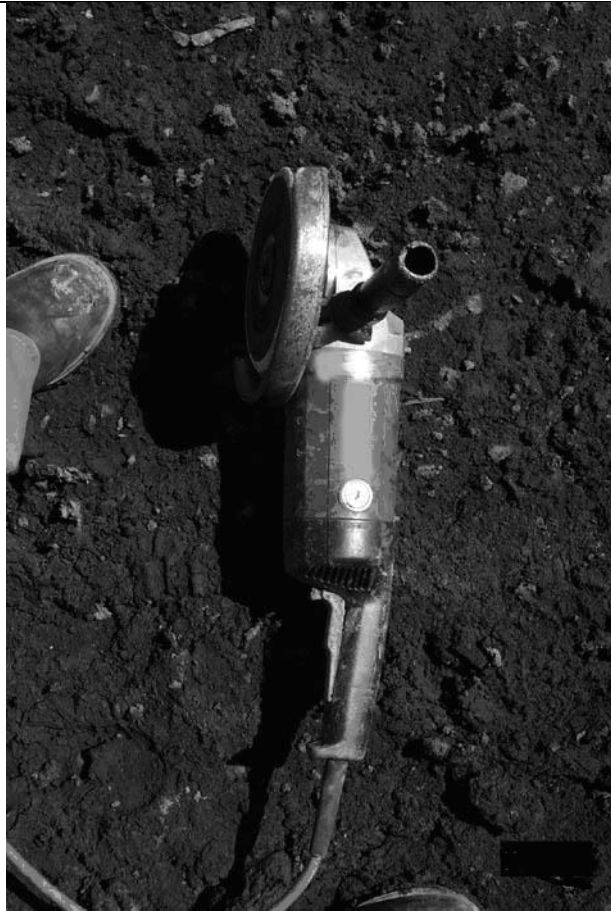
Angle grinder not suitable for the wet and muddy environment

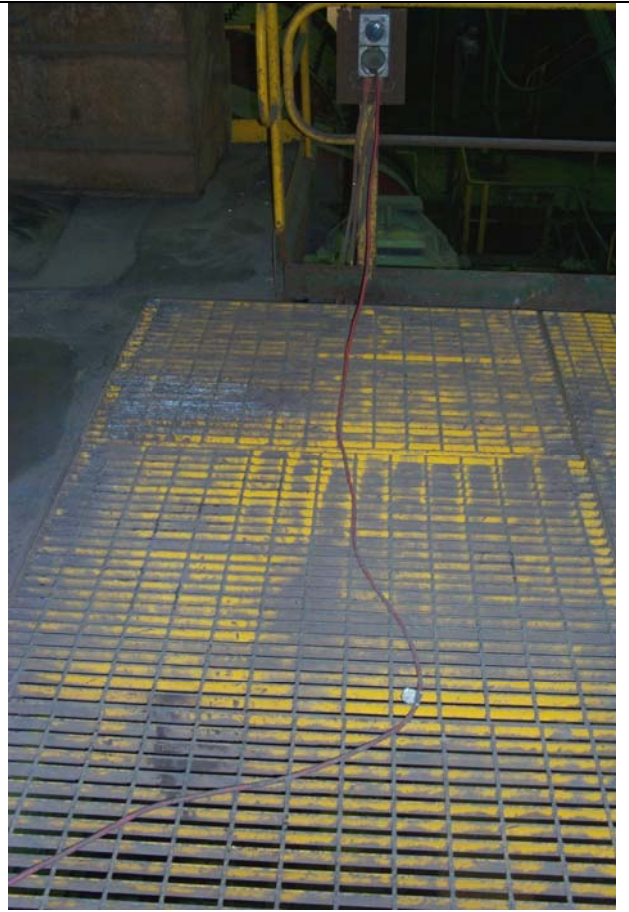
Extension lead poorly installed
