# NSW Minerals Industry OHS Conference 2008

A case study of two NSW DPI incident investigations and the results from testing conducted on a winder haulage rope and chain components

# Case Study One – Failure of a Winder Haulage Rope

## Case Study Two

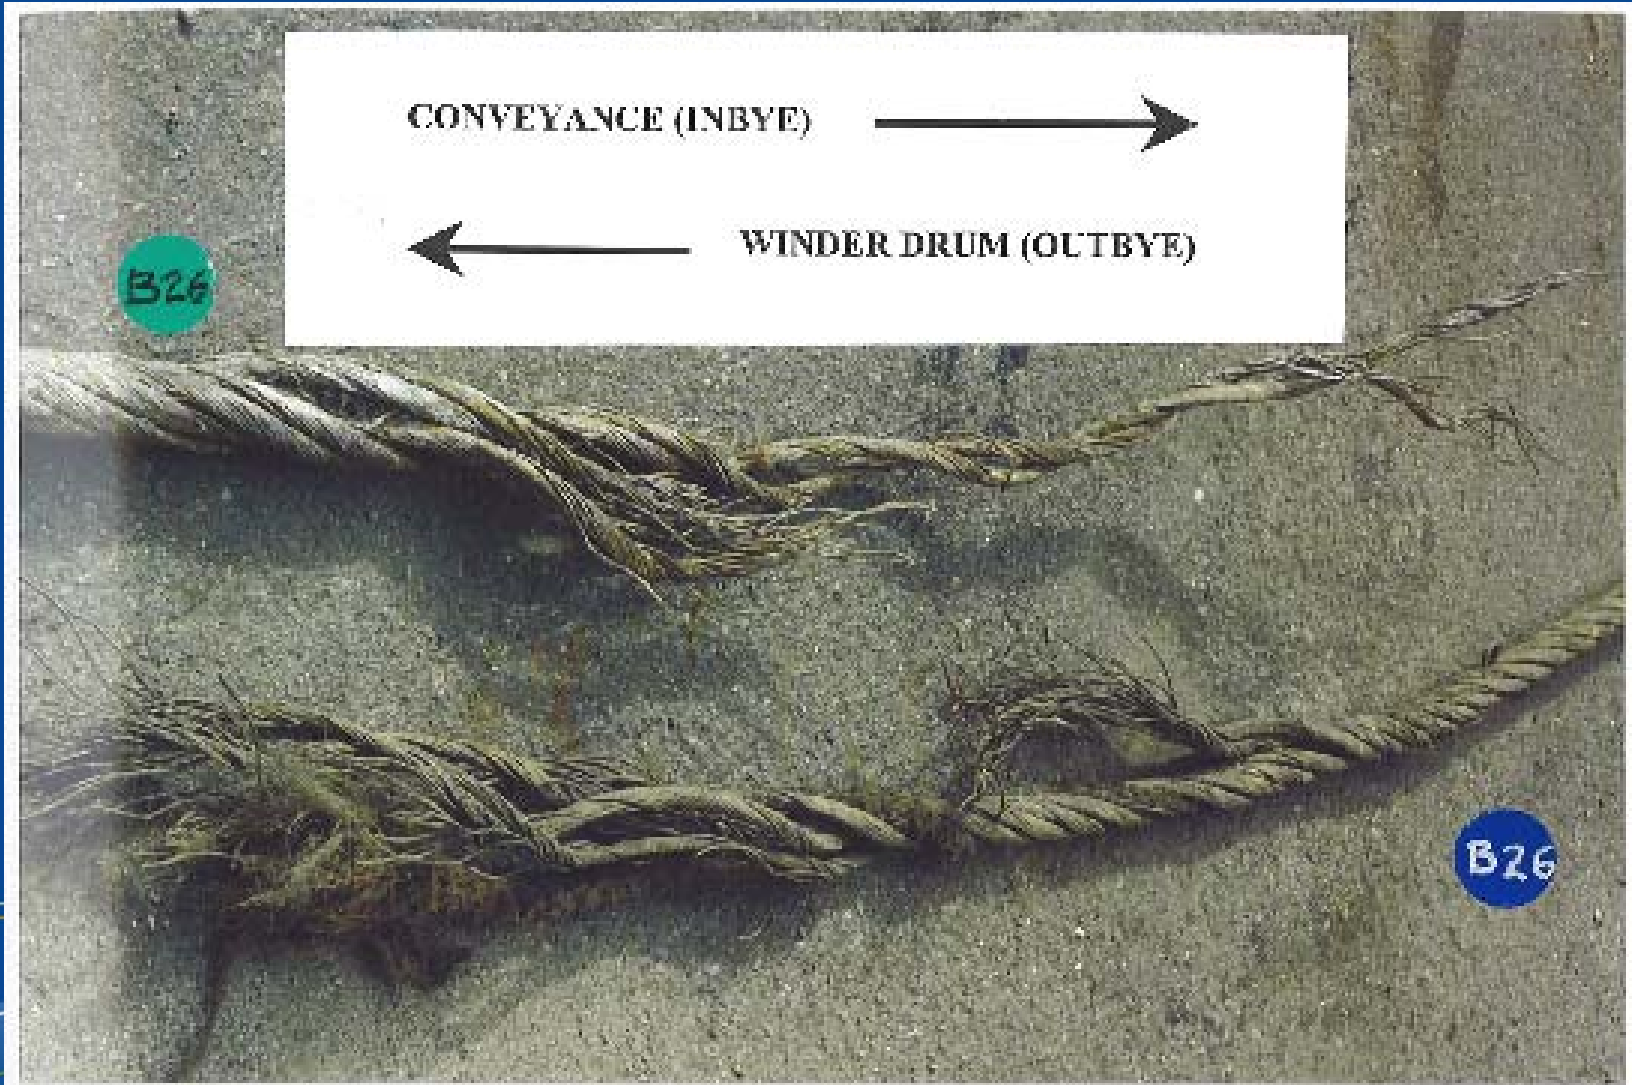
# Failed Haulage Rope

- Incident Date 6 May 1999 the 52mm drift haulage rope broke after being in service for 15 months
- Rope rated at 1828kN (186 tonnes)
- 80 t capacity winding system

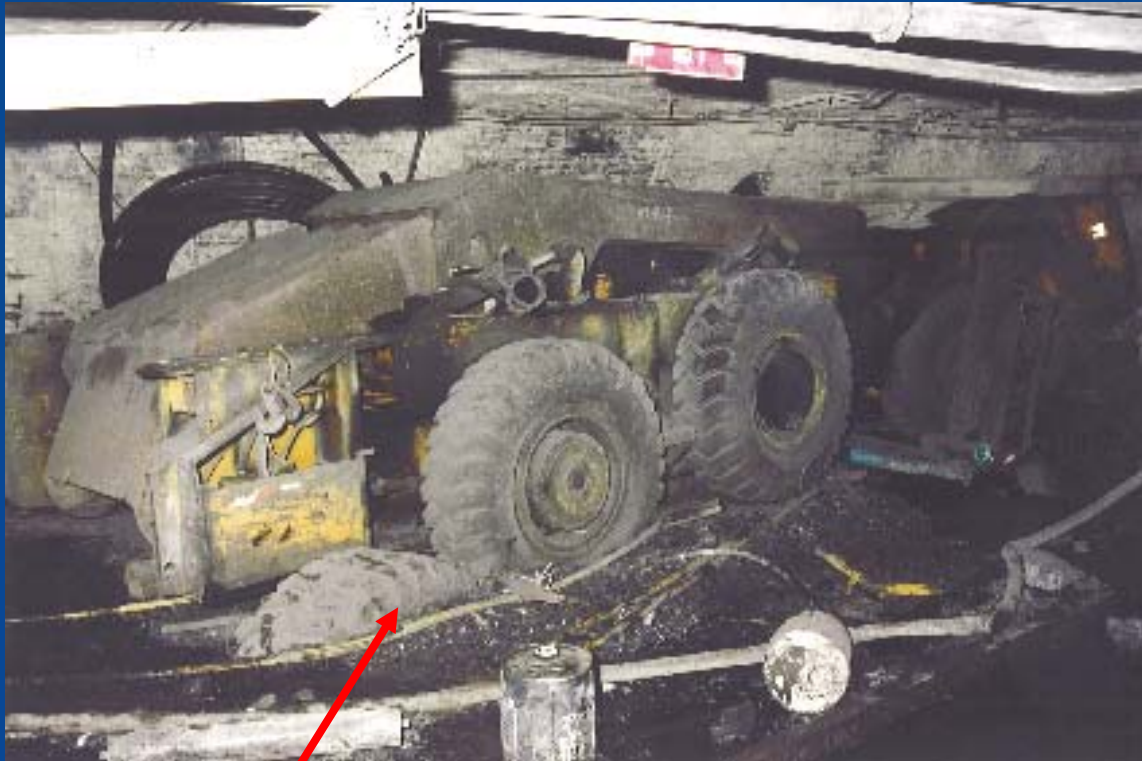
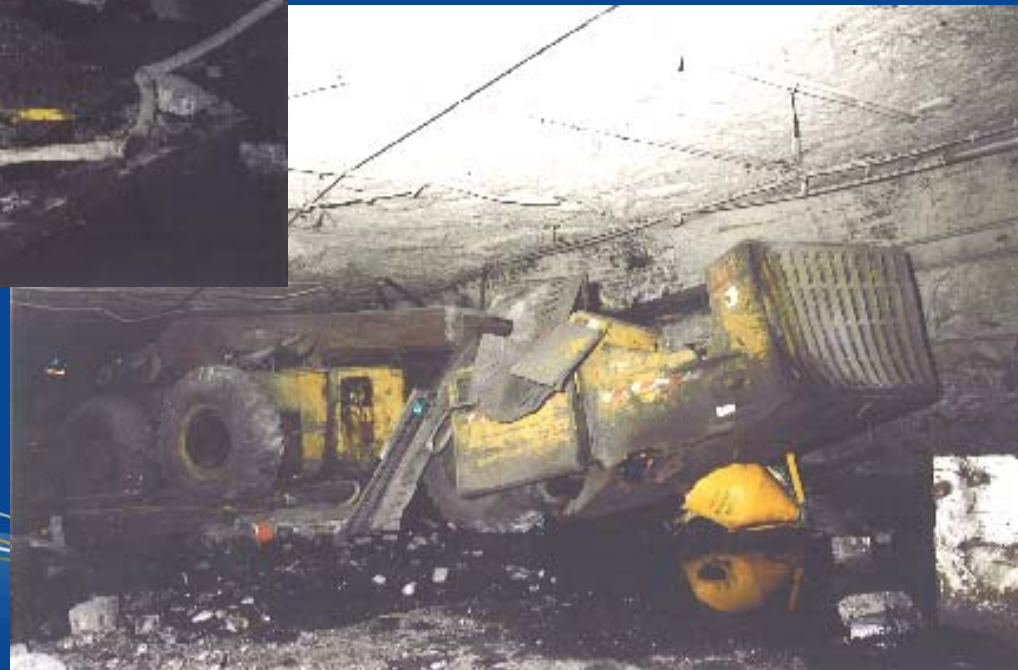
# Consequence of Failed Rope

Longwall chock  
chock carrier  
MPV travelled  
40m from flat top

Tyre tread cut from tyre casing  
as ejected from flat top

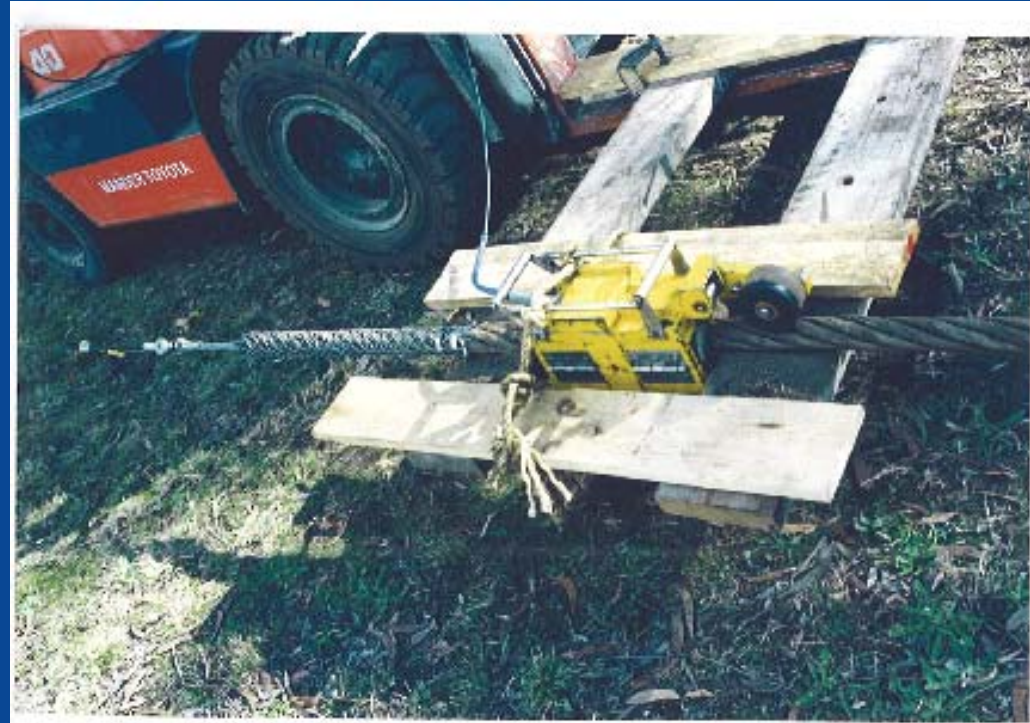
Photograph No. D26 – NDT set-up

- Non destructive testing
  - Inbye 90m of rope NDT
  - Outbye rope NDT examined at wire rope plant

- LMA is not directly proportional to actual loss of strength

- Outer wires contribute 57% to 66% of total strength of wire rope

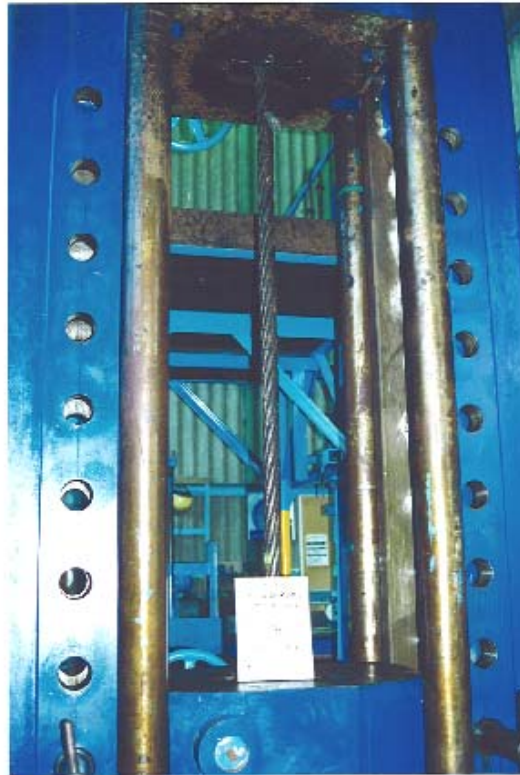
Photo No. 1Y/1 - Rope sample before testing

- Destructive testing
  - Resin end testing
  - Grip testing

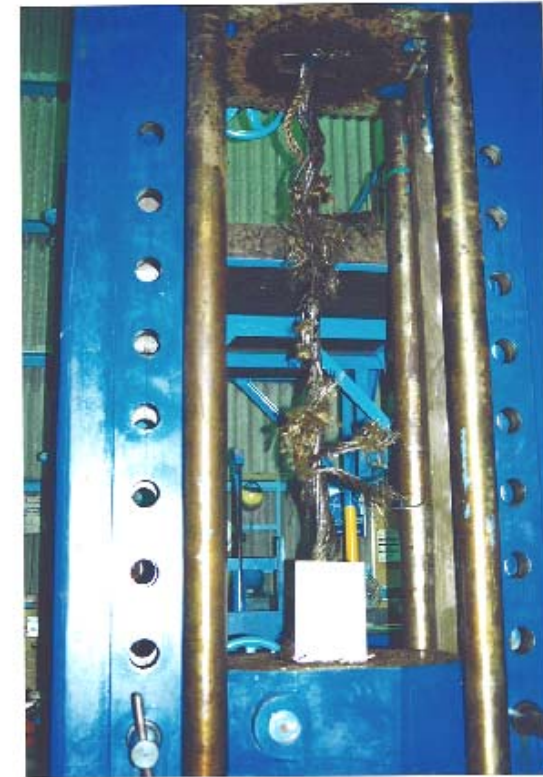
Phot No. 1Y/2- Rope sample after testing

- Relationship between NDT measured LMA and loss of actual strength

- Effects of obstructions in drift were clear

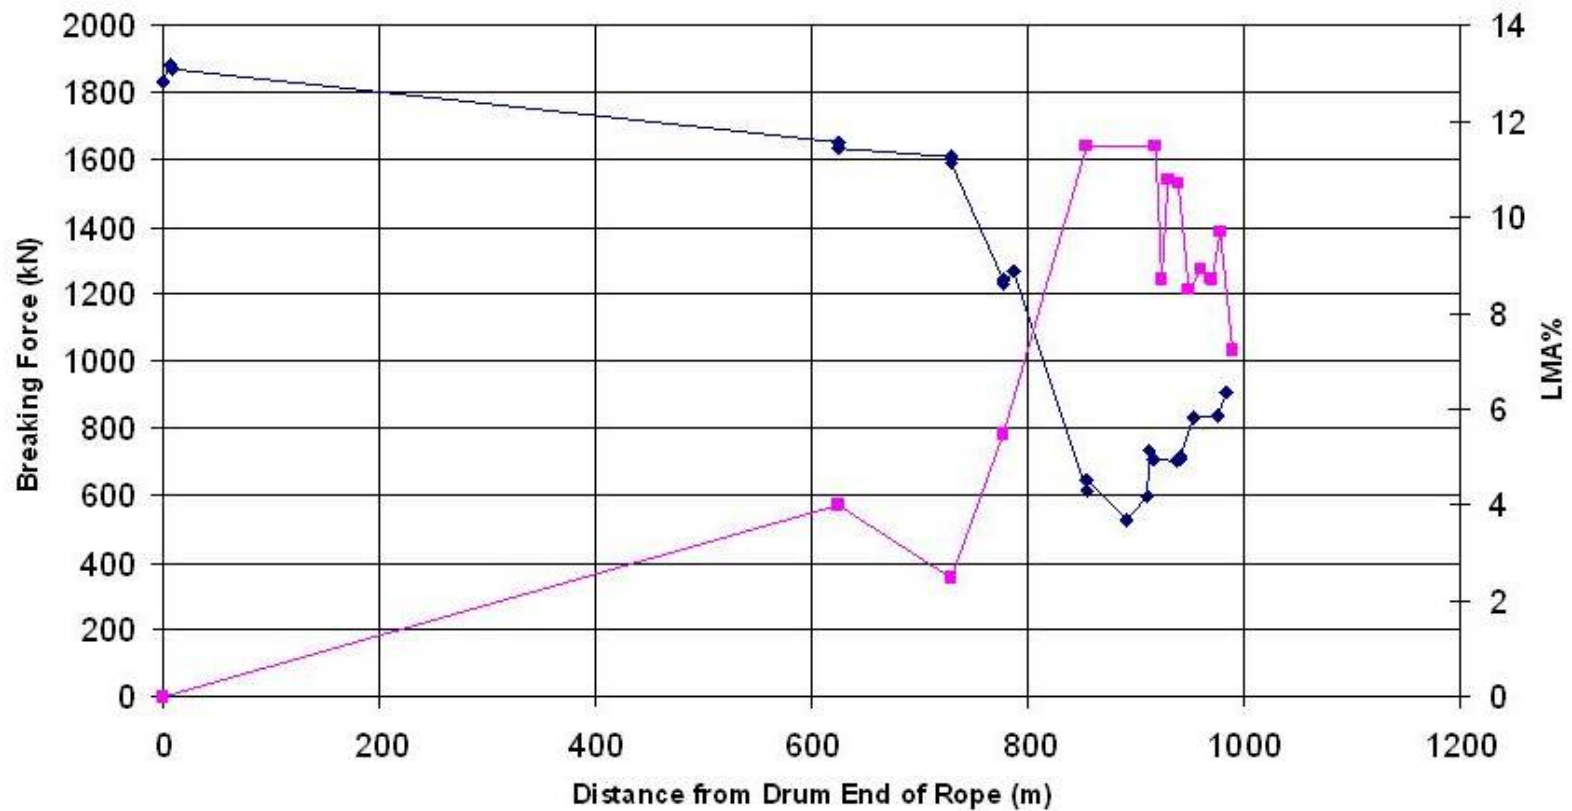
# Breaking Force Vs LMA

**Breaking Force Vs Loss of Metallic Area  
Relative to Position in Rope**

◆ Breaking Force  
■ %LMA

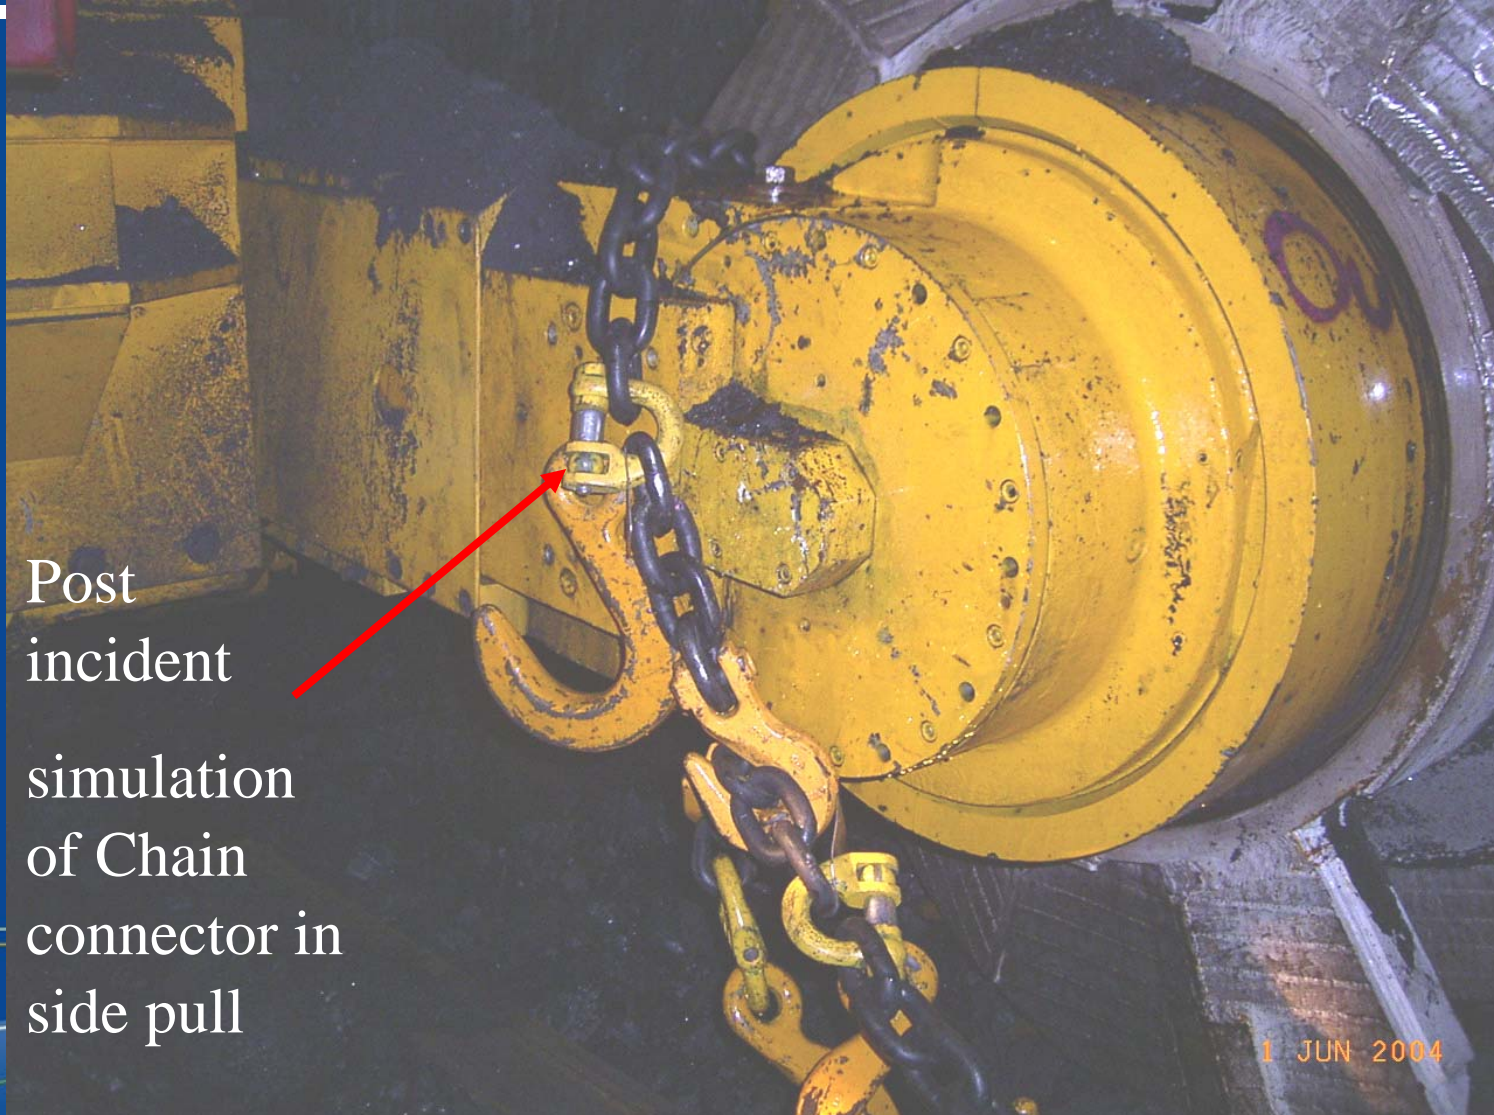
# Chain connectors placed in side pull

- Incident Date 28 May 2004
- Underground coal mine installing a longwall
- Two 1.8m length chain sets reeved around a longwall shearer ranging arm
- 20mm herc alloy chain assembly failed at the connector
- Connector placed in side loading
- Components rated at WLL 9.8 tonne in reeved pull

Post  
incident

simulation  
of Chain  
connector in  
side pull

- Chain sling arrangements in Australian Standards to be modified to reflect best practise .
- *“Assemble only one chain or fitting to each Hammerlock type body half.”*
- Identify working load limits (WLL) of all lifting and pulling equipment

- OEM to assemble chains with only one load bearing component on any one end of a connector
- OEM/Suppliers to supply adequate instructional documentation for assembly, installation and safe use of equipment supplied.
- OEM/Suppliers to identify pulling forces and weight of equipment supplied.

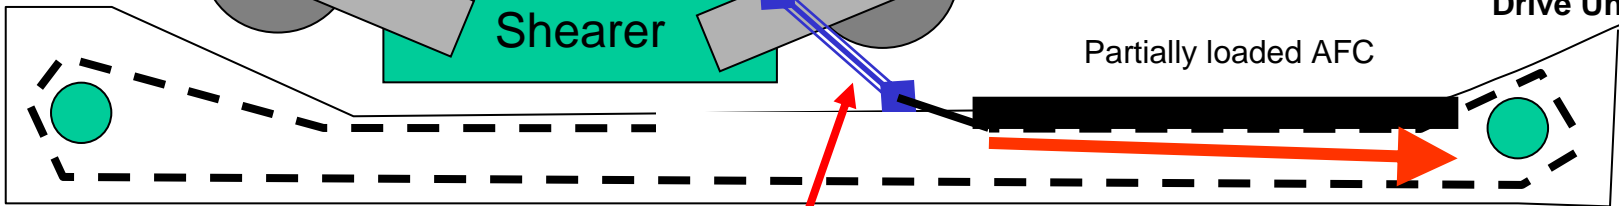
# Effective forces at time of incident

**36 tonne max.  
pull by shearer**

Chain sling assembly  
**WLL of 9.8 tonne**  
in a reeved pull

**Chain  
Component  
Failure**

**Resistance of 269 tonnes**

Maingate drive held  
Stationary by brake system  
1320 kN per strand

Tailgate  
Free to rotate

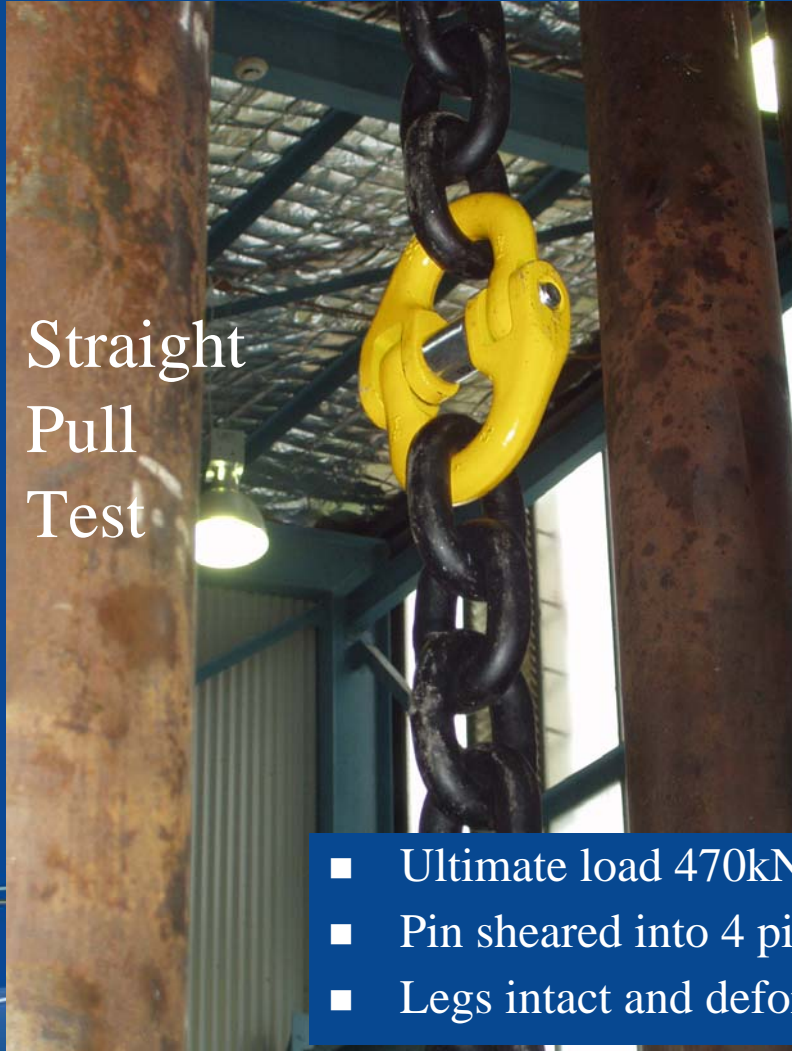
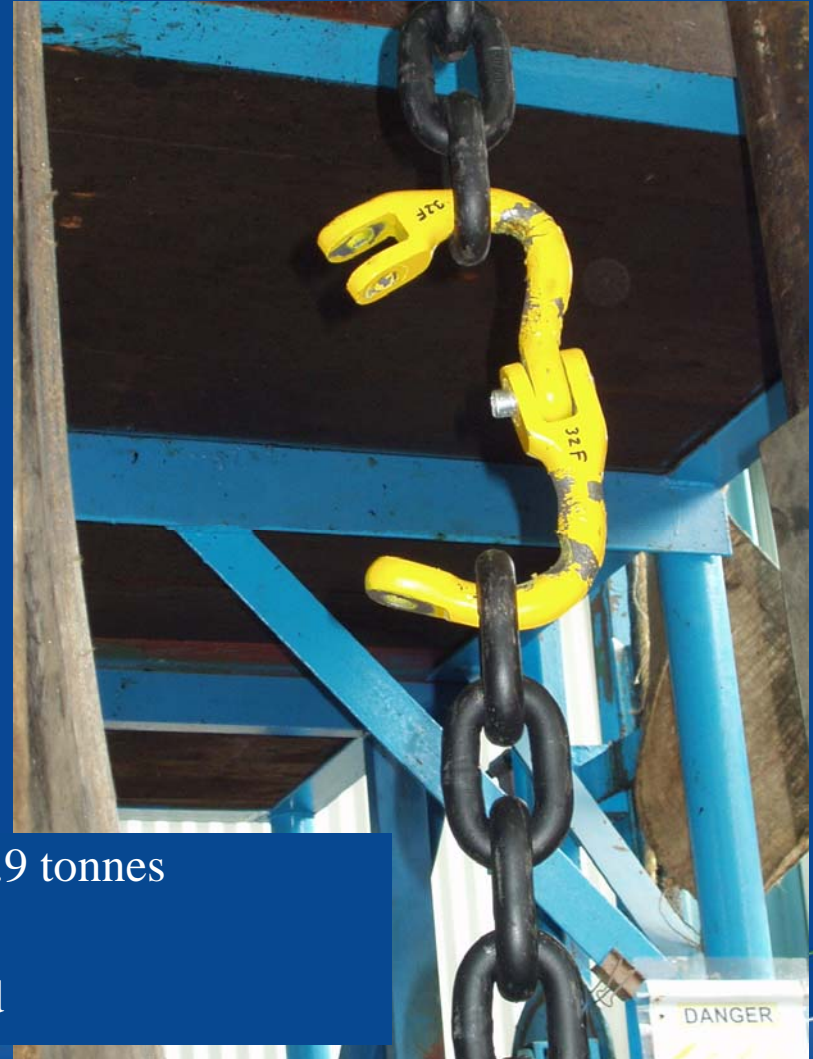
# Connector straight pull test

- Ultimate load 470kN 47.9 tonnes
- Pin sheared into 4 pieces
- Legs intact and deformed

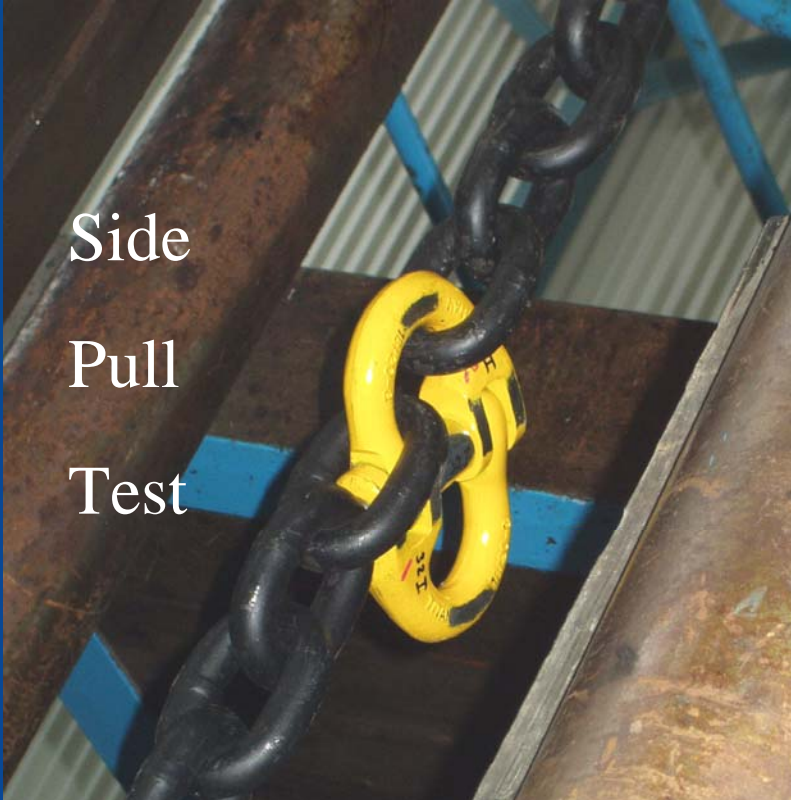
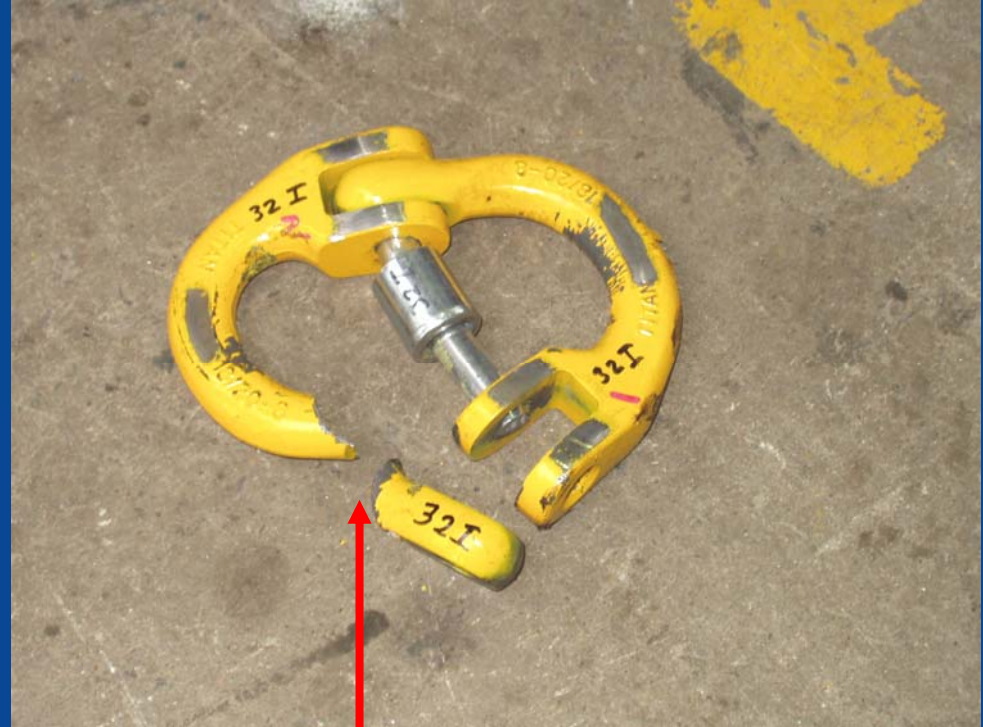
# Connector side pull test

Connector arm failed.  
Similar failure mode to  
connector involved in  
the incident

- Ultimate load 236kN 24.1 tonnes
- Failed connector body near eye
- 52% less than AS 3766-1990 requirement (in straight pull)
