safe diversion of water

Landholder	Ian Clapham – Brooklet Farm Frank Elsworth – Figtree Plantation
Map reference	8
Land use	Macadamias
Soil Erosion Solutions Grant	\$10,000 (earthworks to construct diversion drain, matting to protect drain and grass seed)
Landholder's in-kind contribution	\$16,746 (removal of windbreak, labour)

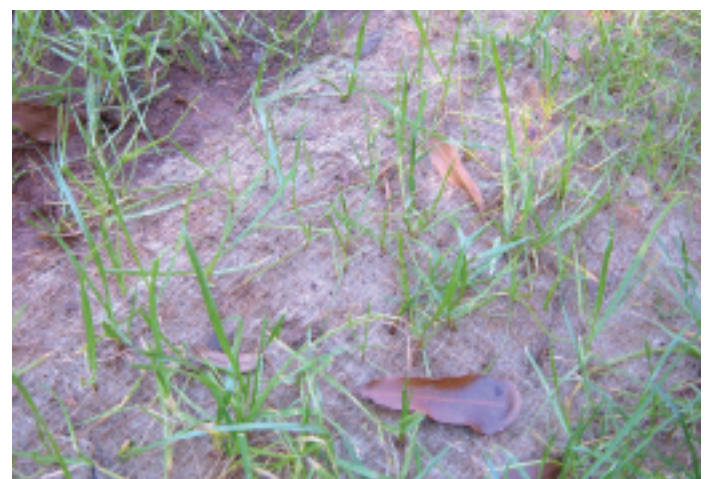
Grass growing through the erosion matting

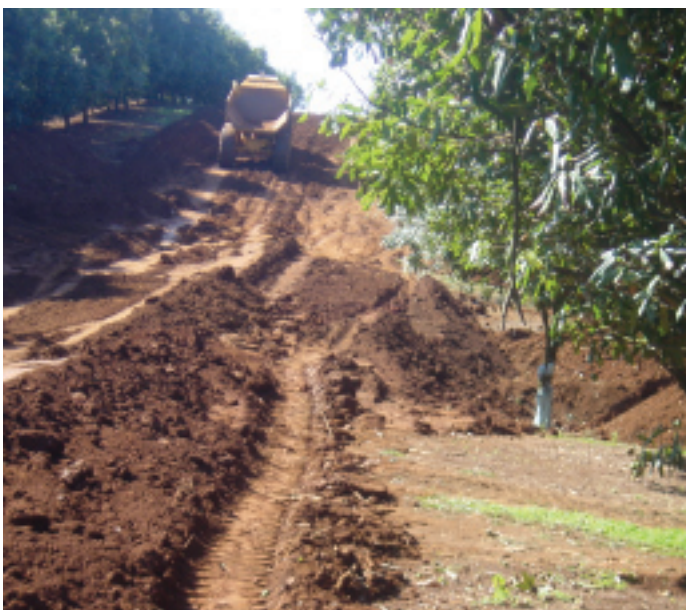
The diversion drain is formed

- The windbreak between the two properties was removed and mulched.
- A broad shallow diversion bank was constructed along the boundary to divert water to the farm dam and into a nearby stable watercourse.
- Excavated soil was used to form low profile mounds along the adjoining eroded tree rows.
- Jute erosion control matting was installed in the high flow area of the new drain to give immediate protection.
- Carpet grass and winter ryegrass were sown in all disturbed areas.
