CASE STUDY – BRINGING BACK THE FISH: NORTHERN RIVERS

GRADYS CREEK ROAD, GRADYS CREEK, KYOGLE

[An extract from: NSW DPI (2005) *Reducing the impact of road crossing on aquatic habitat in coastal waterways – Northern Rivers, NSW*, Report to the Northern Rivers Catchment Management Authority, NSW DPI, Wollongbar, NSW]

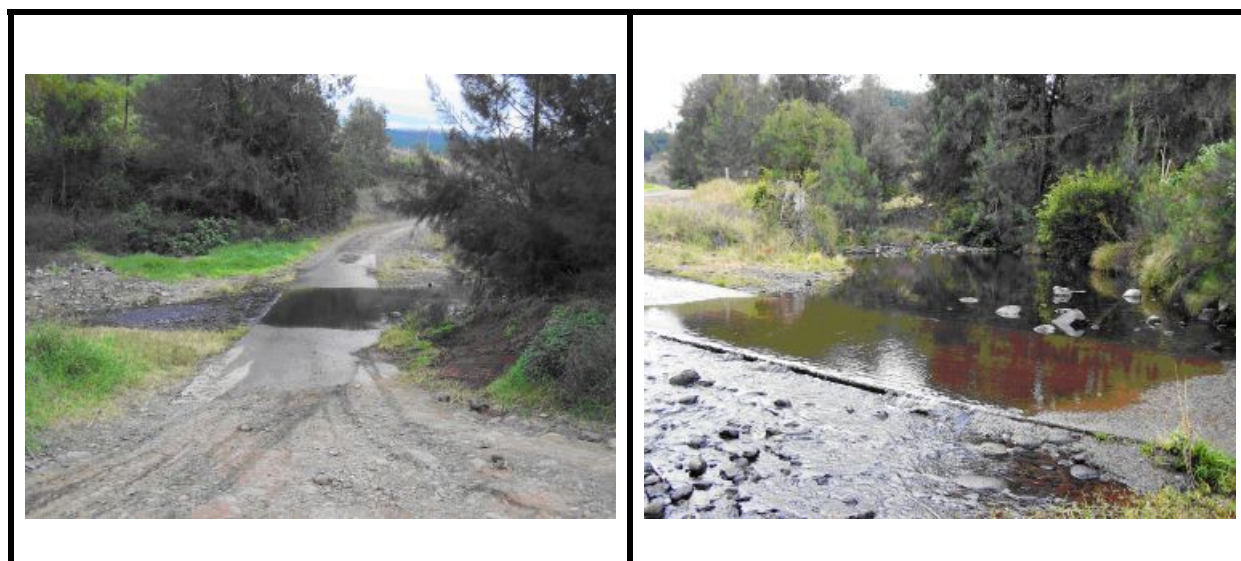
Gradys Creek Road crosses Gradys Creek in the Kyogle Shire local government area. The causeway measured 24 metres in length (from bank to bank) and 4 metres wide, conveying water over the structure in a shallow laminar flow. The crossing prevented fish passage in the upstream direction during low-flow conditions due to shallow flow depths.

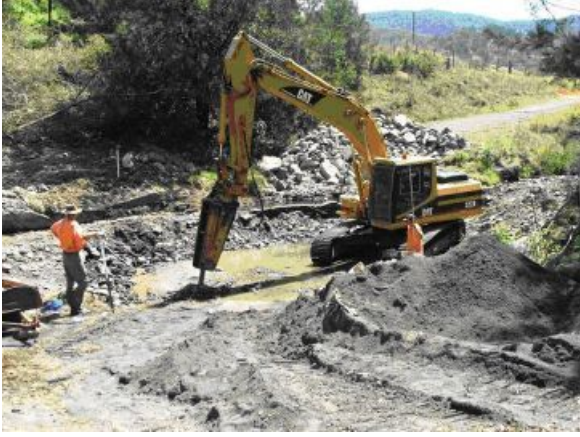
a)

A coffer dam was formed on the upstream side of the causeway to divert water flow through a diversion channel running along the creek's right bank (**Plate a-b**).

The diversion channel was rock protected and underlaid with geotextile fabric to limit bed erosion. The existing causeway, including approaches, was removed using an excavator fitted with a rock hammer (**Plate a**).

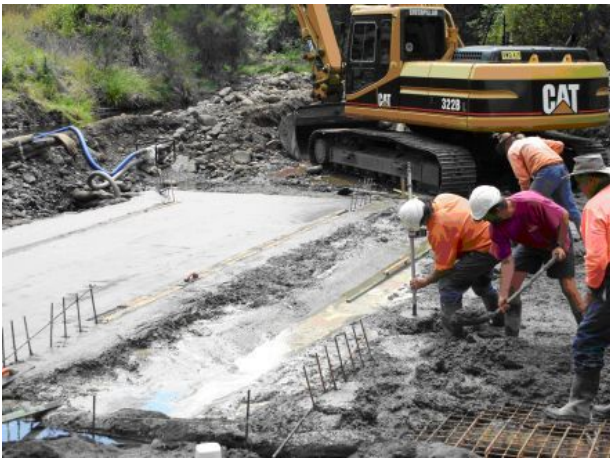
c)

Footings were prepared for the new crossing prior to the insertion of the box culverts, with the middle low-flow channel being formed directly into the concrete slab (**Plate c-d**).

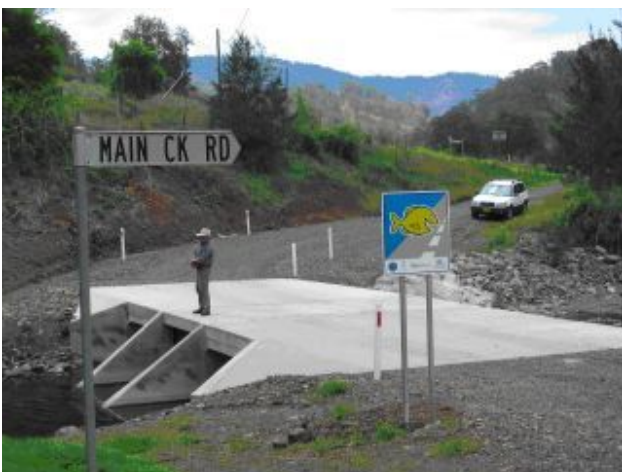
e)

The coffer dam and diversion channel were subsequently removed, allowing stream flow to return through the structure. Approaches for the new road were then graded (**Plate e**), with rock protection being placed on disturbed banks to limit erosion and sedimentation.

were completed over a 6 week period, with Fish-Friendly Road Crossing signs being inserted at the site shortly thereafter (**Plate e-f**).

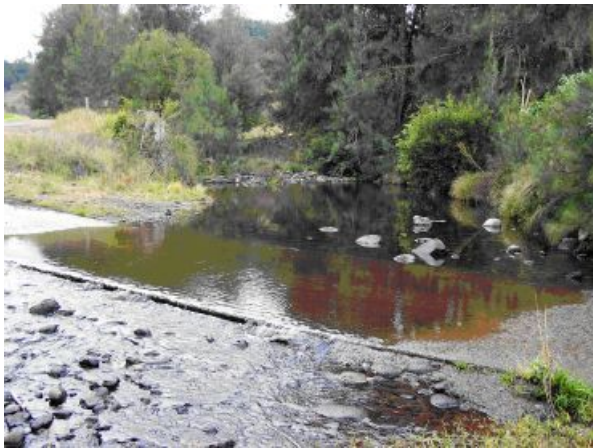
g)

- Improved stream connectivity for native fish species (Plate g-h);
- Education of Kyogle Shire Council of best-practice techniques for the construction of fish-friendly road crossings; and
- Improved safety and reliability of the crossing during minor river rises for ten property owners.
