APPENDIX 6. WETLAND MANAGEMENT STORIES

ROBERT WEBB - “DAPPO”

Where	Narromine, 40km west of Dubbo, NSW
Enterprise	Grazing (sheep)
Size	600 hectares
Wetland area	25 hectares

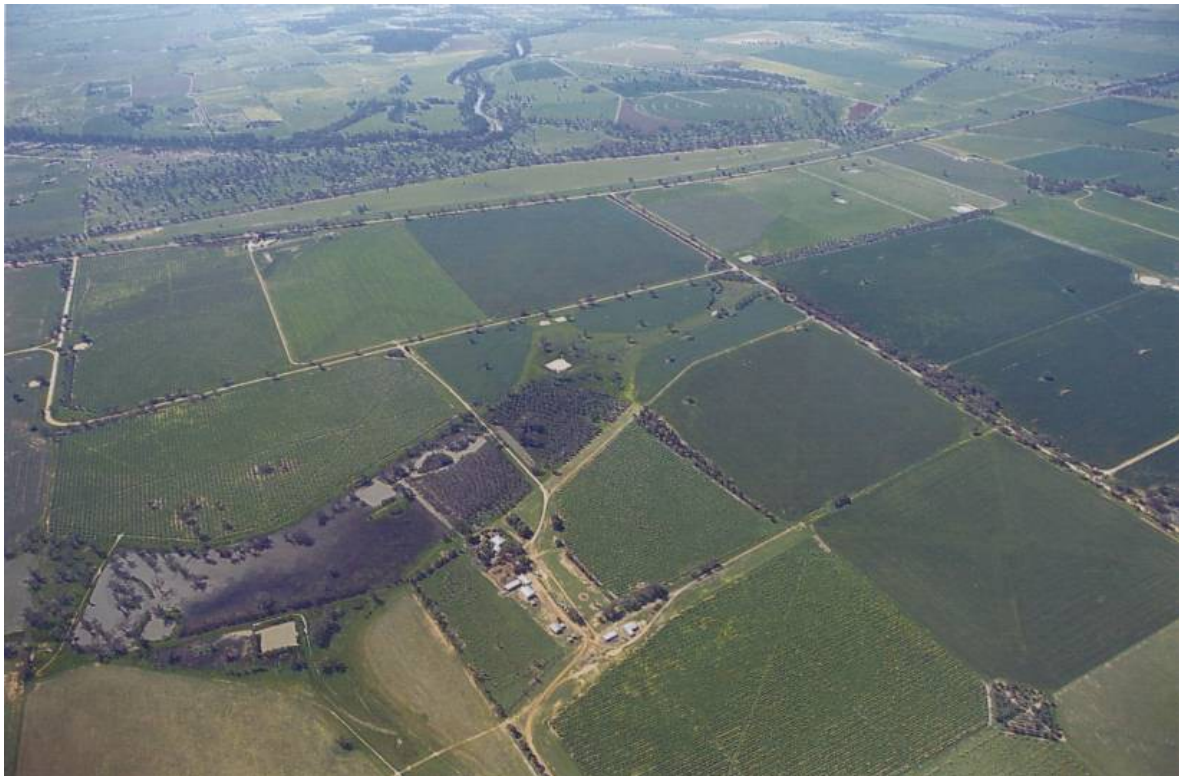
Image 23: Aerial view of the wetland on Backwater Cowal at the property Dappo (view looking north-east with the Macquarie River in the background). The revegetation works commenced in 1993 are obvious at the upstream (eastern) end of the wetland. The road in this area, which connects the two halves of the property, was moved to its present location in 1995. A flow control structure (levee and small weir) was constructed in 1999 and is located at the western end of the wetland (left hand side of the photo).

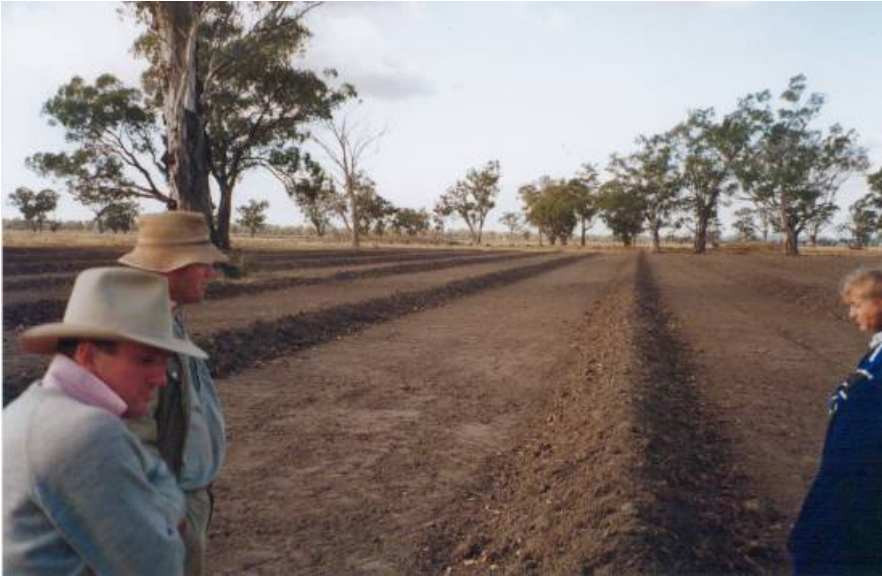
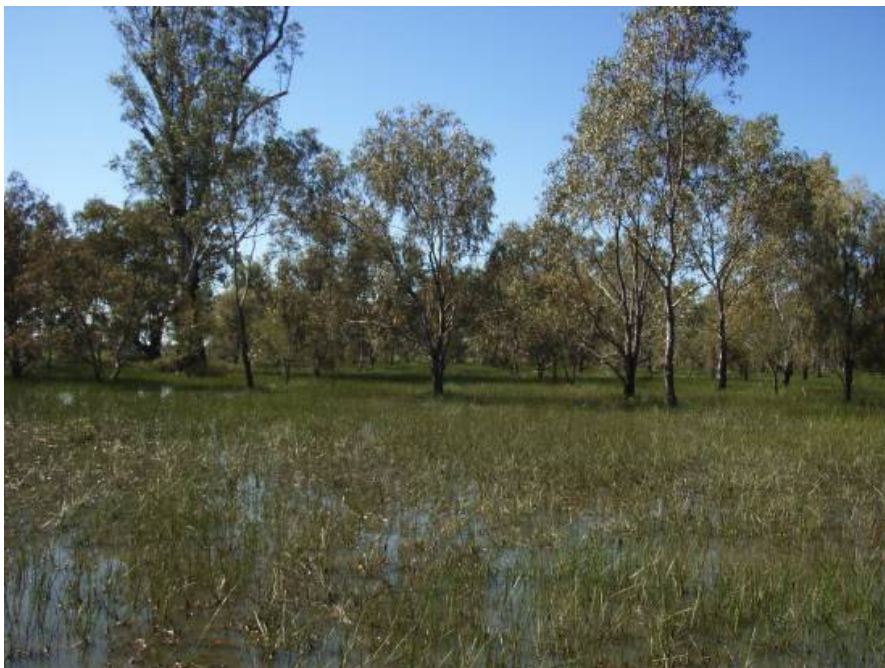
Image 25: Before-and-after photos of the revegetation works carried out at Dappo – the red arrows mark the same spot (above - 1994, below - 2007). Trees were planted into raised beds but the natural regeneration of River Red Gums in particular has now broken up these straight lines somewhat. Once the weir was constructed in 1999, the natural regeneration of wetland plants soon followed (see foreground of lower photo).

The initial revegetation work (1993 – '94) was carried out at the eastern end of the wetland. A grader was used to clear the site and create linear, raised planting beds (see photos on page 69). A range of native trees were planted, the majority of which established well. As was often the case in the early 1990s, this revegetation project included some species that probably would not have occurred in this location originally.

Hindsight is a marvellous thing and as Rob looks back now there are, of course, some things he would have done differently. *'The river red gums we planted grew well, but by the time we fenced the wetland and got the water levels right they just came back by themselves. I'd let natural regeneration do the work if I were starting again.'* However, one advantage of the natural regeneration has been to break up the straight lines created by those first planted trees.

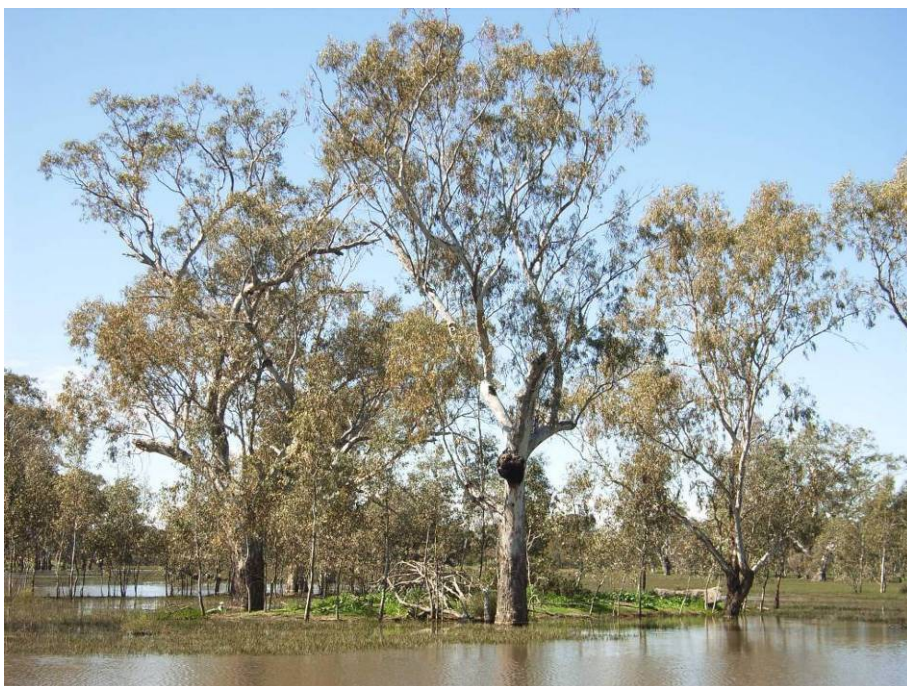
Image 26: Constructed islands such as this one provide valuable nesting sites and reduce the risk of eggs and chicks being taken by foxes.

For ground-nesting waterbirds the taking of eggs and flightless chicks by predators, especially the introduced fox, is a major problem that has been identified as threatening the long-term survival of many species. Islands, and those surrounded by deep water in particular, provide important refuge. A small 'Cato' bulldozer was used to create these nesting islands, but in retrospect an excavator would have done a neater, quicker job.

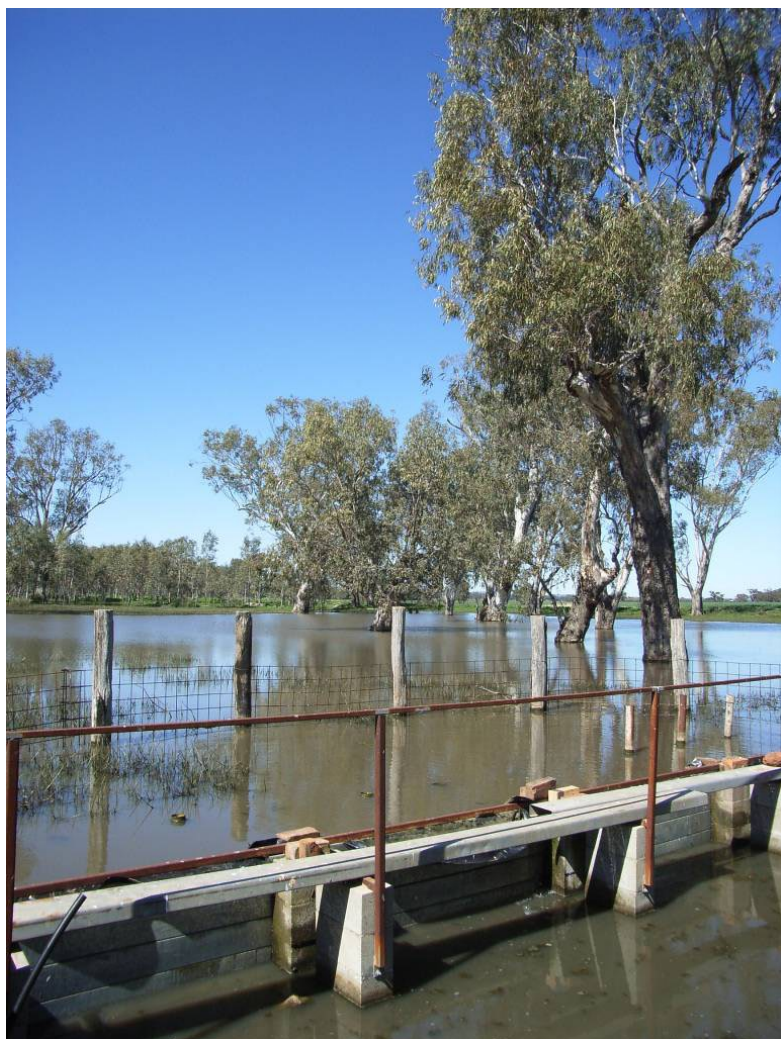
Image 27: Drained in the 1950s, the flow of water in and out of the wetland at Dappo is now controlled by a levee bank and this small weir constructed in 1999.

The weir at Dappo has had an evolving design. Initially, problems were encountered when water falling over the weir wall started to undercut the structure. Added to this, yabbies burrowing under and around the weir were causing leaks. The addition of concrete 'aprons' to the front and back of the weir wall solved these problems. Finally, the inclusion of 'drop boards' (a removable section at the crest of the weir) now enables some manipulation of water levels.
