# **REDUCING THE IMPACT OF WEIRS ON AQUATIC HABITAT**

## **NSW DETAILED WEIR REVIEW**

### **REPORT TO THE NEW SOUTH WALES ENVIRONMENTAL TRUST**

#### **CENTRAL WEST CMA REGION**

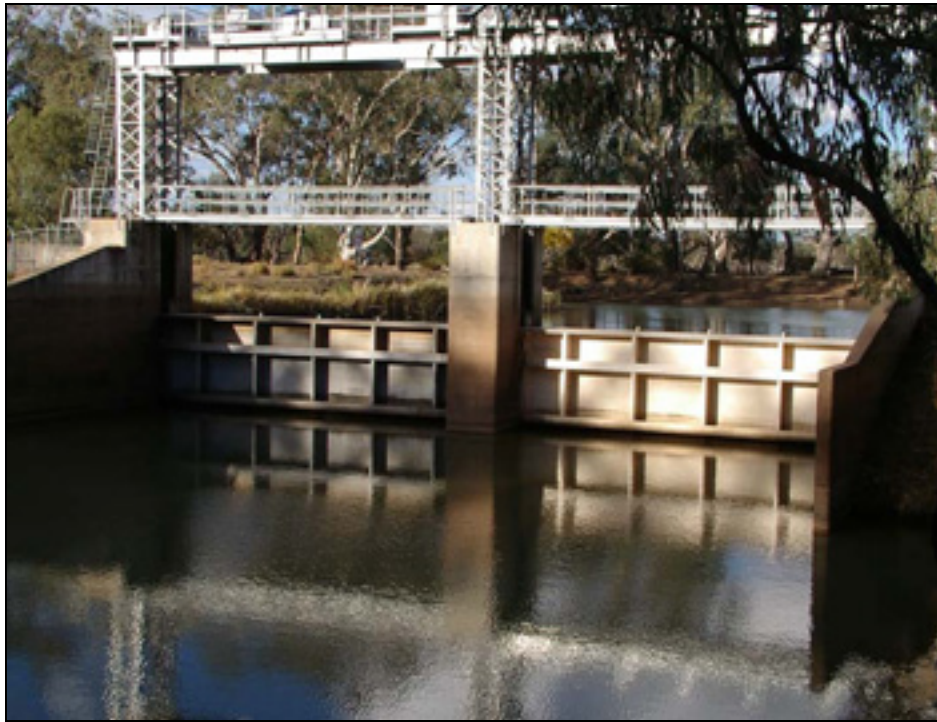
**Figure 1.** Marebone Weir, Macquarie River (19.06.2005, 2.9ML/day).

The weir is approximately 3.3 metres in height and is approximately 30 metres across the length of the crest. Marebone Weir is an undershot structure consisting of two vertical lift gates that act as a barrier to fish passage at all but high flow conditions. In flood or high flow conditions the vertical lift gates are raised to prevent overtopping of the structure. There is currently a dual vertical slot fishway present at the site (Figure 2), which is ineffective at passing fish upstream past the weir but may allow some limited passage downstream.

The concrete weir is owned and operated by State Water and is an adjustable release structure employing two vertical lift steel gates for this purpose. Structural down out of the gated structure does not occur. Limited fish passage may be possible when the gates are raised during flooding conditions, or when infrequent maintenance is carried out on the structure.

It is recommended that the installation of a Deelder fishlock be investigated (Option 1) due to its cheaper cost compared to installation of a vertical slot fishway (Option 2).

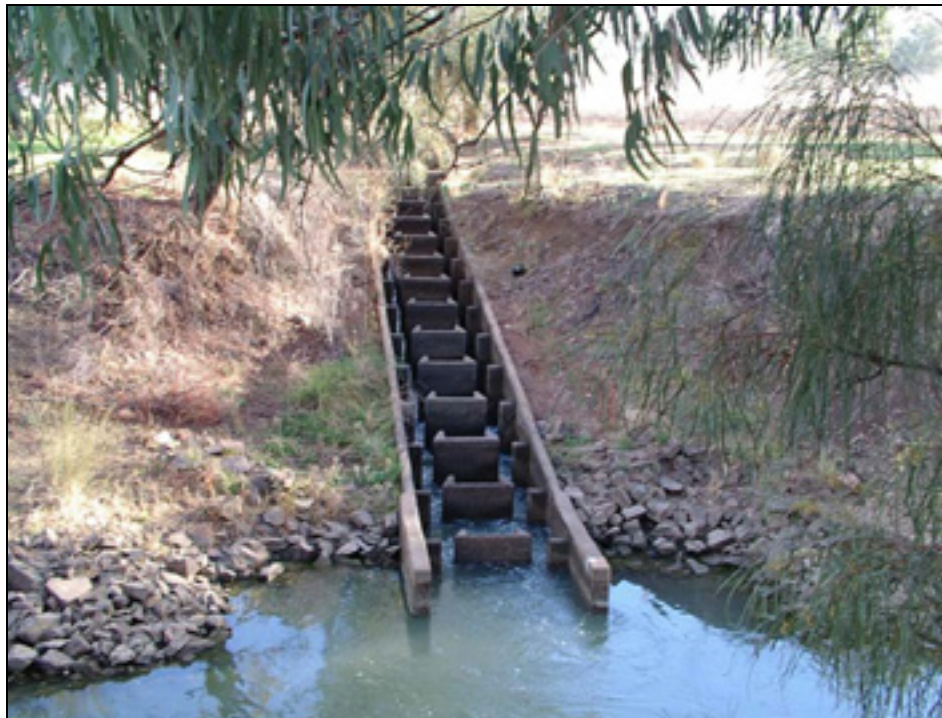
**Figure 2.** Marebone Weir fishway, Macquarie River (19.06.2005, 2.9ML/day).

The fishway is built on a slope of approximately 1:6, which is likely to create an impassable gradient and velocity to native fish species of the Macquarie River catchment in all but very high flow conditions. Excessive head loss and turbulence within the fishway also has the potential to impede fish passage. Although it is unlikely that upstream fish passage is possible, there may be some limited fish passage in a downstream direction.

The entrance to the existing fishway is too far downstream, making it difficult for fish to find. Should any refurbishment or replacement of this structure occur, it is recommended that the downstream fishway entrance be moved closer to the lift gates, so that it is more easily located in all flow conditions.

The removal of the existing fishway and its replacement with a vertical slot fishway is also a viable option at Marebone Weir. Vertical slot fishways are considered one of the most effective fishway designs and is the preferred option where threatened species are present (this site is within the expected distribution of silver perch, olive perchlet, and purple spotted gudgeon) and when located on the main stem or major tributary of a waterway.

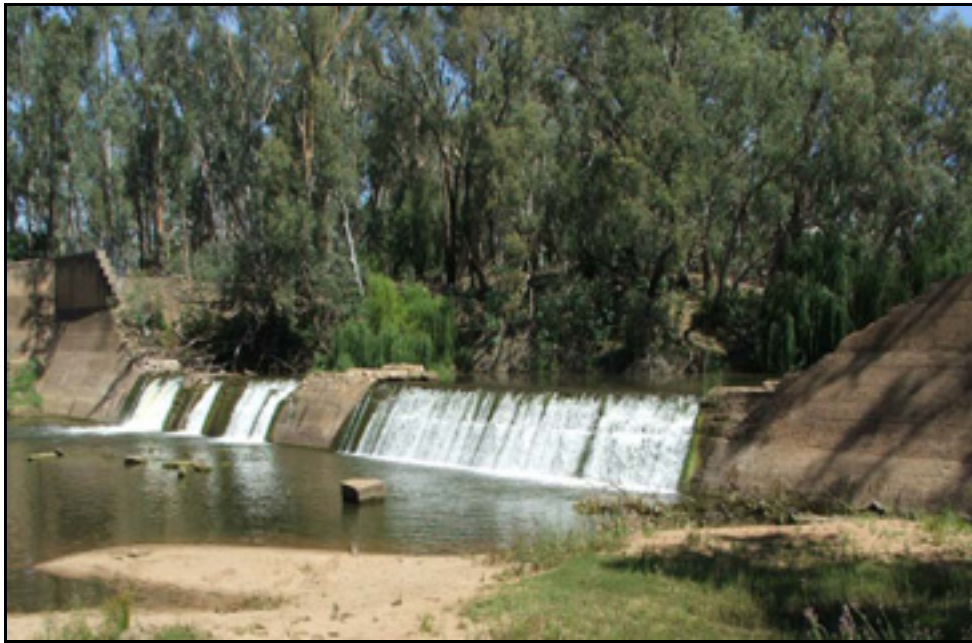
**Figure 1.** Gin Gin Weir, Macquarie River (21.12.2004, 333ML/day).

The weir is owned and operated by State Water. Construction of the weir began in 1896 for the conservation of water for irrigation, stock and domestic supply in the Macquarie River, and to divert water down Ewenmar Cutting into Crooked and Ewenmar Creeks. Currently the weir does not back up water far enough for the diversion of water into these creeks. The weir is also currently used for recreation, and is valued by the community for its aesthetics. It is believed that damage to the weir occurred in 1903, and was later blasted to reduce the crest height to its current level of 4 metres (Opus and Golder 1999). No regulating infrastructure is associated with the weir, and there is no fishway present.

It is recommended that a vertical slot fishway (Option 1) be considered for the remediation of fish passage at this site. The Deelder fishlock could also be considered if a power supply could be sourced at this site.

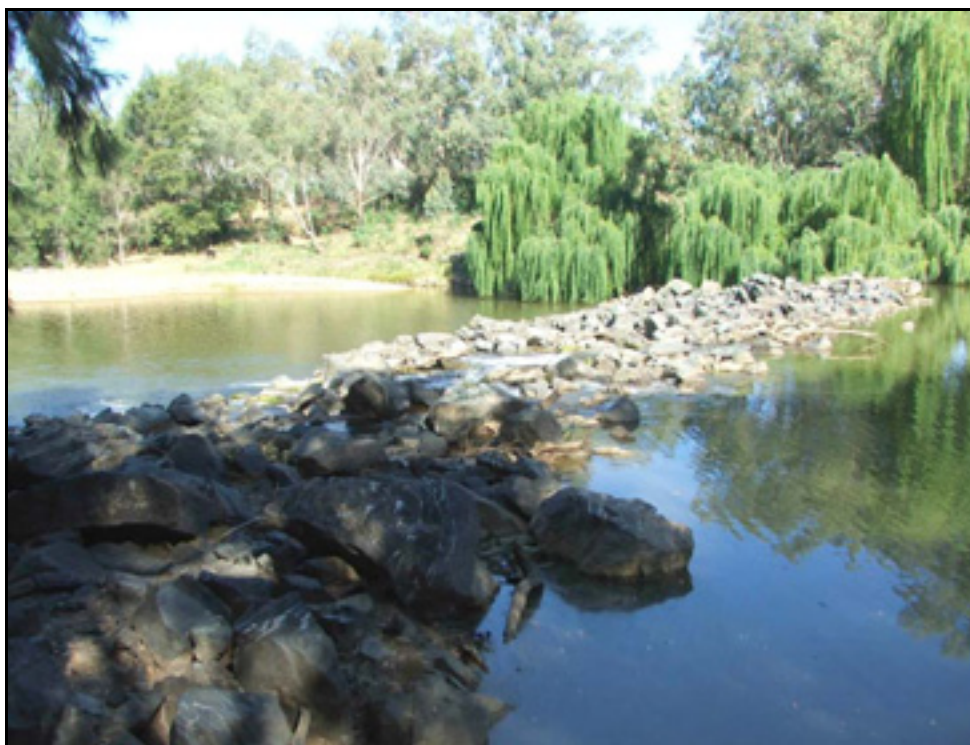
**Figure 1.** Narromine Council Weir, Macquarie River (21.12.2004, 333ML/day).

All options will require modification of the crest of the weir to create a low flow channel at or near the fishway. Currently there is large rock approximately 400mm in diameter with large crevices across the entire structure, in some places water appears to be flowing through the rock and not cascading over the top of the structure. During the site inspection, several native and exotic fish species were observed dead in the rock work after becoming trapped. It is recommended that some of the large rock be removed to the level of the maximum headwater height, and smaller rocks placed to form a low flow channel. In addition to the rock ridges, geofabric should be used to line any rock ramp fishway to maintain a minimum depth of 500mm within the fishway and assist the upstream movement of fish.

This current rock fill weir may require major modifications to facilitate the installation of a vertical slot fishway, such as the construction of a concrete retaining wall parallel with the rock crest. Geofabric would also be required to line the upstream side of the weir to prevent water leaking through the structure and direct water through the fishway. In addition, the weir would need to be lowered significantly on the side where the fishway is to be installed to ensure adequate attraction flows were created. The cost of the vertical slot fishway is based on a broad estimate of \$150,000 per vertical metre, although this is dependant on site location, access and various structural and hydrological constraints.

As the weir does not drown out regularly, it is recommended that fish passage options be further investigated at this site. It should be remembered that it is important to try and achieve fish passage for all species and life stages, rather than focusing on the traditional iconic adult recreational species.

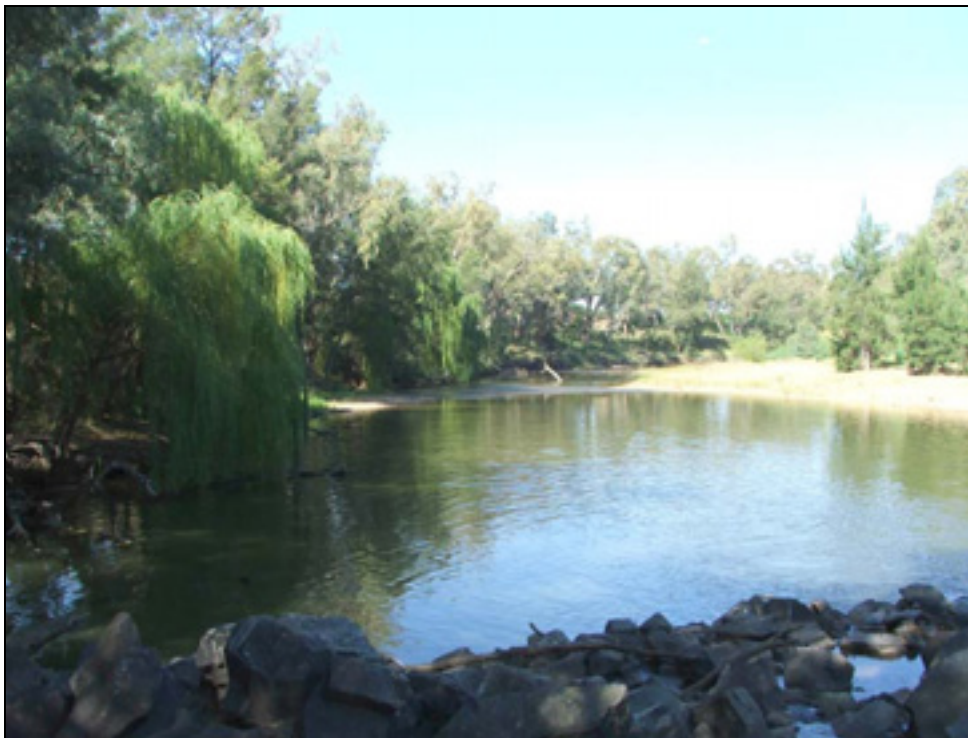
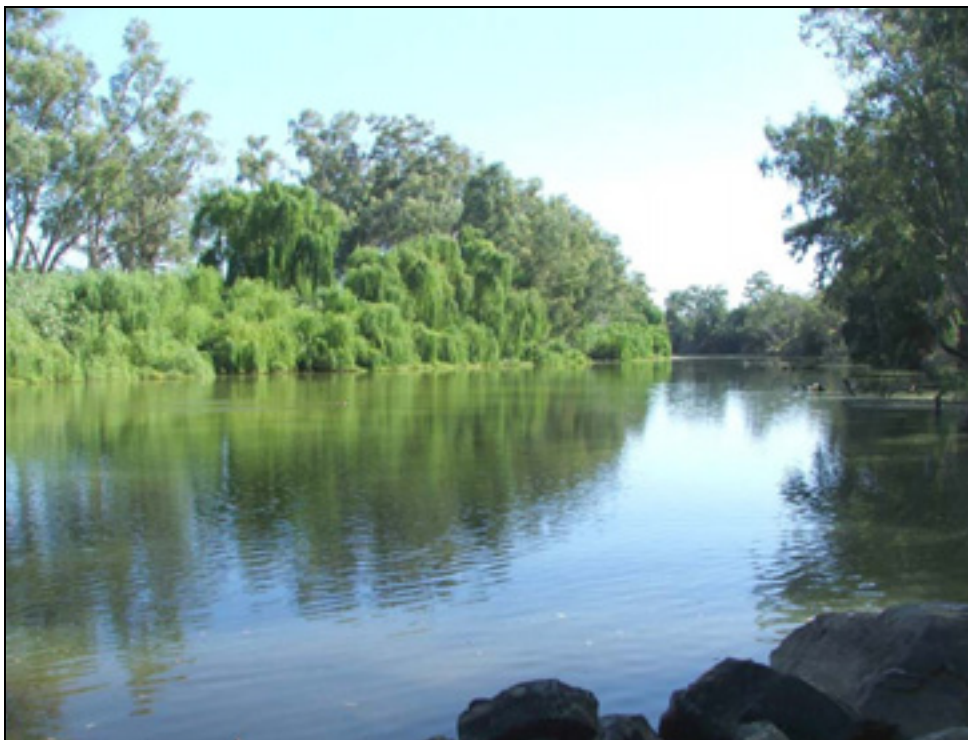
The Macquarie River at Narromine is just beyond the limit of cold water pollution from Burrendong Dam. The site possesses some important fish habitat components including instream large woody debris, which provides valuable shelter for fish from strong water currents and larger avian and aquatic predators. In addition, woody debris also provides an important substrate for fish to lay eggs and for the growth of algae (thereby creating a food source for macroinvertebrates). The weir site has moderately vegetated banks either side of the weir, with native species, willows and other pest plant species present upstream and downstream of the site (Figures 2 and 3).

**Figure 2.** Macquarie River downstream of Narromine Shire Council Weir (21.12.2004, 333ML/day).

**Figure 3.** Macquarie River upstream of Narromine Shire Council Weir (21.12.2004, 333ML/day).

The removal of pest species is advised in conjunction with any fish passage remediation works at this site to enhance the habitat available to native fish.

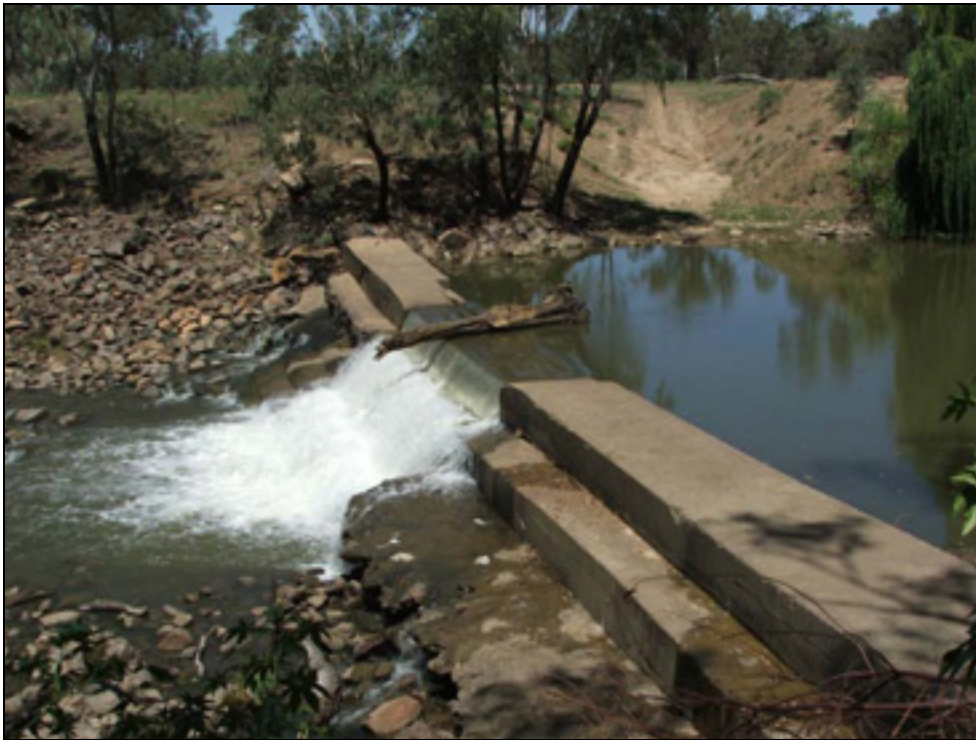
**Figure 1.** Warren Shire Council Weir, Macquarie River (22.12.2004, 210ML/day).

At the time of the inspection the structure was leaking and Council were concerned about the structural integrity of the weir. Council were advised that as this weir was a priority site in the Central West CMA, and that fish passage should be investigated. Council were also advised that if the weir was modified, provision of fish passage was a requirement of the *NSW Fisheries Management Act 1994* which states that “the Minister may require a person who constructs, alters or modifies a dam or weir to provide fish passage”. Consultation must be carried out with NSW DPI if future works are planned at this site.

As this weir drowns out very infrequently, it is recommended that fish passage options be further investigated at this site. The weir currently leaks, indicating that structural modifications to the weir would be required prior to the construction of any fishway, and repair work providing an ideal opportunity to undertake fish passage remediation at this site. It should be remembered that it is important to try and achieve fish passage for all species and life stages, rather than focusing on the traditional iconic adult recreational species.

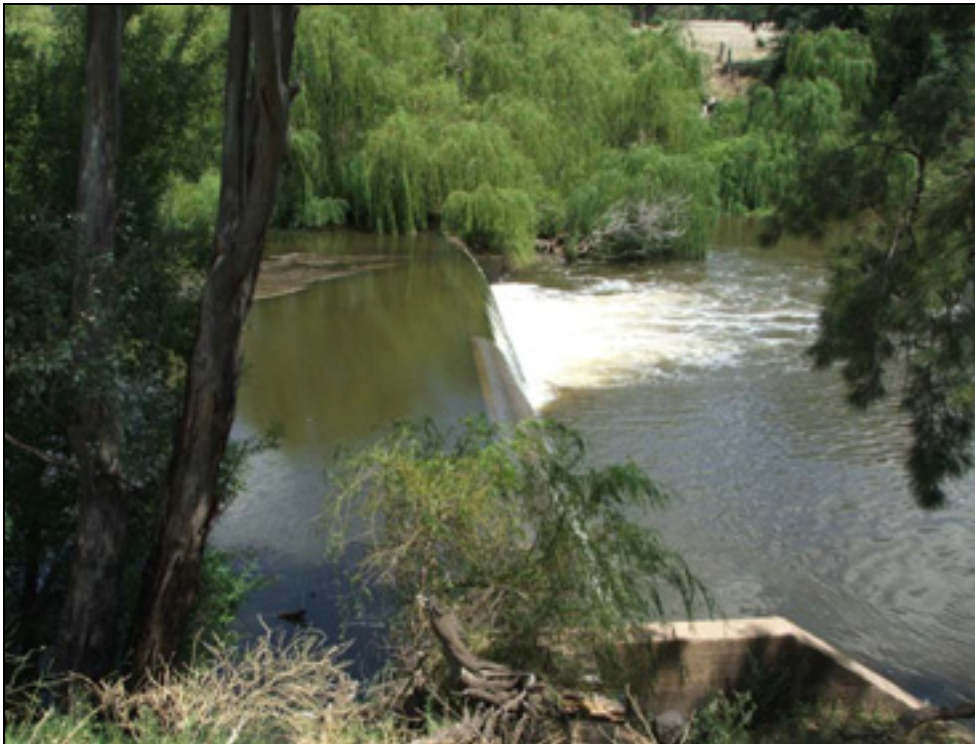
**Figure 1.** Dubbo City Council Weir, Macquarie River (21.12.2004, 377.5ML/day).

Dubbo City Council Weir was built in the 1930's to secure town water from the Macquarie River and was last modified in 1989. The weir is constructed of concrete with a canoe chute located on the left hand bank, although there is currently no fishway present. The weir is owned and managed by Dubbo City Council. At the time of the inspection willows were observed to be colonising the area adjacent to the structure, with concerns being expressed by Council about the structural integrity of the weir if the willows were to remain.

The construction of a vertical slot fishway (Option 1) is the preferred option for fish passage remediation at this site. The structural integrity of the weir must be addressed prior to construction of any fishway. Willow removal at the weir is recommended at this time.

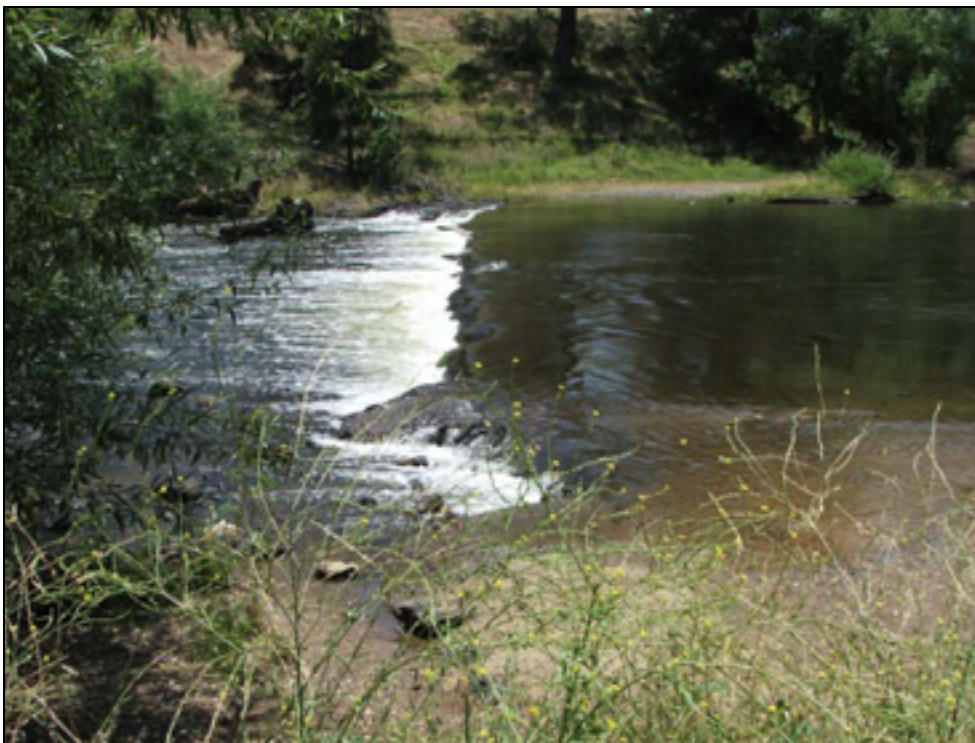
**Figure 2.** Falls Road Crossing upstream of Dubbo City Council Weir, Macquarie River (22.12.2004, 452ML/day).

In addition, it is recommended that fish passage options be addressed at the Falls Road crossing upstream of this site (Figure 2). A partial width rock ramp fishway with a low flow channel across the road could be constructed on the crossing. An assessment of the vehicle traffic load and continuing need for the crossing should also be carried out.

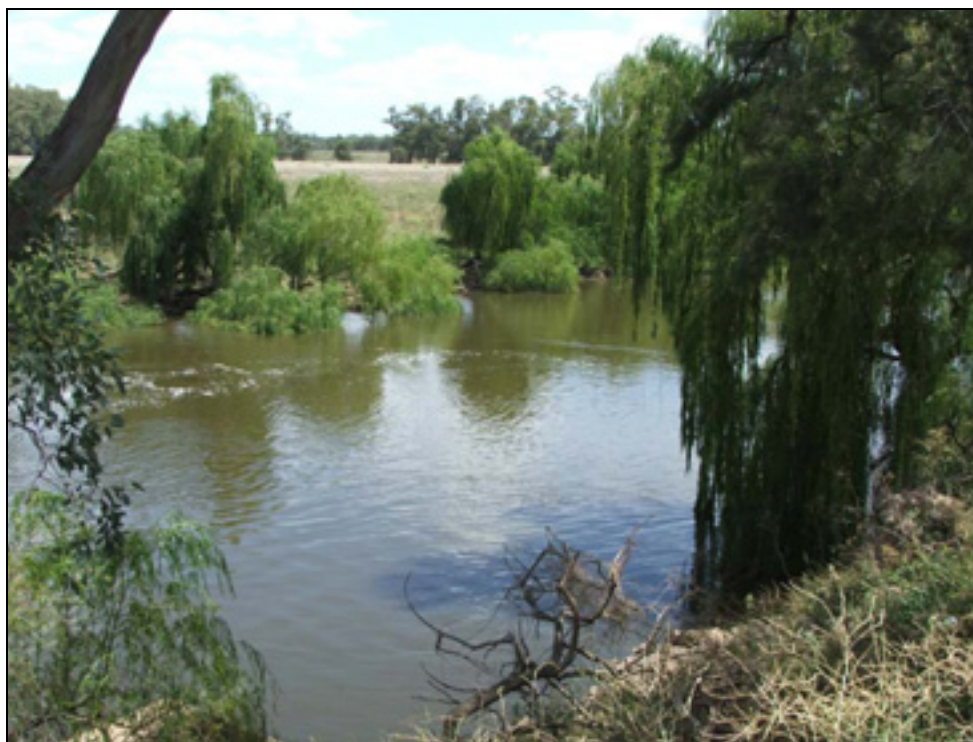
**Figure 3.** Macquarie River downstream of Dubbo City Council Weir (21.12.2004, 377.5ML/day).

The weir site has moderately vegetated banks either side of the structure (Figure 3). Willows and other pest plant species are present upstream and downstream of the weir. The removal of these pest species is recommended in conjunction with any fish passage remediation works at this site to enhance the habitat available to native fish.

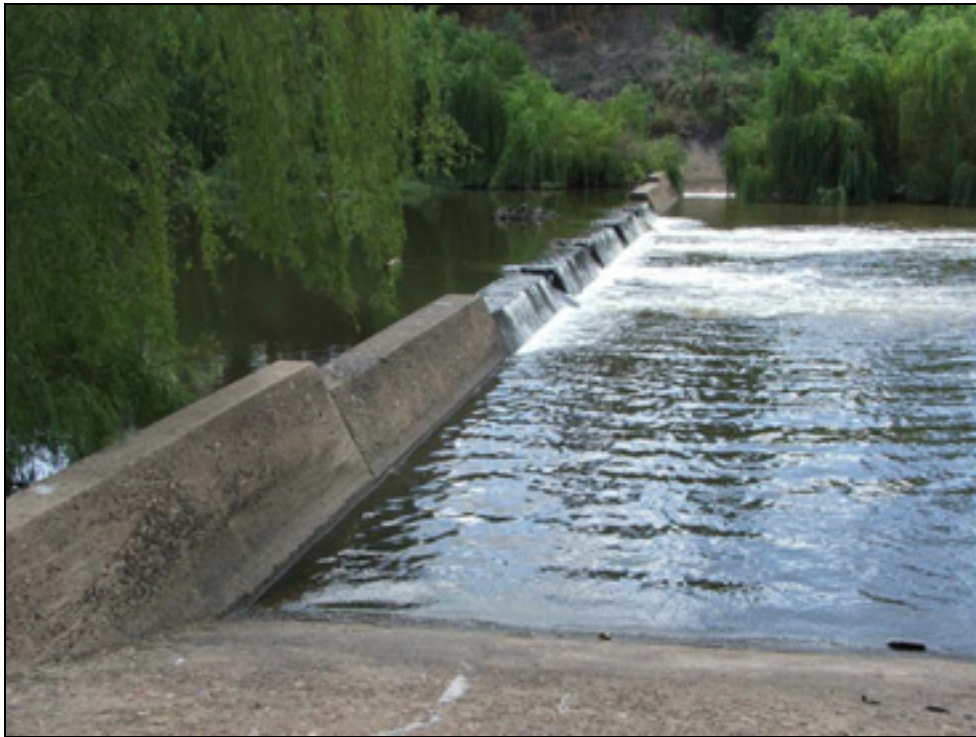
**Figure 1.** Dubbo Weir, Macquarie River (21.12.2004, 377.5ML/day).

As this weir does not drown out regularly, it is recommended that fish passage options be further investigated at this site. It should be remembered that it is important to try and achieve fish passage for all species and life stages, rather than focusing on the traditional iconic adult recreational species.
